# Watershed Study No. 4

## Four Mile Creek Watershed

Preliminary Engineering Report

MCSWS Project No. 61001

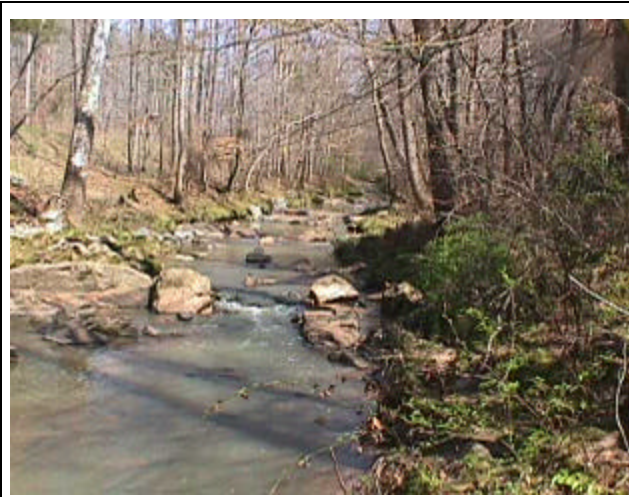
Fig. 1 At Windlock Drive, Looking U/S

Under the base flow conditions the flow is mostly tranquil (Figure 2), occasionally forming small pools and drops due to rock lining of the bed and banks (Figure 1). A main sewer line extends along the full course

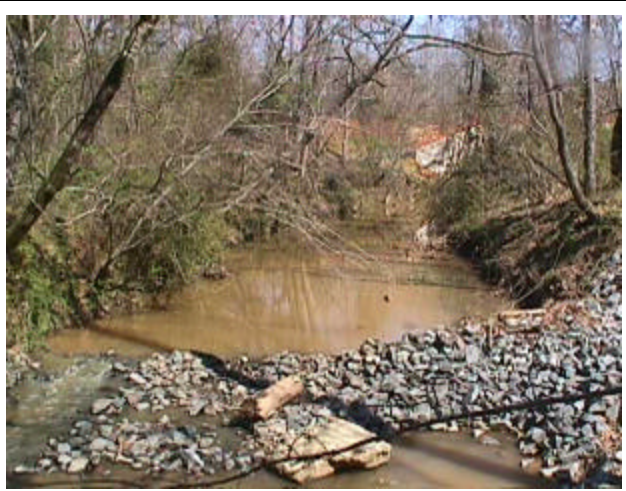
Fig. 3 Near Maynard Road

of Four Mile Creek. Many channel bank segments are stabilized by rock riprap due to the presence of the sewer line. The banks are also stabilized wherever roads cross the stream, and in a few places where individual homeowners or land developers have made an attempt to stabilize the banks. However, individual efforts seem to be non-engineered, and some of the riprap rocks line the channel bed rather than the banks (Figure 3).

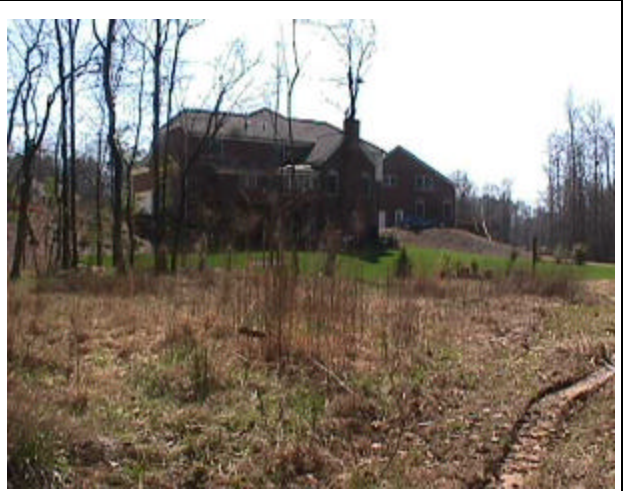
Fig. 4 Near Barington Place

The floodplain in this reach is gently sloping, and generally well vegetated. In a few undeveloped reaches along the stream, the floodplain is heavily wooded. However, in the mostly developed remaining sections the cover is a mix of trees, grass, wild weed and bushes (Figure 4).

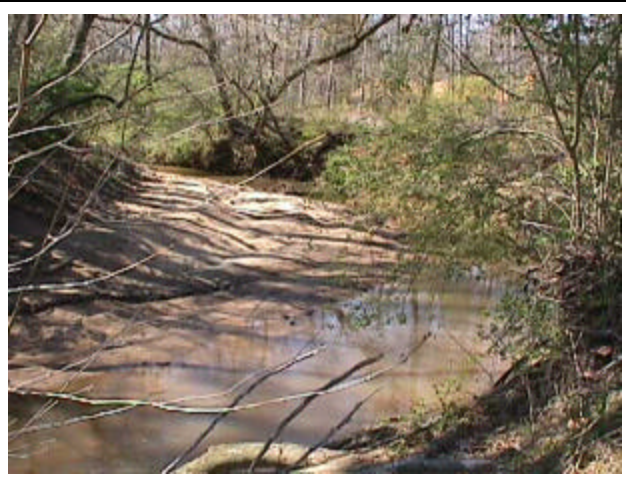
Fig. 5 Near Hugh Forest Road

exposed roots are evident along this reach of the creek. The sediment-laden water in this reach indicates that a certain degree of bank erosion does occur. However, the rapidly developing reaches of the creek probably contribute the larger portion of the sediments. In addition to the point bars, there is sediment deposition near the road crossings and in the stabilized sections of the stream.

evolutionary transition to a type F channel. There are occasional reaches where the channel has developed sufficient belt width to begin to form a meandering pattern with stable point bars as Figures 5 and 6 show. However, being an urban stream, the heavy development on both sides of the stream does not allow free meandering of the main channel, and it demonstrates the low values of sinuosity as observed in this case.

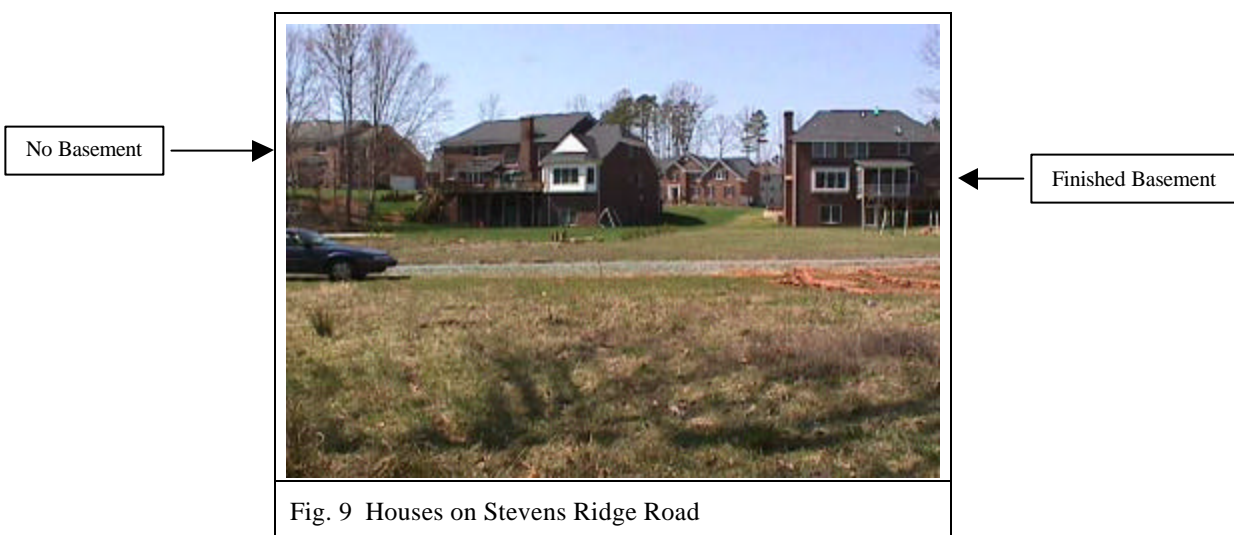
Fig. 9 Houses on Stevens Ridge Road

Inspection of the homes under construction indicates that homes are being built with finished floor elevations above the existing 100-year floodplain. However, many homeowners may have finished basements or made additions to their homes after the purchase of their property. This may have caused houses to be inundated in the floods of 1995 and 1997. Figure 9 illustrates a typical case. The two houses in the right and middle of the picture have a first floor elevation roughly at the elevation of the house on the far left. However, these houses have finished basements, and suffered inundation damage in the floods whereas the house on far left did not. Figure 4 shows a similar case where the house in the front of the picture suffered inundation while the house in the back, built on fill, did not.
