PRELIMINARY ENGINEERING REPORT

Watershed Study No. 2

Mallard Creek Watershed

MCSWS Project No. 25001

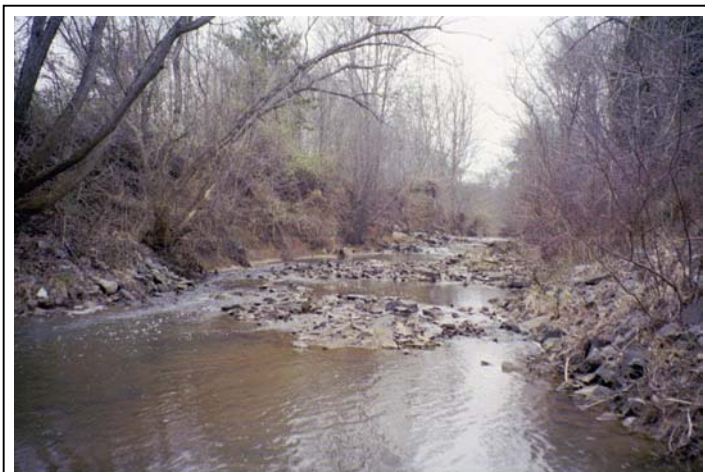
Figure 1. Typical Channel, Mallard Creek at David Taylor Drive, Facing Upstream (Roll #1, Photo #23)

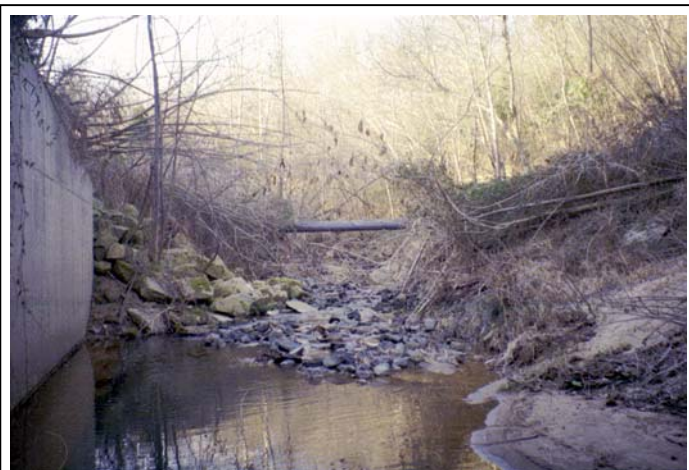
Figure 4. Typical Channel, Doby Creek Upstream of W.T. Harris Boulevard (Roll #2, Photo #23)

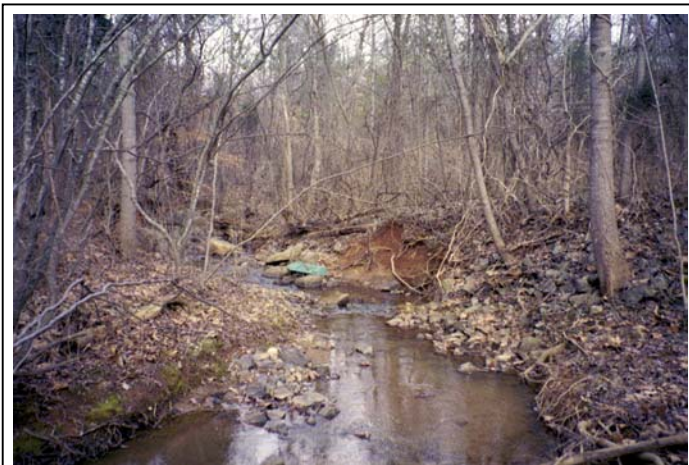
Figure 5. Typical Channel, Doby Creek Tributary Downstream of IBM Drive (Roll #2, Photo #18)

upper IBM Drive crossing is a series of five culverts, with the right two pipes full of sediment. Downstream of the lower IBM Drive crossing, full bank erosion was observed at a meander in the channel (Figure 5). A sanitary sewer line also crosses the channel at this location. Scour is occurring upstream of W.T. Harris Boulevard.

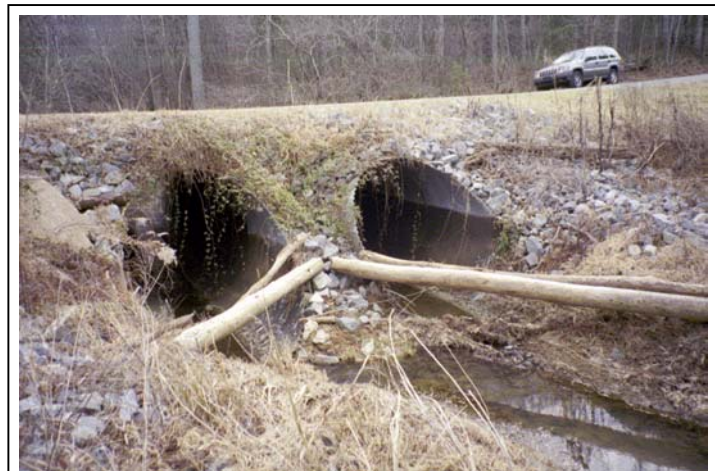
Figure 7. Typical Channel, Stoney Creek Tributary at Homewood Drive, Looking at Upstream Face (Roll #2, Photo #14)

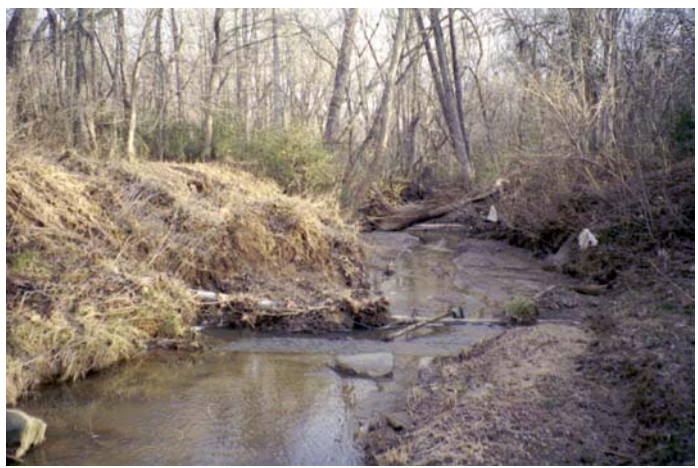
unstable in this reach and will be further discussed in Section 1.5. Between US 49 and Chancellors Park Drive, the banks are very steep as a result of severe downcutting. Trees along the banks are unstable. A beaver was also observed near its dam in this area. Grade-control structures have been installed downstream of the W.T. Harris Boulevard West ramp from University City Boulevard. The intention of these structures is to limit headcutting. Riprap intended to reduce headcutting has also been added to the mouths of tributaries entering Toby Creek near Toby Creek Road and W.T. Harris Boulevard. Placing riprap for headcutting protection has proven to be effective.

Figure 8. Typical Channel, Toby Creek Downstream of W.T. Harris Boulevard West (Roll #3, Photo #4)

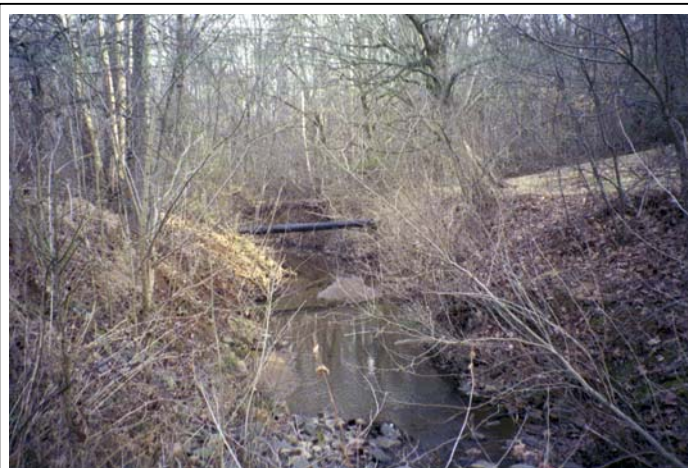
Figure 10. Sanitary Sewer Line Crossing Doby Creek Tributary (Roll #2, Photo #20)

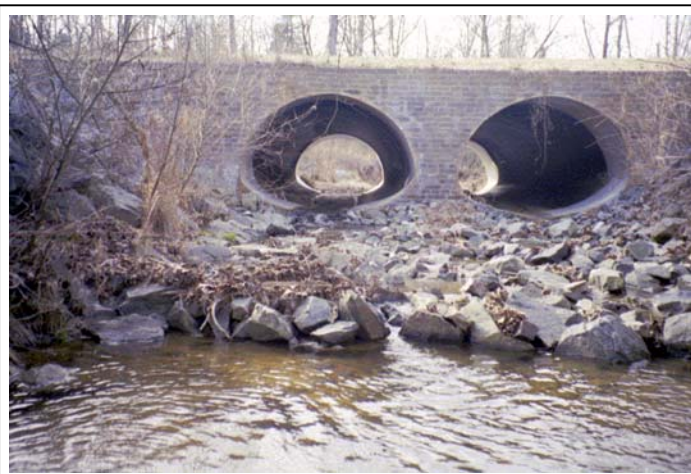
Figure 13. Riprap Stabilization, Toby Creek at Rocky River Road Looking at Downstream Face (Roll #3, Photo #12)

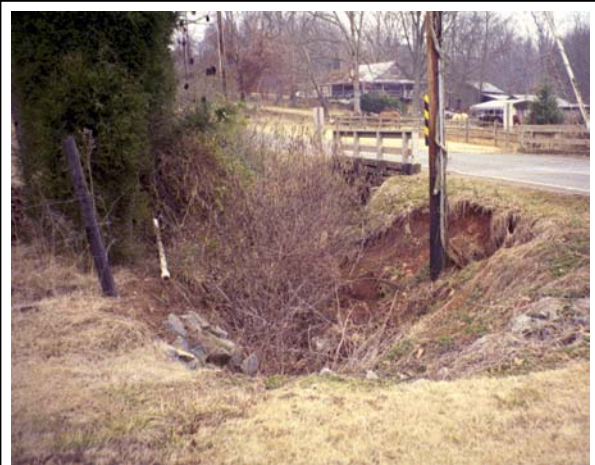
The banks of Clarks Creek Tributary No. 1 are eroding at the Hucks Road bridge (Figure 15). The City flushes a water main weekly into a drainage ditch, contributing to the erosion problem. The stability of a utility pole, visible in the Figure 15, is in jeopardy. This area should be repaired for safety concerns, as well as stream bank stability.

Figure 15. Erosion, Clarks Creek Tributary No. 1 at Hucks Road (Roll #1, Photo #8)

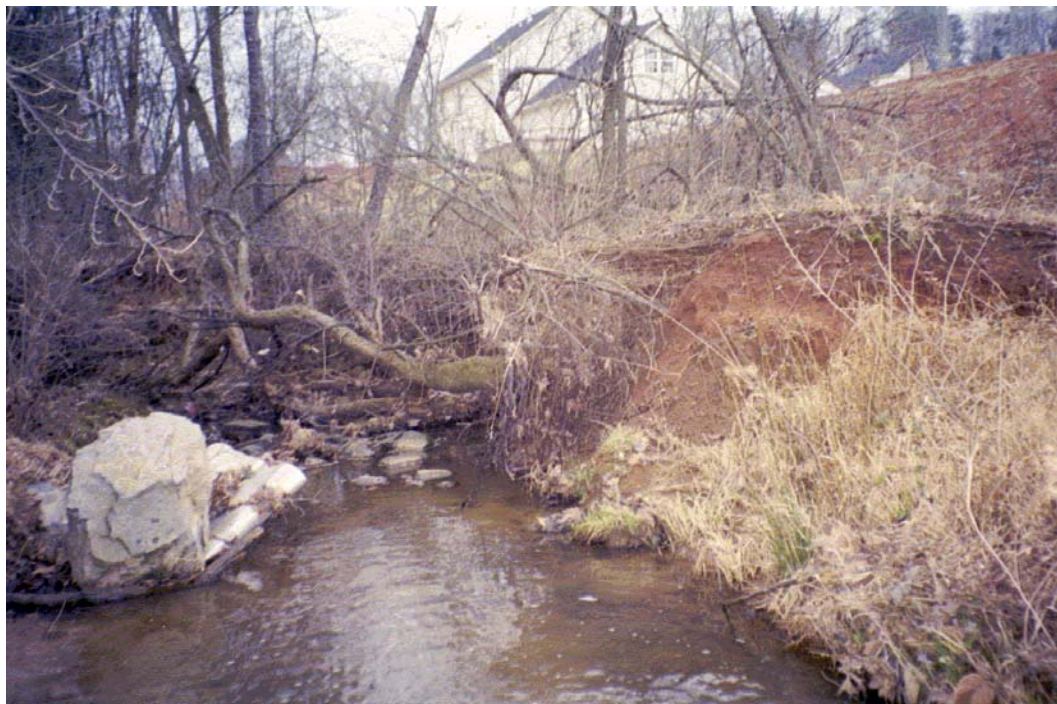
Clarks Creek View, D/S Roll #1 Photo #3
EROSION OBSERVED ON RIGHT BANK, LOOKING DOWNSTREAM OF DEARMON ROAD
CROSSING.

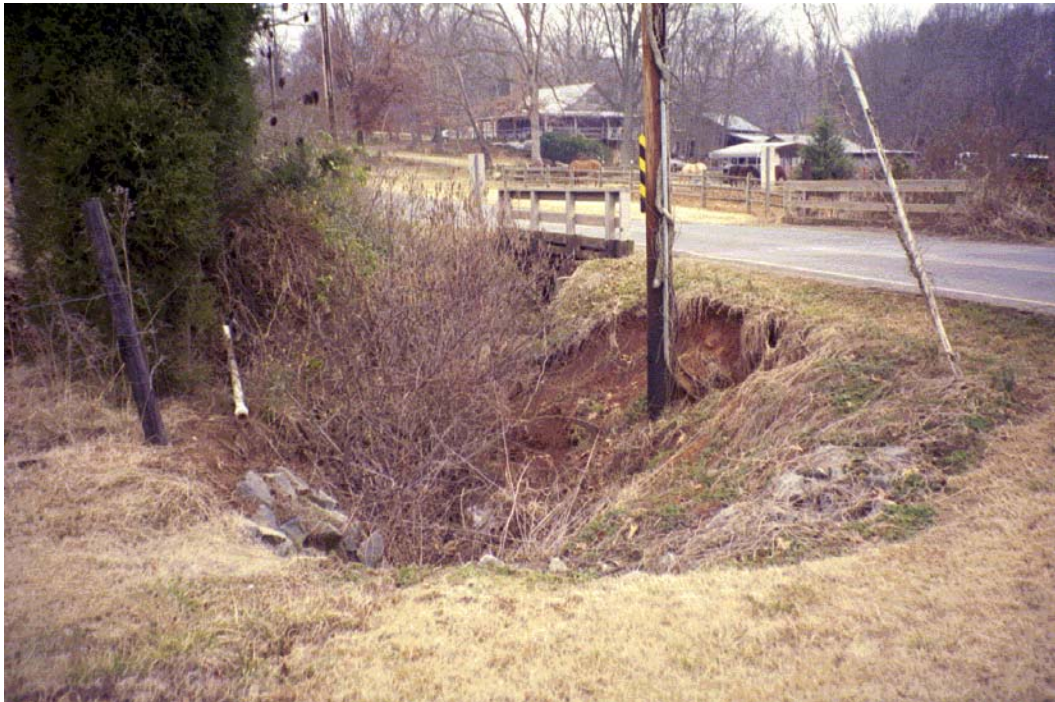
Photo #8

Clarks Creek Tributary #1 View, D/S Roll #1
EROSION OBSERVED AT DOWNSTREAM SIDE OF HUCKS ROAD CROSSING. CITY
WATER MAIN FLUSHED WEEKLY INTO DRAINAGE CHANNEL.

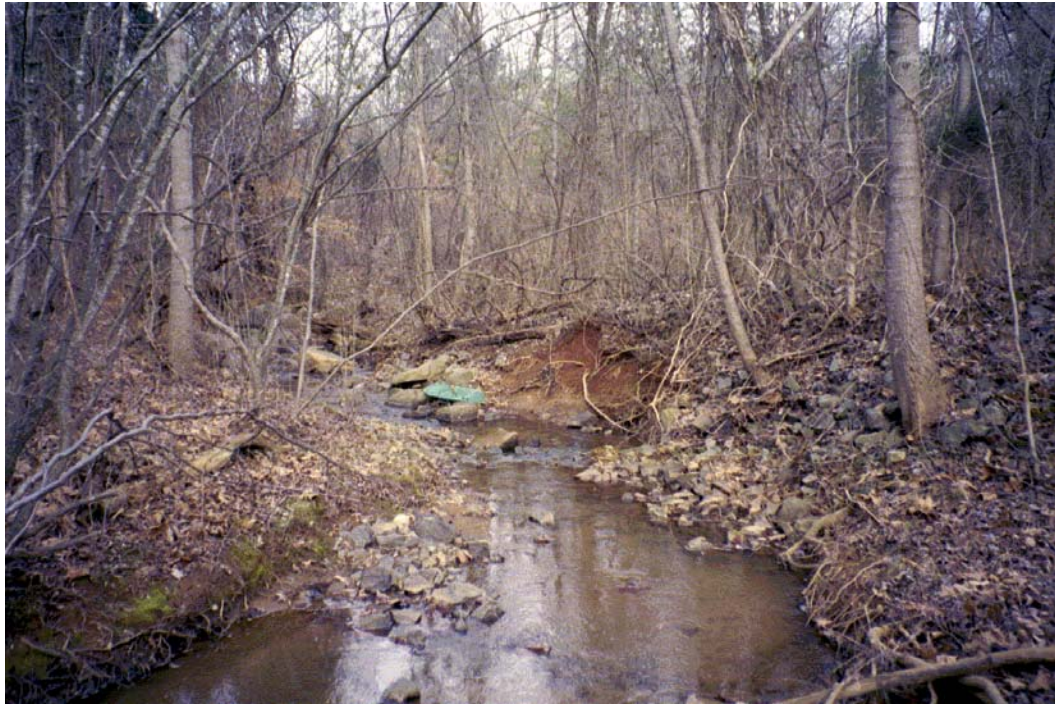
Doby Creek Tributary # 1 View D/S Roll #2 Photo #18
RIGHTBANK EROSION DOWNSTREAM OF IBM DRIVE (UPPER) CULVERT CROSSING.

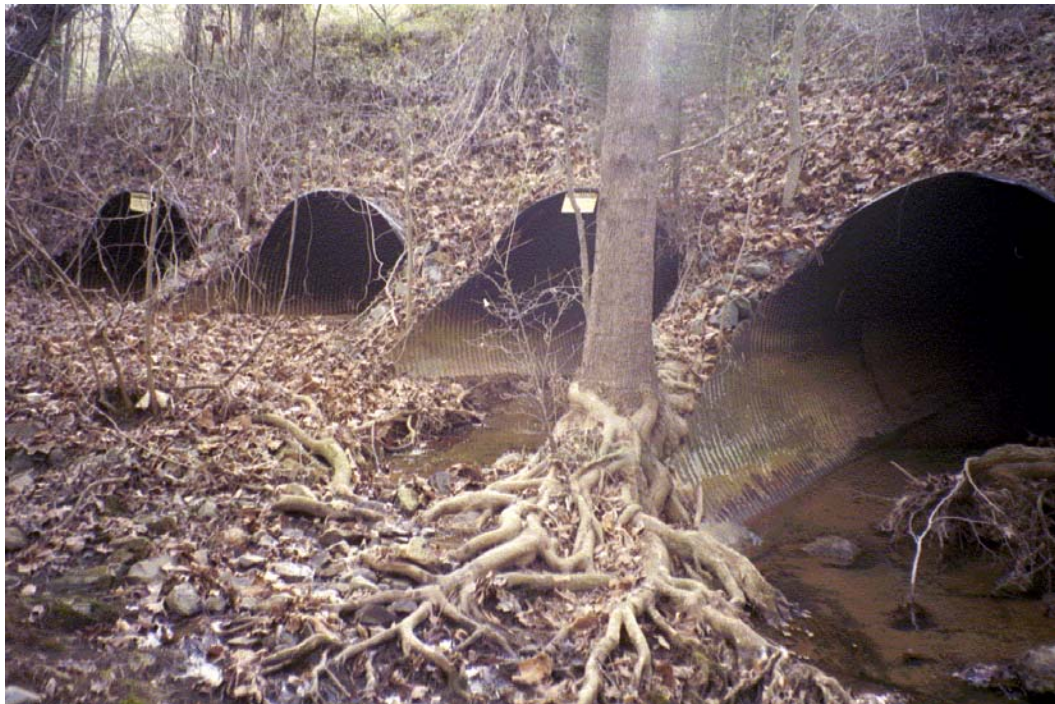
Doby Creek Tributary # 1 View D/S Roll #2 Photo #19
DOWNSTREAM FACE OF 5 BARRELS 7' 10" CMP CROSSING AT IBM DRIVE (UPPER).
SEDIMENT PRESENT IN 2 LEFT BARRELS.

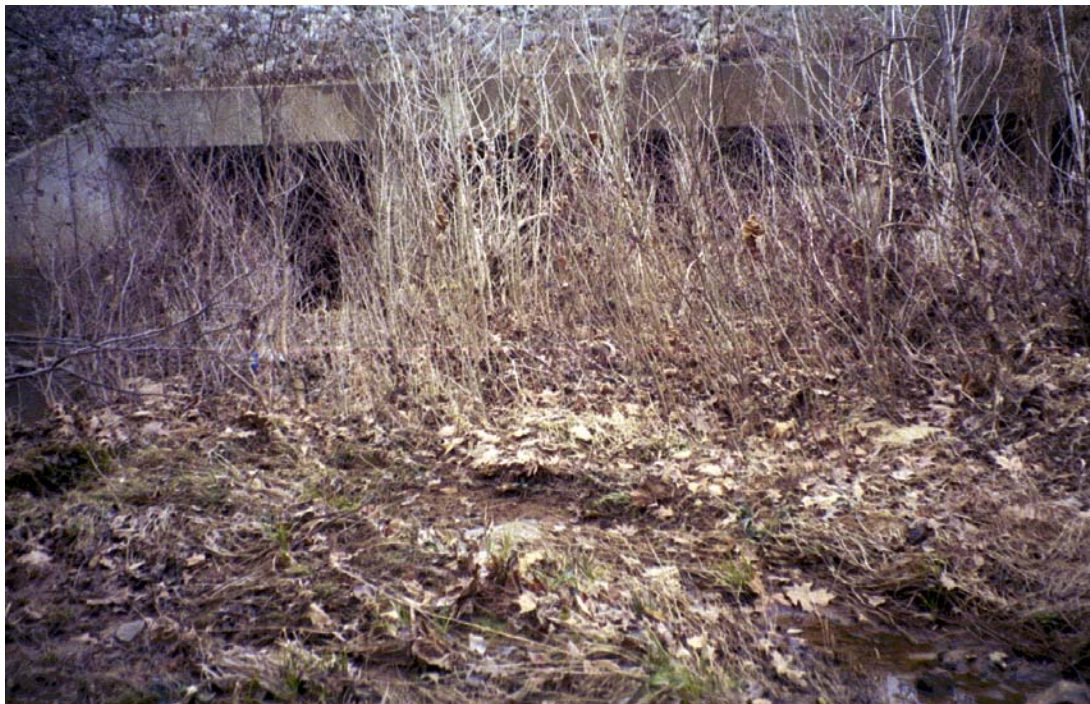
Photo #18

Mallard Creek View, U/S Roll #1
EXTENSIVE DEPOSITION IN UPSTREAM FACE OF 4 BARREL 13' x 9' BOX CULVERT
CROSSING AT W.T. HARRIS BOULEVARD.

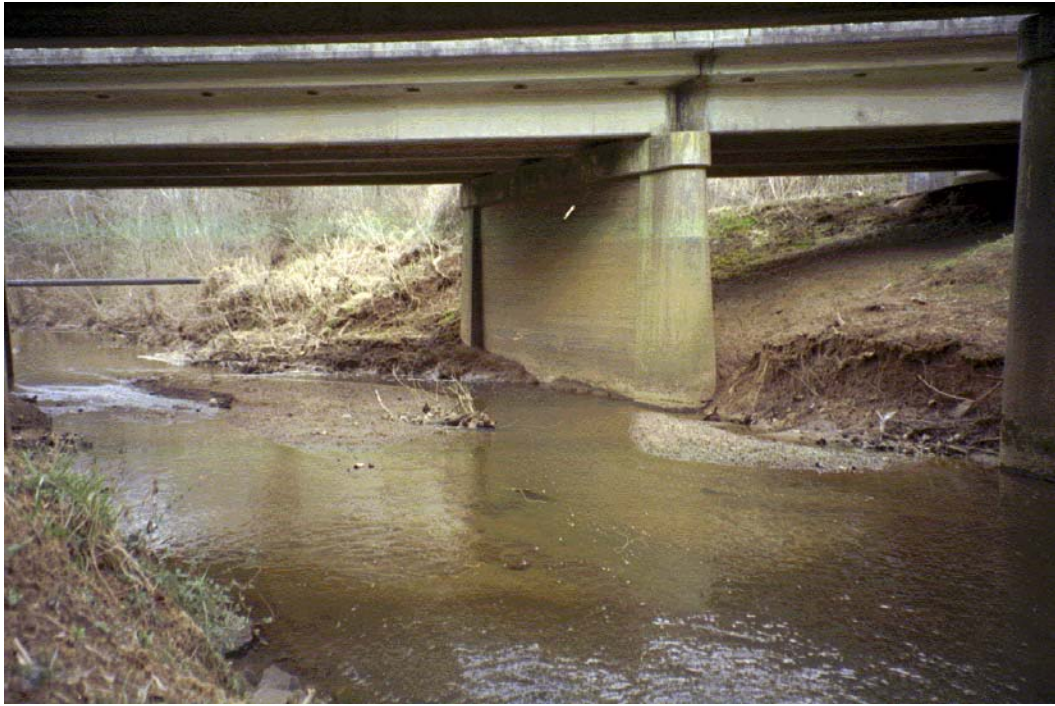
Mallard Creek View, D/S Roll #2 Photo #4
LOWER BANK EROSION AT N. TRYON STREET. SANITARY SEWER CROSSING IN
BACKGROUND.

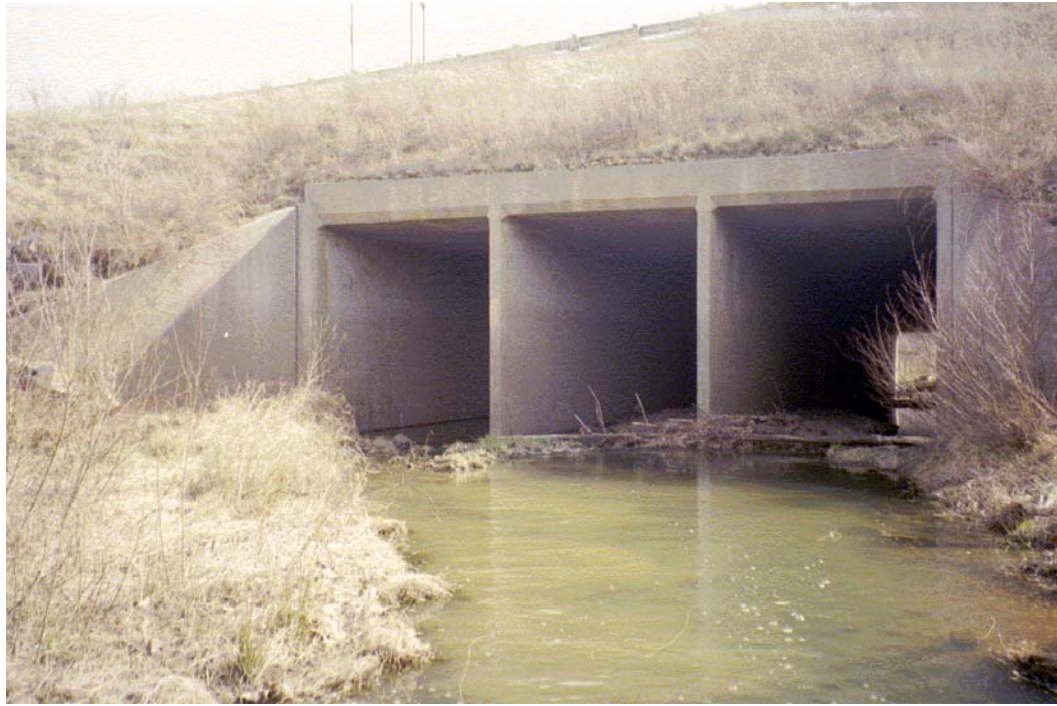
Stoney Creek View, U/S Roll #2 Photo #10
UPSTREAM FACE OF 3 BARREL 11' x 13' CONCRETE BOX CULVERT CROSSING AT
US 29/TRYON STREET. COBBLES HAVE ACCUMULATED IN RIGHT 2 BARRELS.

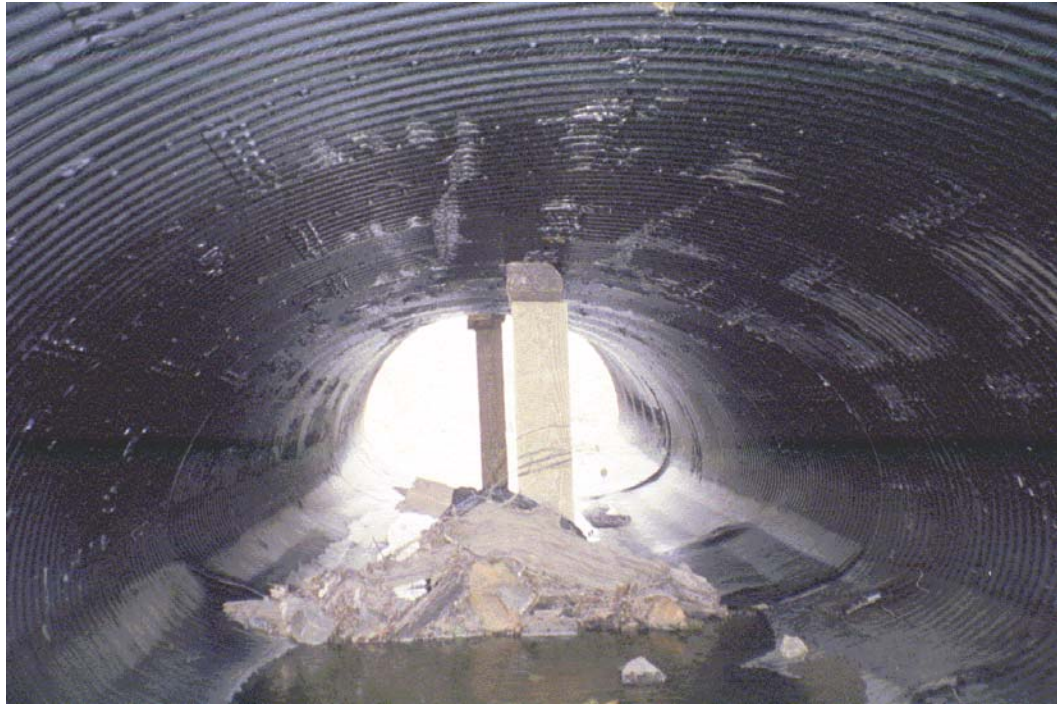
Stoney Creek View inside culvert Roll #2 Photo #16
INSIDE OF 12' x 7.5' CMPA AT MALLARD CREEK ROAD. CULVERT IS COLLAPSING
AND CURRENTLY SUPPORTED BY PILLARS. DEBRIS IS COLLECTING INSIDE
CULVERT.

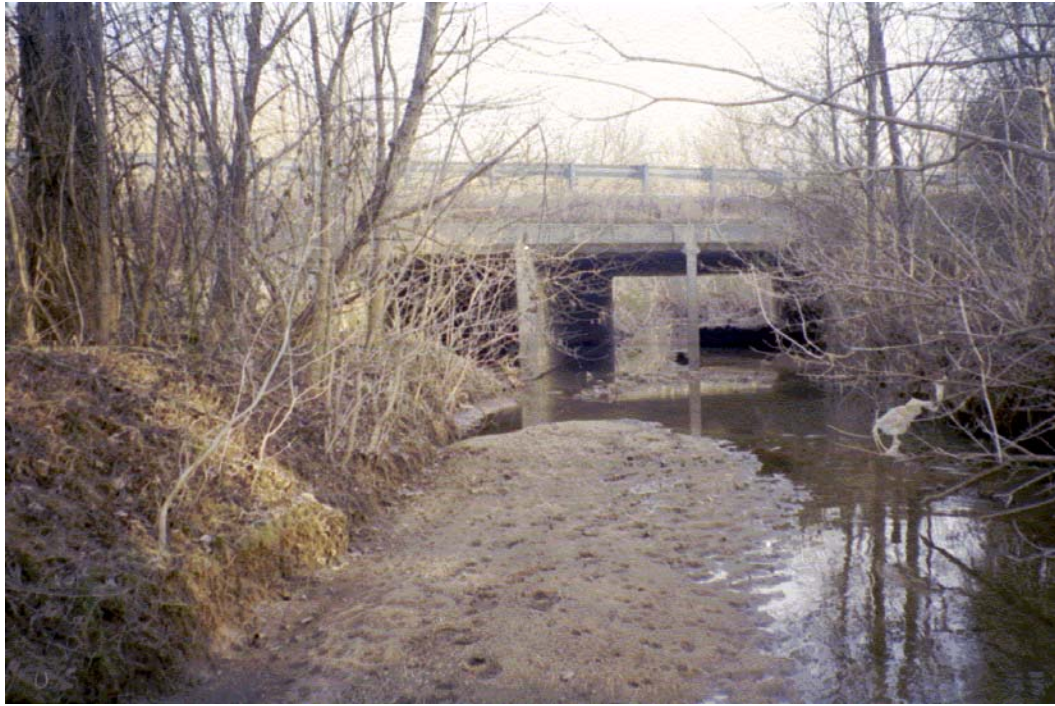
Toby Creek View U/S Roll #3 Photo #3
UPSTREAM FACE OF 3 BARREL 10'x 9' BOX CULVERT CROSSING AT TOBY CREEK ROAD.
DEPOSITION PRESENT AT UPSTREAM SIDE, DOWNCUTTING OCCURRING DOWNSTREAM.

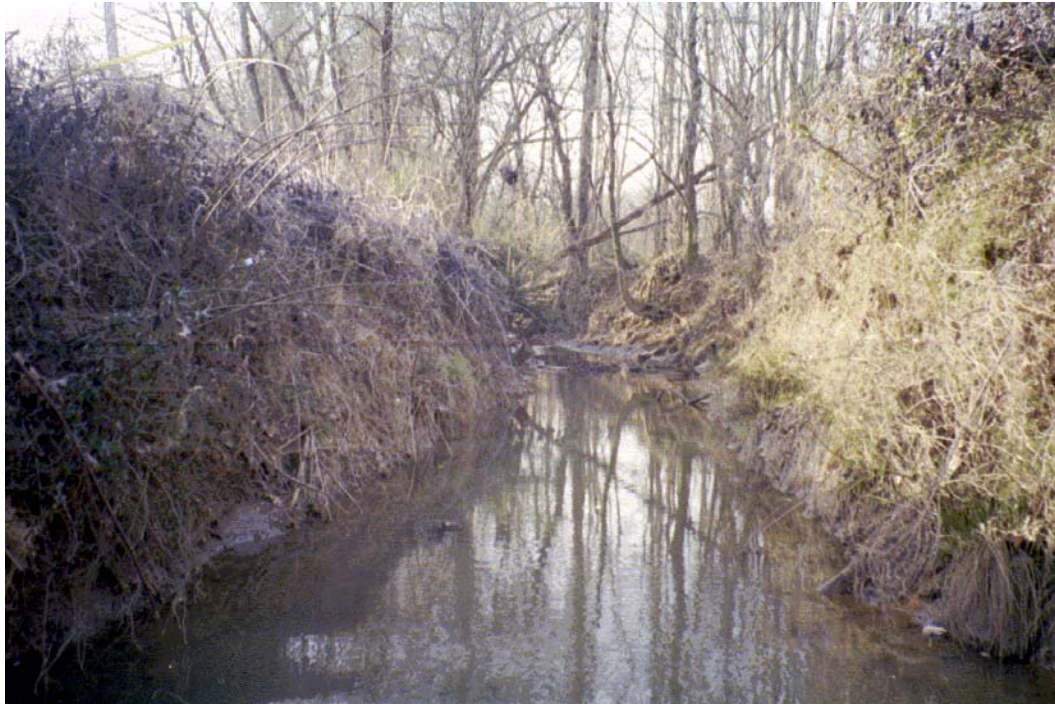
Toby Creek View U/S Roll #3 Photo #6
SEVERE DOWNCUTTING UPSTREAM OF CONCRETE BOX CULVERT CROSSING HWY 49.
OBSERVED BEAVER.

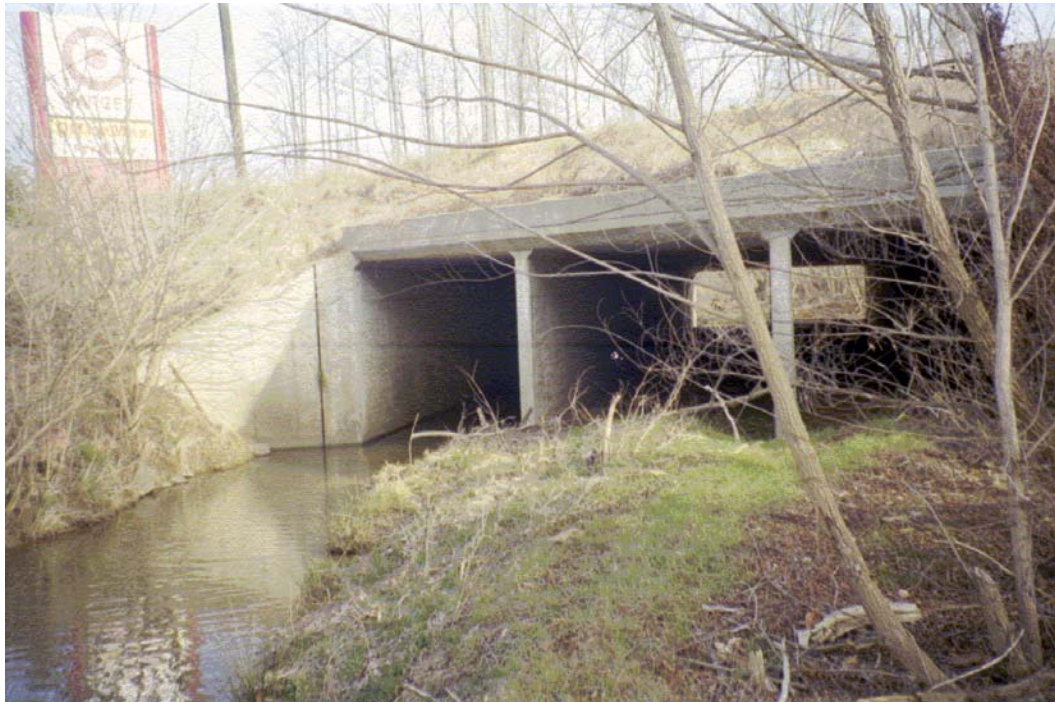
Toby Creek View U/S Roll #3 Photo #8
UPSTREAM FACE OF 5 BARREL 10' x 10' CONCRETE BOX CULVERT CROSSING
CHANCELLORS PARK. DEPOSITION PRESENT IN 4 BARRELS.

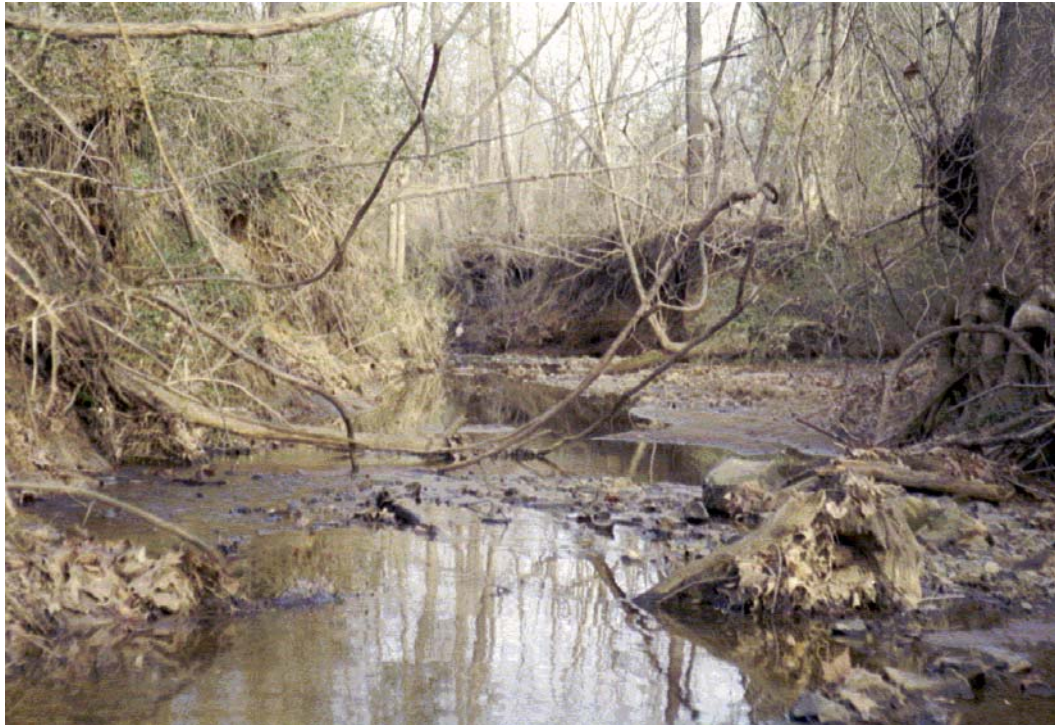
Toby Creek View D/S Roll #3
BANK EROSION DOWNSTREAM OF ROCKY RIVER ROAD CROSSING.
