# 1. GENERAL WATERSHED CONDITIONS

## 1.1 Watershed Characteristics

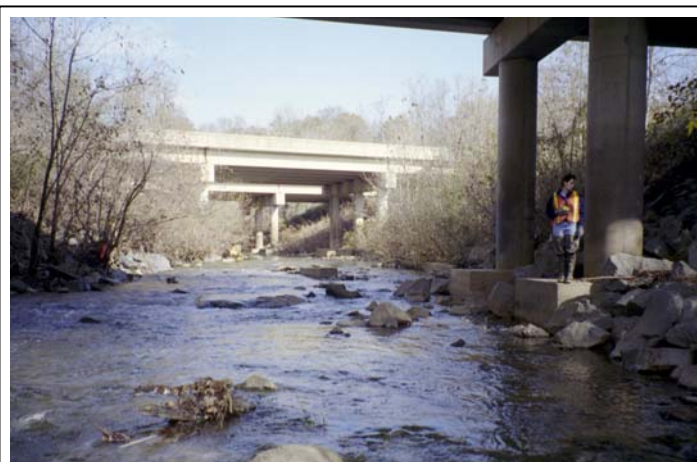
*Figure 1. Typical Channel, Sugar Creek at Yorkmont Road and Billy Graham Parkway, Facing Downstream (Roll #2, Photo #14)*

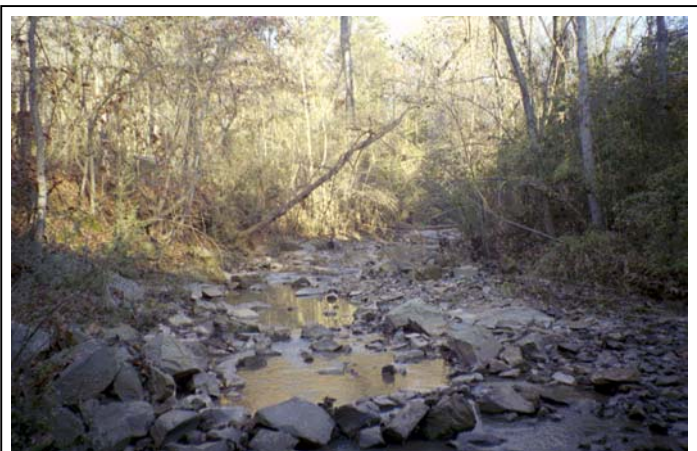
*Figure 2. Typical Channel, Coffey Creek Upstream of Byrum Drive (Roll #1, Photo #8)*

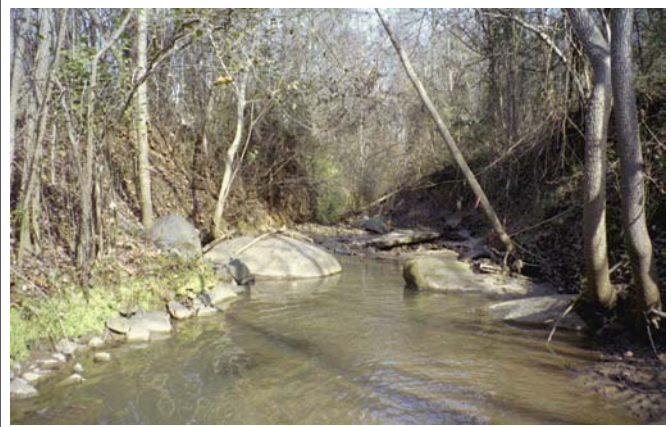
***Figure 3. Typical Channel, Kings Branch Looking Upstream of Hebron Street (Roll #2, Photo #2)***

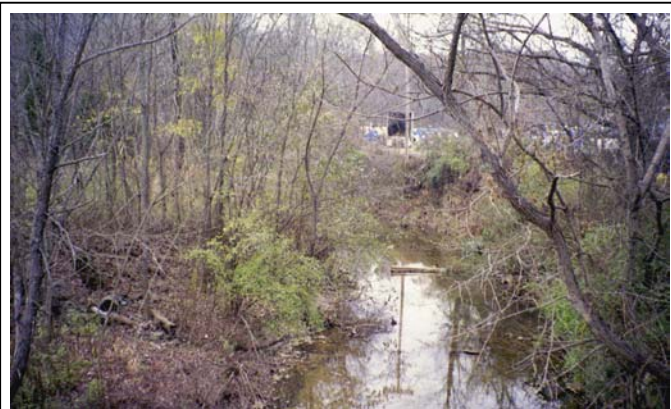
***Figure 4. Typical Channel, Taggart Creek Looking Upstream of Morris Field Road (Roll #2, Photo #2)***

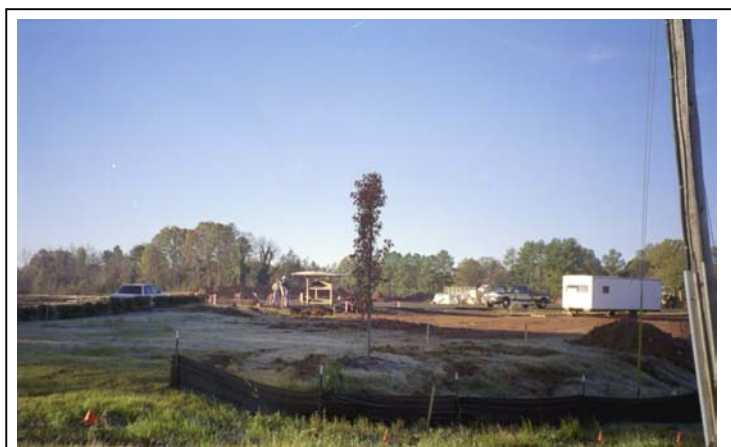
*Figure 5. Coffey Creek Sub-Watershed Development Near Yorkmont Road (Roll #1, Photo #9)*

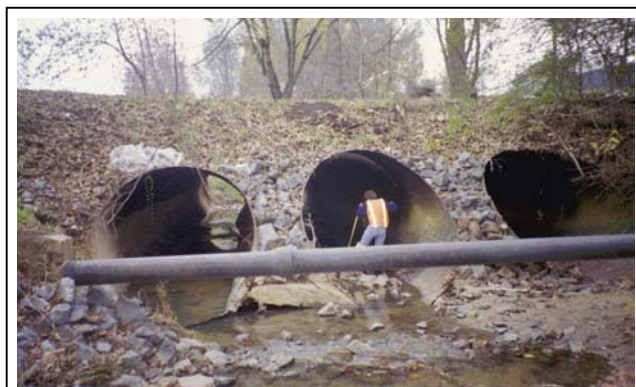
*Figure 6. Sanitary Sewer Crossing at Kings Branch Below Archdale Road (Roll #1, Photo #22)*

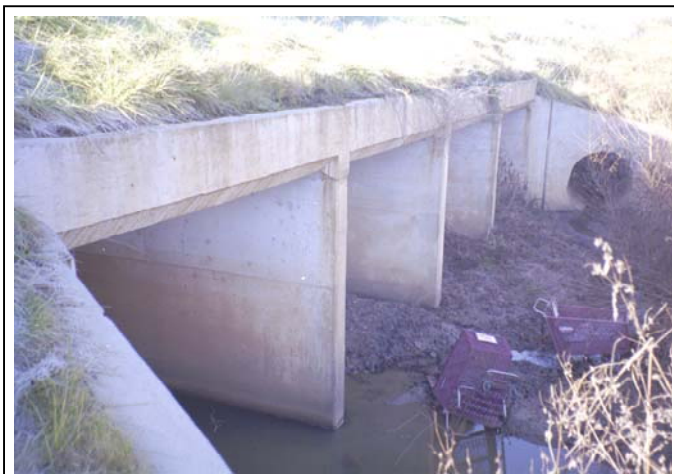
**Figure 8. Heavy Sedimentation and Debris on Coffey Creek at Arrowood Drive (Roll #1, Photo #14)**

Problems throughout the watershed include sediment transport (sediment accumulation in road crossing culverts) and urban debris (trash, shopping carts), as seen in Figure 8. The vegetated riparian zones also may not be providing their full filtering functions because of channel entrenchment throughout the watershed. Entrenchment of a stream channel lowers the water table, with the effect being a loss of water quality improvement for infiltrated water.

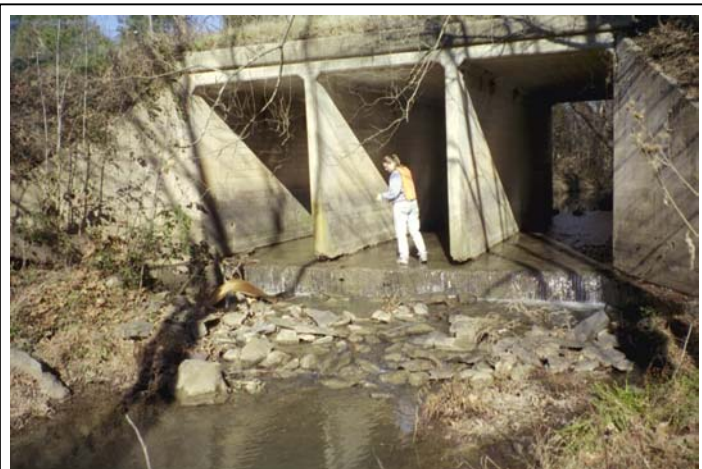
*Figure 9. Headcutting on McCullough Creek at Highway 51, Looking at Downstream Face (Roll #1, Photo #18)*

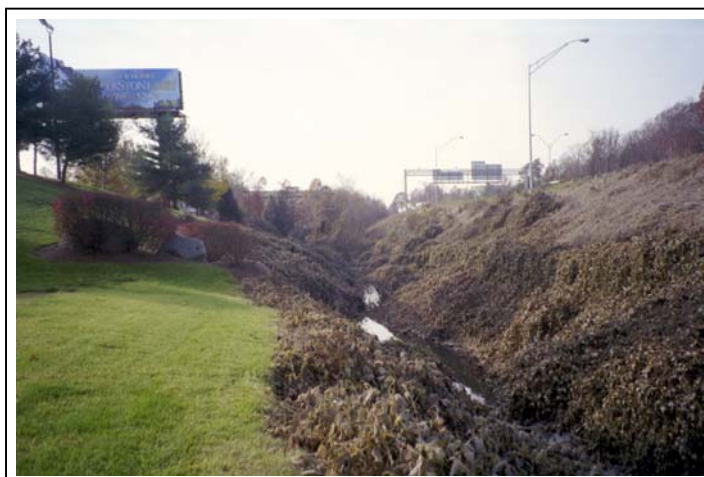
*Figure 10. Kings Branch Along I-77 Corridor, Facing Downstream (Roll #2, Photo #2)*

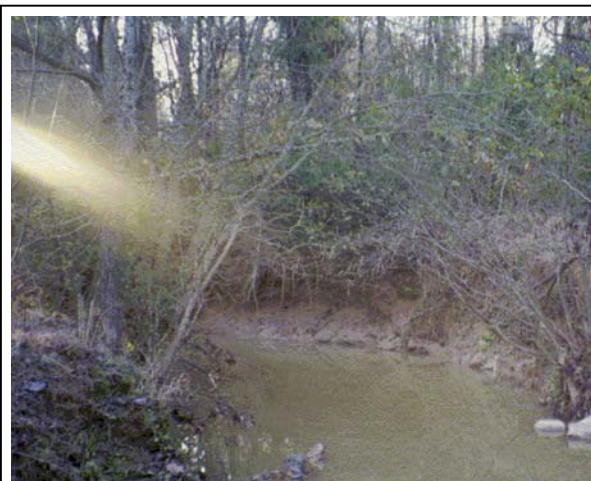
Bank stability problem areas were identified near some road crossings and are described with photos. Erosion on the right bank (looking downstream) of Coffey Creek near West Boulevard is creating a steep and unstable bank (Figure 11). Exposed roots are visible. The same problem was observed on Kings Branch at Archdale Road along the left bank (looking downstream) (Figure 12). The outer bank of a meander receives more sheer stress than the inner bank and is therefore more susceptible to erosion. In these cases, instability is the result. The right bank (looking downstream) of Sugar Creek south of S. Tryon Street is unstable and collapsing (Figure 14). This problem was identified during previous field work in June 2000 and is discussed as part of the flood hazard mitigation options. Changes in fluvial processes over time are most likely contributing factors to these erosion problems because vegetation along these banks is not providing adequate stability of the soil.

*Figure 11. Bank Erosion, Coffey Creek Near West Blvd. (Roll #1, Photo #2)*

Other problems not visible from these vantage points may exist and should be researched before any bank stabilization projects are planned. In addition, bed material is mobile and is accumulating on point bars in some locations throughout the watershed, and specifically is scouring around the W. Arrowood Road westbound bridge piers (Figure 13). Erosion of the McCullough Creek box culverts is also a concern and should be investigated (Figure 9). Proposed solutions to bank stability problems are included in the Flood Hazard Mitigation Alternatives listed in Section 3. Further quantitative studies of bank erosion rates and aquatic habitat throughout the study area should precede future restoration efforts.

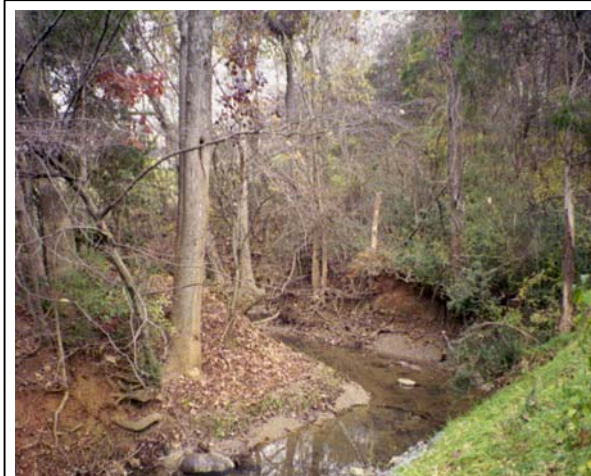
*Figure 12. Bank Erosion, Kings Branch Near Archdale Road (Roll #1, Photo #23)*

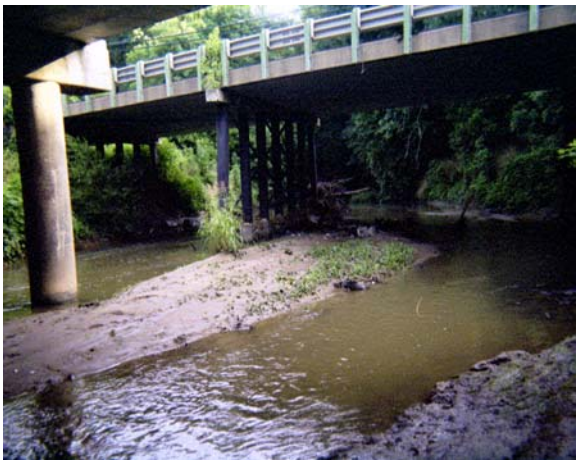
*Figure 13. Pier Scouring, Sugar Creek on Westbound Bridge of W. Arrowood Road (Roll #5, Photo #18)*

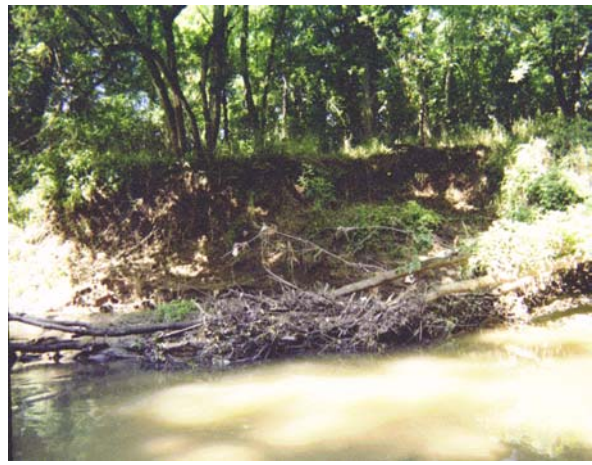
*Figure 14. Bank Erosion, Sugar Creek Near S. Tryon Street (Roll #6, Photo #25)*

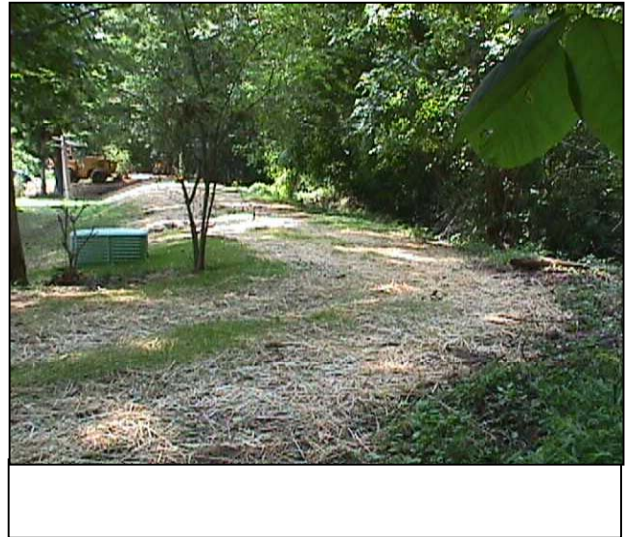
The levee behind Brian Circle immediately upstream of Highway 51 was located, and evidenced some disturbance since originally constructed, possibly due to buried cable TV installation. Current elevation at top of the levee was surveyed, and the lowest spot was found to be at 541.7. Figure 15 shows the existing levee behind the houses on Brian Circle.

The existing levee provides a level of protection equal to:

- 4% annual flood (25-year flood) for the existing land use condition.
- 10% annual flood (10-year flood) for the future land use condition.

The existing levee should be improved or replaced to provide a level of protection against the 1% annual flood (100-year event) for both the existing land use and future land use conditions. HDR researched and investigated the original levee, and was not able to locate any engineering drawings or other data. Since it is unable to verify the suitability of the existing structure for inclusion in a higher levee, HDR recommends that the levee be replaced in its entirety with a properly designed and constructed structure. The economic analysis of levee improvement for the Brian Circle area is shown in Table 26. No Action is recommended for this area.
