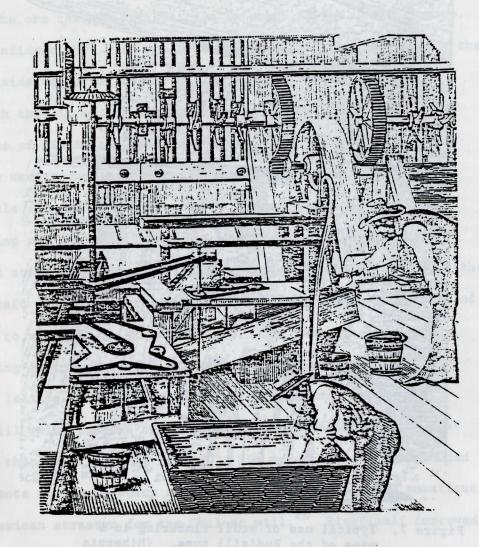
Figure 8. Early stamp mill of the type probably used for crushing gold ore at the St. Catherine Mill (Illustration from Hutchings' California Magazine, 1857)

After being crushed, the material would roll down a succession of both coarse and fine sieves. The part rejected by the sieves was returned for additional crushing. The upper, coarse sieves were of perforated sole leather or strong cast iron wire, while the lowest, finest sieves were of copper wire.
