# PRELIMINARY ENGINEERING REPORT

## Watershed Study No. 8

## Irwin Creek Watershed

Mecklenburg  
Storm Water Services

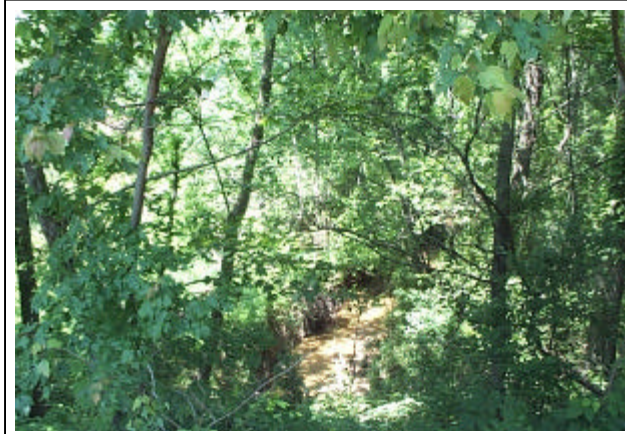
**Figure 2. Kennedy Branch – Looking upstream from Cindy Lane.**

The Kennedy Branch study reach is located in the upper portion of the Irwin Creek Watershed. It flows in a southeastern direction from upstream of Cindy Lane to its confluence with Irwin Creek, for a distance of approximately 2.1 miles. The Branch flows along I-77 through undeveloped land, transportation right-of-ways, and limited other land uses. In addition, it crosses I-77 midway along its length through an 1800+ foot culvert.

The Kennedy Branch channel is similar in shape and bed characteristics to the upper portions of Irwin Creek, having an average top width of approximately 35 feet. However, it has been altered significantly to accommodate the I-77 transportation corridor.

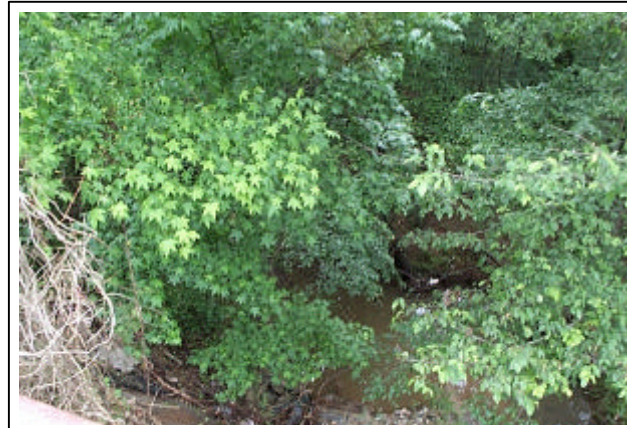
**Figure 3. Irwin Creek Tributary 1 – Looking downstream from Barringer Drive.**

The Irwin Creek Tributary 1 study reach is located in the lower portion of the Irwin Creek Watershed. It flows in a northwestern direction from just downstream of Stuart Andrew Boulevard to its confluence with Irwin Creek, for a distance of approximately 1.0 miles. The tributary has a relatively uniform channel and flows through commercial/industrial, undeveloped, and residential land uses. A well established riparian zone lines the tributary for much of its length. The channel bed is comprised primarily of sandy-silty material with cobble and rock.

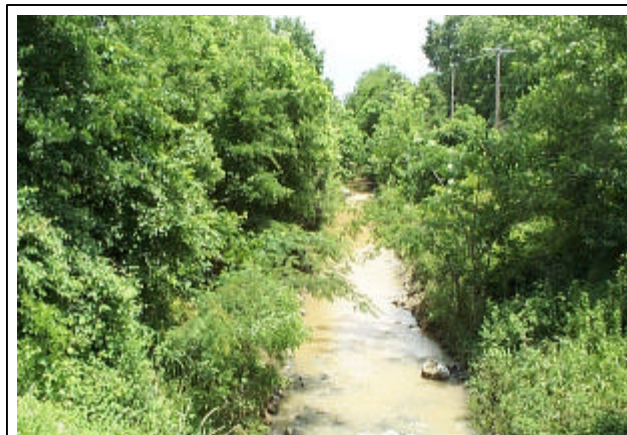
**Figure 4. Stewart Creek – Looking upstream from Rozzelles Ferry Road.**

Stewart Creek is a large tributary of Irwin Creek that accounts for approximately one-third of the Irwin Creek Watershed drainage area. The Creek starts in the northern portion of the Watershed and flows in a southern direction for approximately 5.4 miles to its confluence with Irwin Creek, just upstream of Wilkinson Boulevard. Unlike Irwin Creek, Stewart Creek is not as heavily impacted by the Interstate system, and flows through/along primarily residential and industrial land uses, as well as scattered undeveloped areas.

The Stewart Creek channel is similar in shape and bed material to the upper/middle sections of the Irwin Creek channel, with a top width ranging from 20 feet in the upstream portions to 50+ feet in the lower sections.

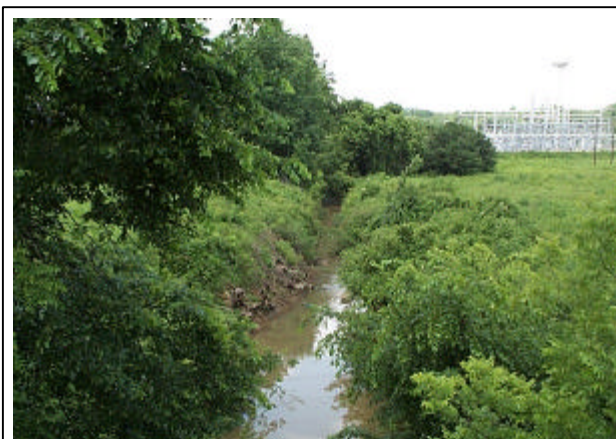
**Figure 6. Stewart Creek Tributary 2 – Looking upstream from Parkway Avenue.**

The Stewart Creek Tributary 2 study reach is located in the west-central portion of the Irwin Creek Watershed. It flows in a southeastern direction from I-85 to its confluence with Stewart Creek (near Rozzelles Ferry Road), for a distance of approximately 1.6 miles. The upstream portion of the Tributary flows through primarily open/undeveloped areas, including a large Duke Power substation property, where it then transitions into more residential land uses.

The Stewart Creek Tributary 2 channel is relatively uniform, with an average top width of approximately 40 feet. Scattered riparian zones line the majority of the Tributary. The channel bed is comprised primarily of sandy-silty material with cobble and rock areas.

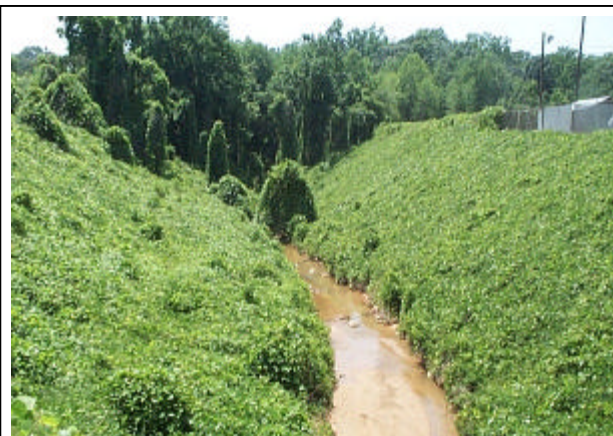
**Figure 7. Stewart Creek Tributary 3 – Looking upstream from Hoskins Road.**

The Stewart Creek Tributary 3 study reach is located in the upper portion of the Irwin Creek Watershed. It flows in a southeastern direction from Lawton Road to its confluence with Stewart Creek, for a distance of approximately 1.1 miles. The Tributary runs through almost all industrial land uses, along the back edge of property lines.

The Stewart Creek Tributary 3 channel is relatively uniform, with an average top width of approximately 35 feet. A limited riparian zone is scattered along the Tributary. The channel bed is comprised primarily of sandy-silty material with cobble and rock areas
