**PRELIMINARY ENGINEERING REPORT**

# *Watershed Study No. 1*

## *Lower Little Sugar Creek Watershed*

**August 2002**

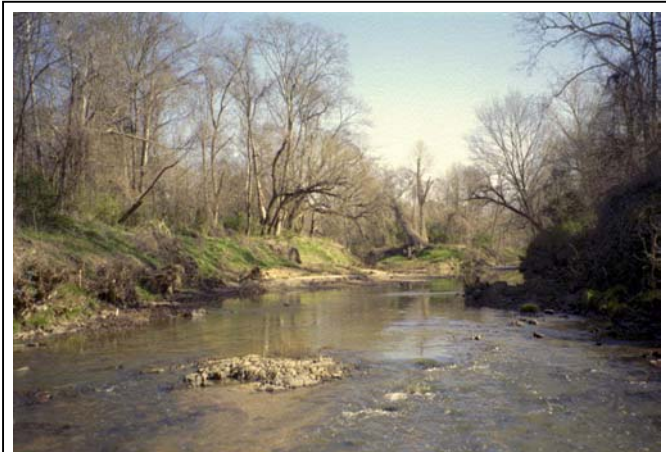
**Figure 1. Confluence of Briar Creek and Upper Little Sugar Creek (Roll #4, Photo #9)**

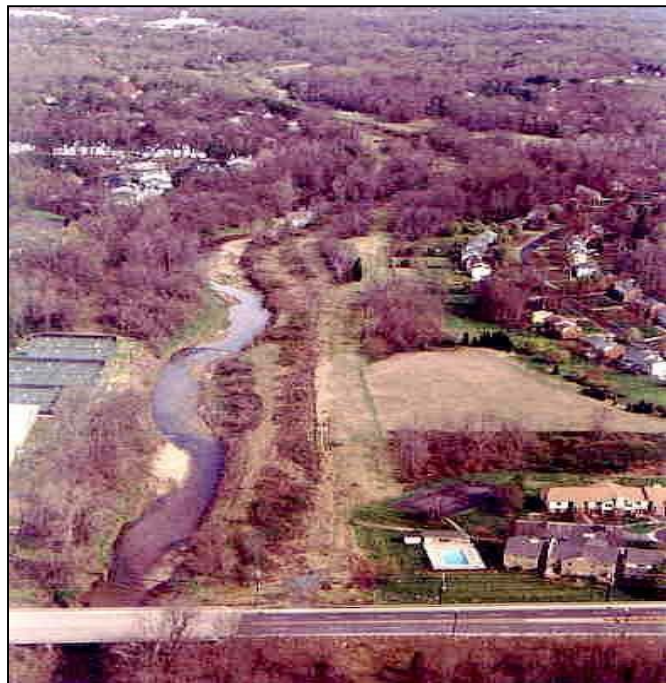
**Figure 2. Little Sugar Creek Stream Bank Stabilization Project, Sharon Road West (Photo Courtesy of MCSWS)**

Further downstream at the Sharon Road West crossing, a stream bank and channel stabilization project was completed in 2000 (Figure 2). This stream reach is attempting to find equilibrium by meandering within its limitations, creating a Rosgen C type channel within an E channel. Point bar deposition is visible in Figure 2, presenting further evidence of channel processes.

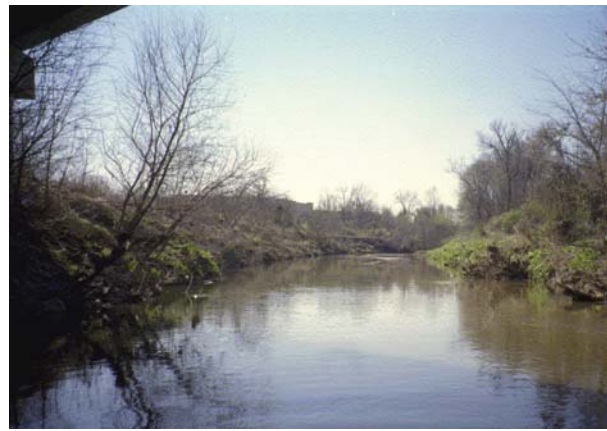
*Figure 3. Typical Channel, Lower Little Sugar Creek at I-485, Looking Downstream (Roll #4, Photo #15)*

Lower Little Sugar Creek. Trees are present on the overbanks. Similar stream characteristics were also observed near the I-485 crossing (Figure 3), where three bridges cross Lower Little Sugar Creek. The Polk Road (Old US 521) Bridge is the final road crossing before Lower Little Sugar Creek leaves Mecklenburg County. Rocks in the channel near the bridge create riffle habitat (Figure 4). Banks in this area of Lower Little Sugar Creek are generally stable with vegetation; however, one area of erosion was visible on the left bank (looking downstream).

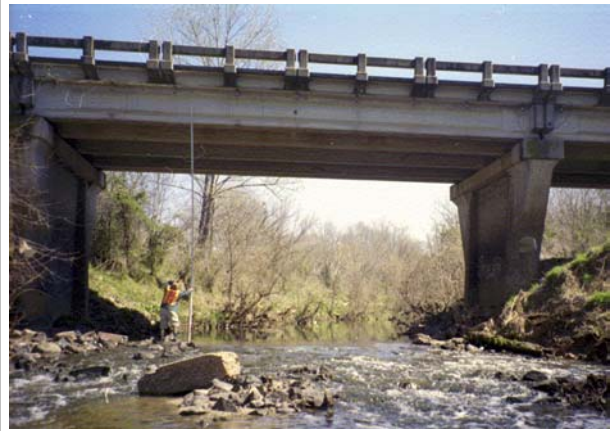
*Figure 4. Typical Channel, Lower Little Sugar Creek at Polk Road (Roll #4, Photo #23)*

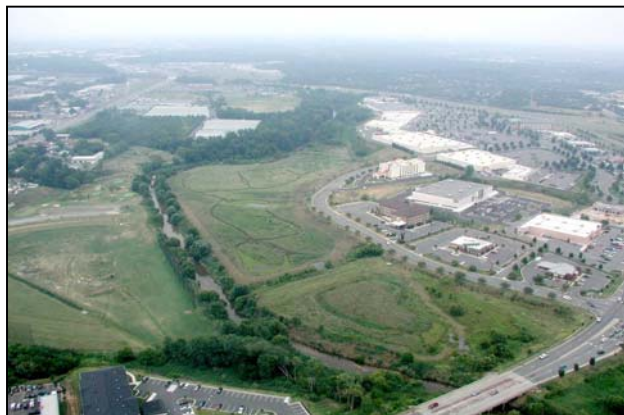
*Figure 5. NCDOT Constructed Wetland at upstream of NC 51 (Photo Courtesy of MCSWS)*

Figure 5 shows a constructed wetland by North Carolina Dept. of Transportation (NCDOT) at immediately upstream of Pineville-Matthews Road (NC 51). Downstream of NC 51, Lower Little Sugar Creek begins to meander. Observations from this vantage point were similar to other parts of the watershed; the stream has a sandy bottom with some rocks present under and near the bridge. The banks are grassy with some brush and appear stable. A USGS gage is also present at this location.

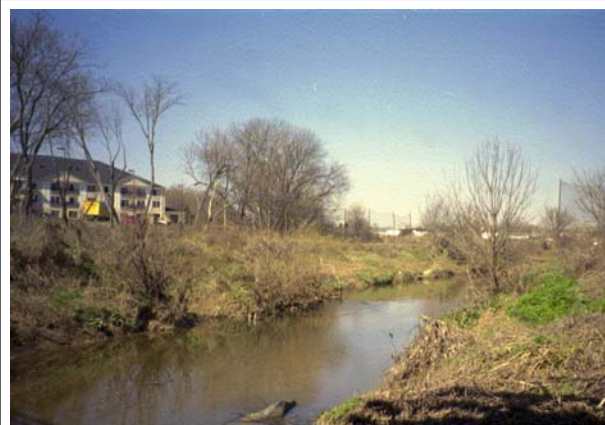
The watershed is one of the most developed suburban and commercial watersheds in Mecklenburg County (Figure 6). Flowing south, the Little Sugar Creek watershed is bounded on the west by South Boulevard and on the east by Park Road. The upper study limit, the confluence with Little Hope Creek, is between the Sugar Creek WWTP and Tyvola Road. I-485 crosses the southern portion of the watershed. Transportation

*Figure 6. Development, Lower Little Sugar Creek at NC 51, Looking Upstream (Roll #4, Photo #20)*

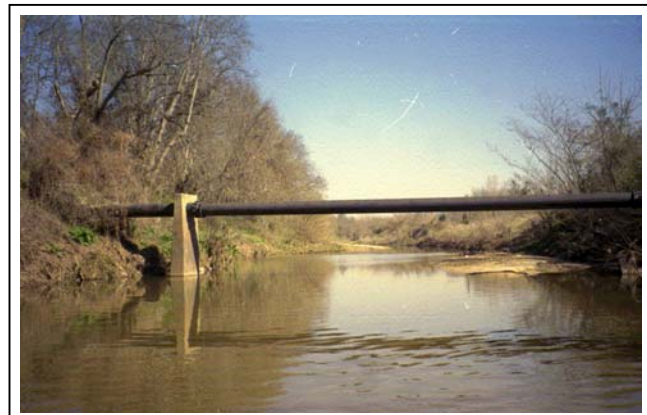
*Figure 7. Sanitary Sewer Crossing, Lower Little Sugar Creek upstream of Sharon Road West (Roll #4 Photo #14)*

Any streamside capital improvement projects will need to accommodate the existing utilities. Sanitary sewers are present along Lower Little Sugar Creek until near Carolina Place Parkway when the line crosses the watershed to the McAlpine Creek Wastewater Treatment Plant. Sugar Creek Wastewater Treatment Plant (WWTP) discharges into Lower Little Sugar Creek just below the confluence with Little Hope Creek; this also impacts water quality. Dual eight-inch force mains transmit sludge between the Sugar Creek WWTP and McAlpine WWTP. Duke Power maintains right-of-ways for major transmission lines along segments of the stream corridor. Additionally, a Piedmont Natural Gas (PNG) pipeline travels along the right bank, looking downstream, from Archdale Road to Ramblewood Lane. Just south of Ramblewood Lane, the 16-inch gas line crosses Little Sugar Creek and continues along the left bank until Sharon Road West. The City's Year 2000 Inter-Agency Coordination of CIP Map (Figure E-8) does not indicate that Charlotte-Mecklenburg Utilities (CMU) has proposed any CIP along the length of Lower Little Sugar Creek. Mecklenburg County Storm Water Services (MCSWS) should continue to coordinate with CMU and PNG to identify any potential projects or conflicts that arise in the future. If MCSWS is aware of CMU projects, it may influence the alignment of the relief sanitary sewer to coincide with the recommendations of this report.

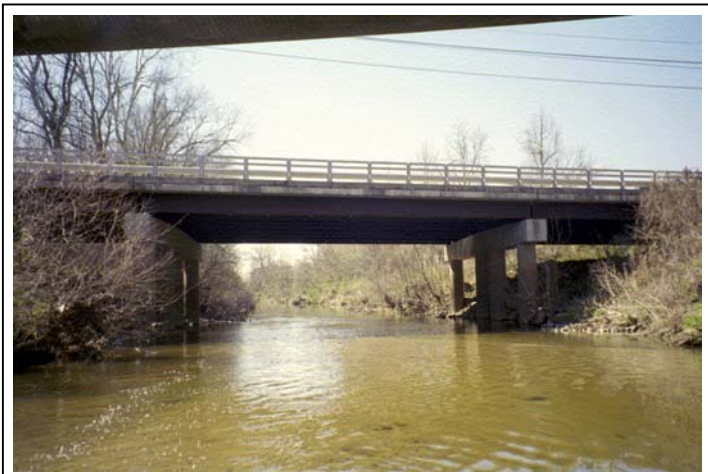
**Figure 9. Realignment, Lower Little Sugar Creek at Sharon Road West (Roll #4, Photo #14)**

When humans interfere with fluvial processes by increasing watershed imperviousness and change stream channels by realignment and armoring the banks, the stream counteracts by gradually lowering the bed slope (the flow remains fairly constant once the watershed is developed) in the upstream direction from a control point, such as the confluence with a larger stream or at a culvert. Review of historical aerial photos shows changes in stream channel alignment. For instance, Lower Little Sugar Creek has been realigned along Sharon Road West (Figure 9). The realignment and straightening of the creek has caused increased entrenchment (and related bank erosion) as the stream attempts to re-

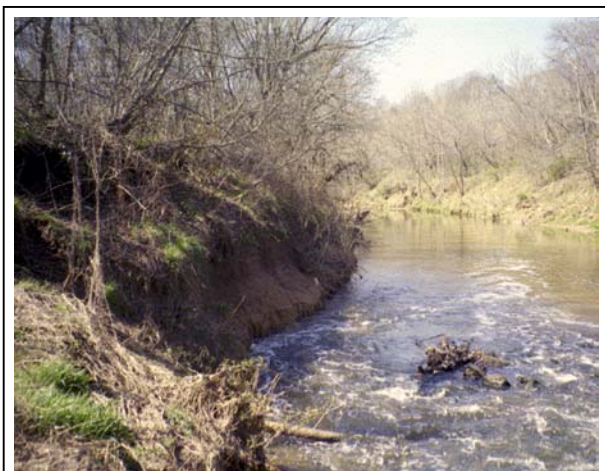
*Figure 10. Erosion, Lower Little Sugar Creek at Polk Road, Looking Downstream (Roll #4, Photo #21)*

The left bank of Lower Little Sugar Creek is eroding at the Polk Road (Old US 521) bridge (Figure 10). Shear stress on the bank is causing erosion. Vegetation on the bank has not been sufficient to prevent erosion. The bank toe is unprotected. Roots are exposed and vegetation is falling into the channel.

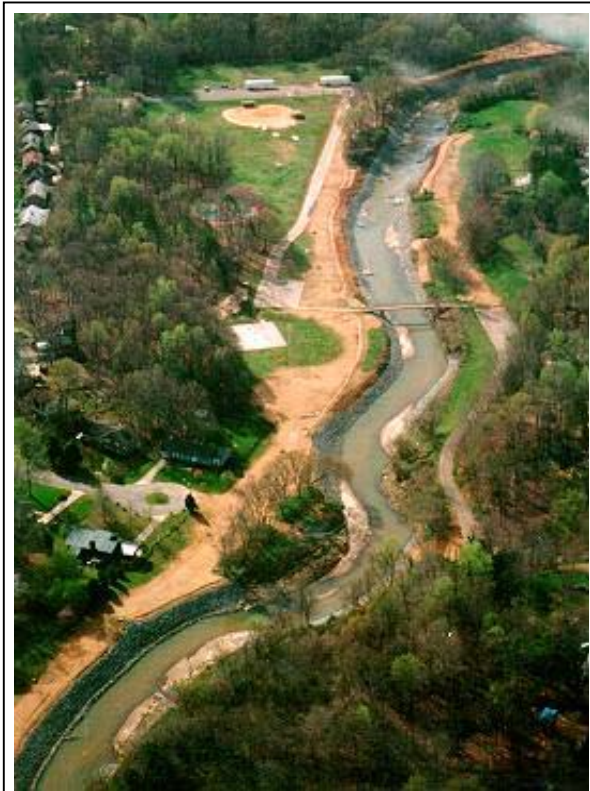
The area of Huntingtowne Farms Park from Burnt Mill Lane to Ramblewood Lane was suffering from bank erosion and stream channel instability. MCSWS addressed this problem with a soil bioengineering and channel stabilization project in 1997 (Figure 11). The goals of this project include providing aquatic habitat, improving water quality, and improving bank stability. MCDEP monitored the aquatic community impacts of this site for two years after construction. When compared to preconstruction data, fish and macroinvertebrate communities were not significantly different. This indicates the project had little impact to date, neither positive nor negative, on these communities. MCDEP suggests this may be influenced by the water quality impacts of the Sugar Creek WWTP upstream. The bank stability improvements have been successful, with establishment of a willow forest buffer. Park maintenance and mowing habits have also been altered to promote bank stability; mowing is only to the top of bank.

**Figure 11. Little Sugar Creek Stream Bank Stabilization Project, Huntingtowne Farms (Photo Courtesy of MCSWS)**

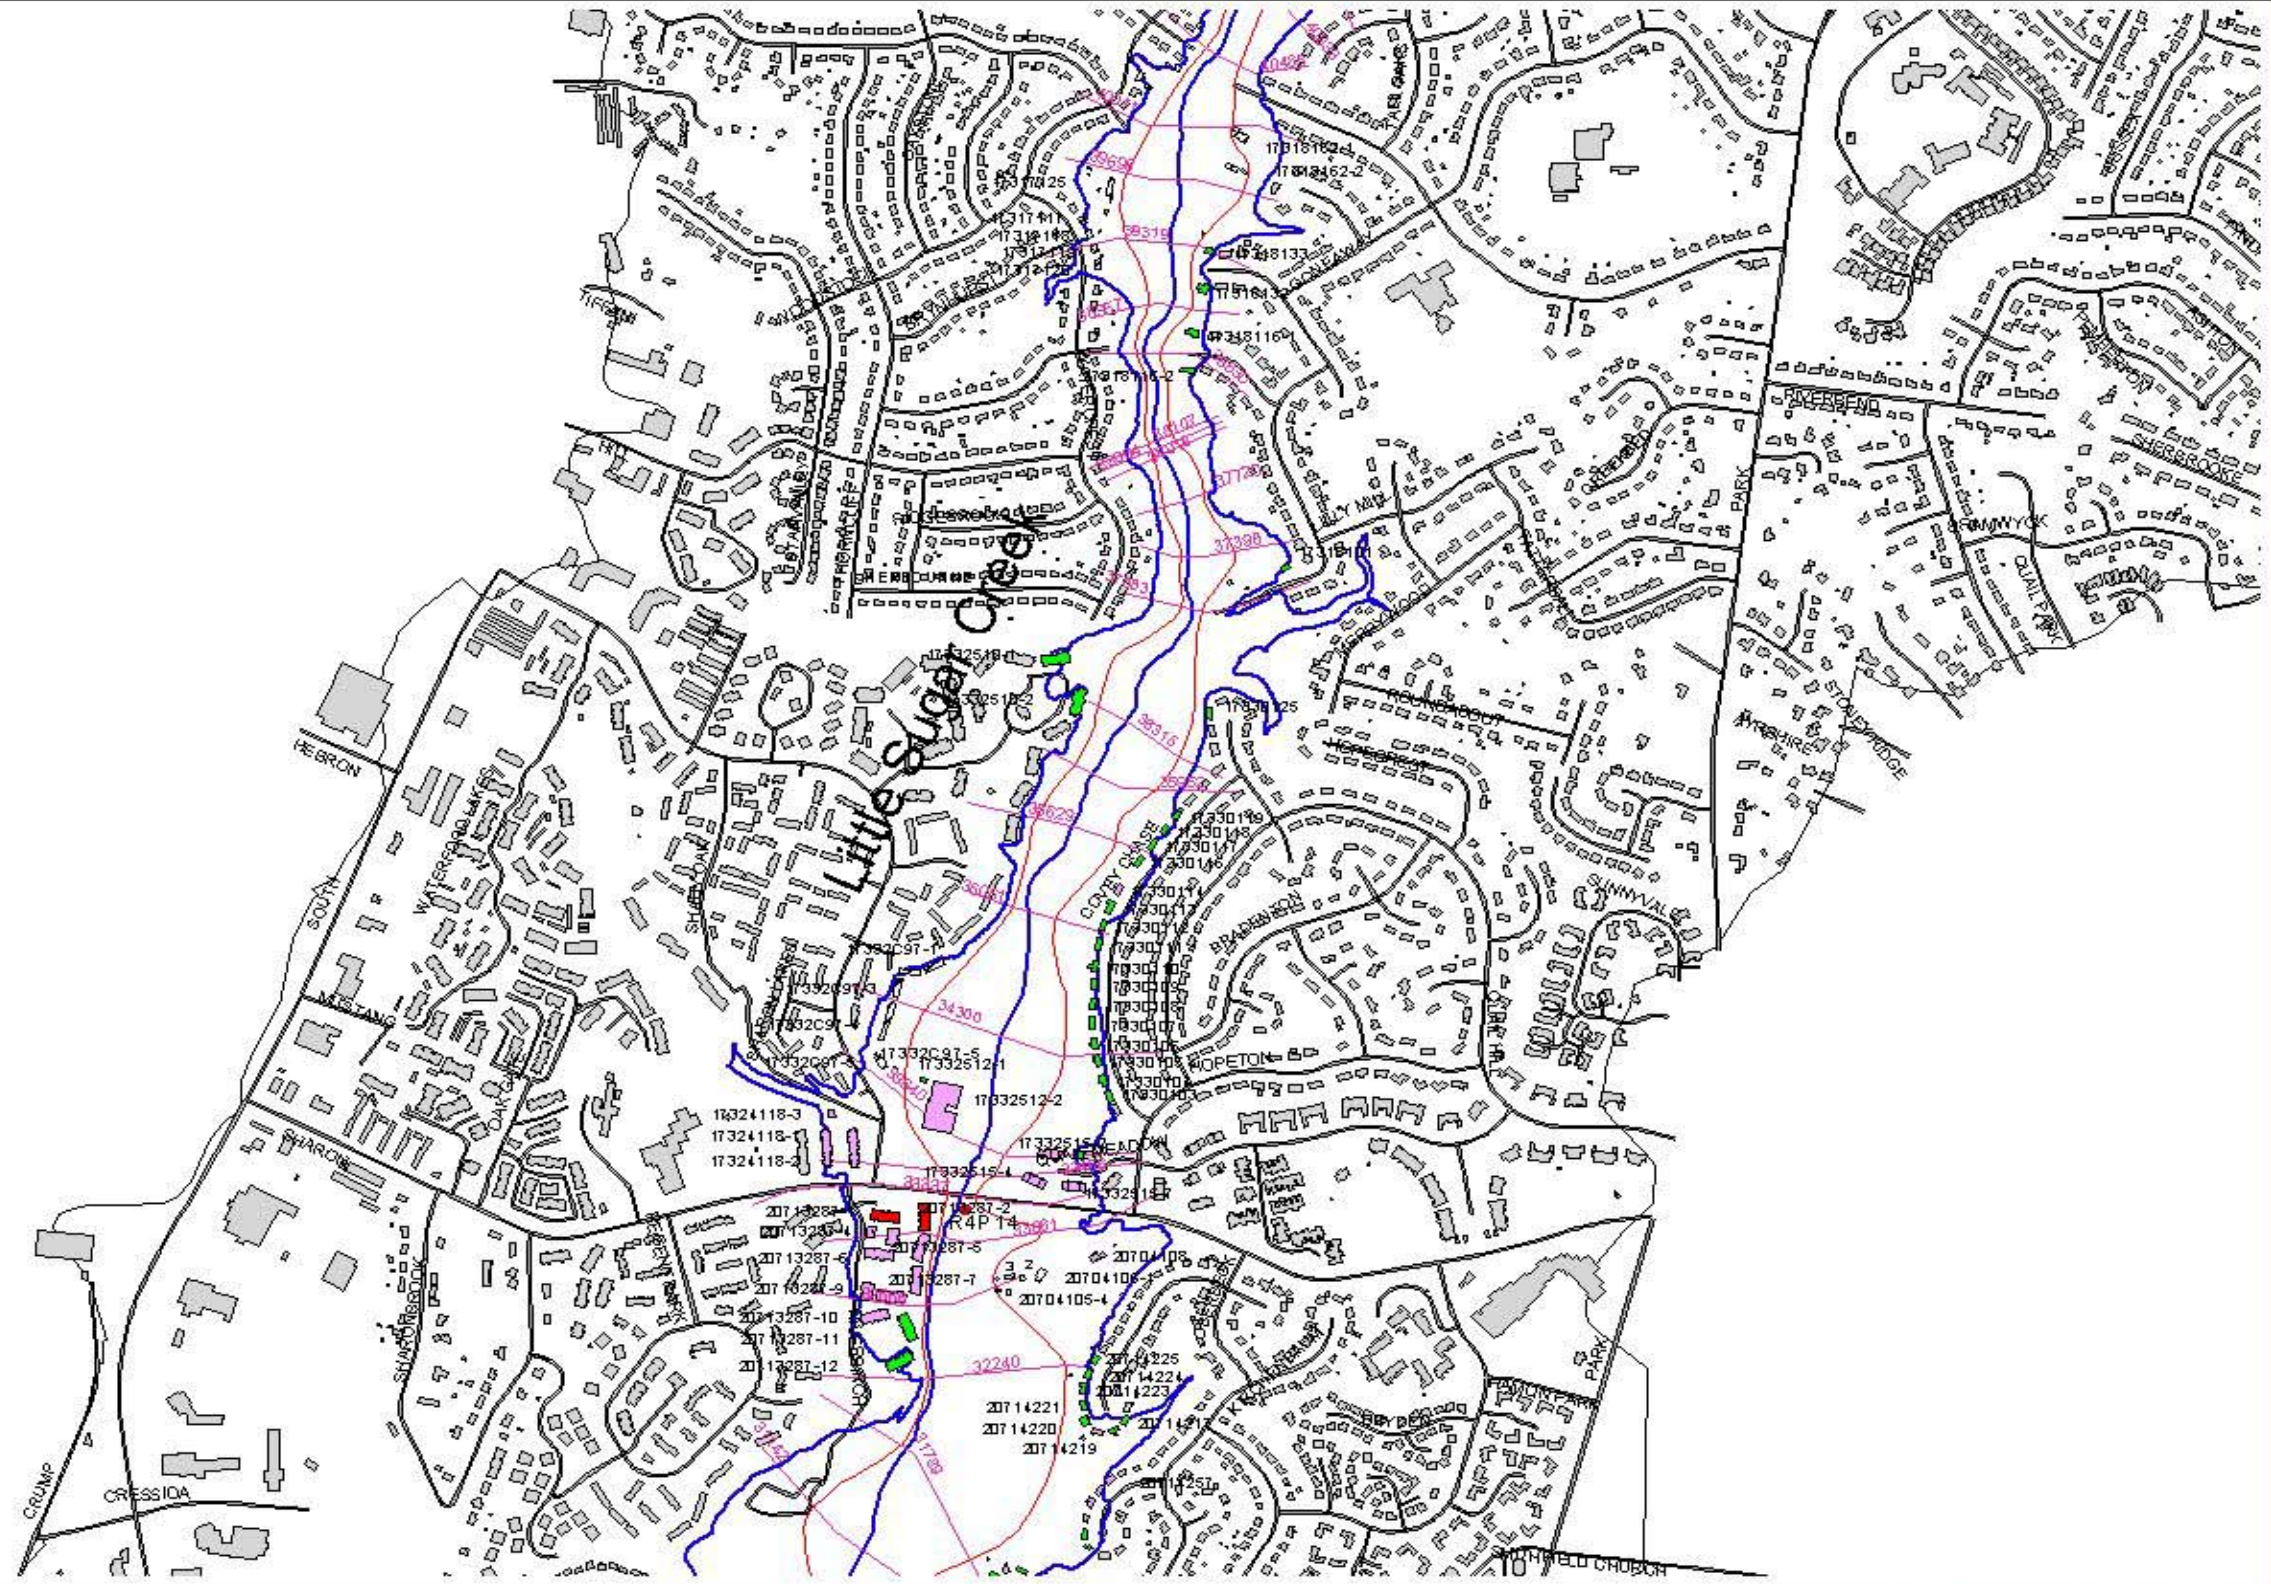
# Figure A-1 Study No.1, (Lower) Little Sugar Watershed Existing Conditions, Sheet 2

The first project goal for this study was an economic analysis of flood hazard mitigation opportunities for a total of 248 structures located within the limits of the 1% annual chance **Future Condition Floodplain** (FCF) (Figure A-1). The second project goal of this study was to consider ecological restoration opportunities consistent with the flood hazard mitigation opportunities. Much of the ecological restoration would occur through off-line wetland construction and stream bank stabilization. One hundred and nine of the 248 structures have lowest finished floor elevations below the **Base Flood Elevation** (BFE: 1% annual chance FCF water surface elevation). Of these 248 structures, 19 were constructed before 1973 (Pre-FIRM). The total improvement construction costs, operation and maintenance costs, and buyout costs for the recommended improvements in the Lower Little Sugar Creek watershed are estimated at \$6,898,900 (2001 dollars) and are summarized in Table E-1 and Graph E-1. Identified problem location “I,” below Polk Street (Old U.S. 521) near the South Carolina state line, has recommended improvements that would provide both flood mitigation and water quality improvement benefits through stream restoration and construction of an off-line wetland. Figures E-1 through E-3 exhibit a representative cross section in this location for both existing conditions and mitigation options. Figures E-4 through E-7 illustrate the recommended improvement locations. Figure E-8 presents Mecklenburg County’s Inter-Agency Capital Improvement Project (CIP) Map.

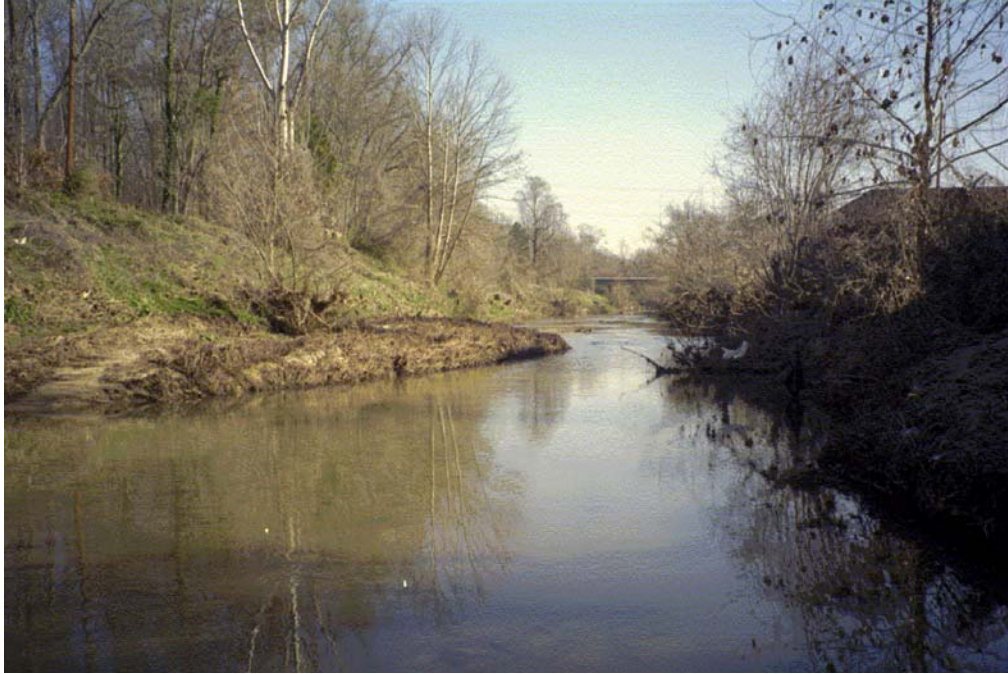
Lower Little Sugar Creek      View U/S      Roll #4      Photo #4  
LOOKING UPSTREAM OF SUGAR CREEK WASTEWATER TREATMENT PLANT (WWTP).  
SLOPING, VEGETATED BANKS.

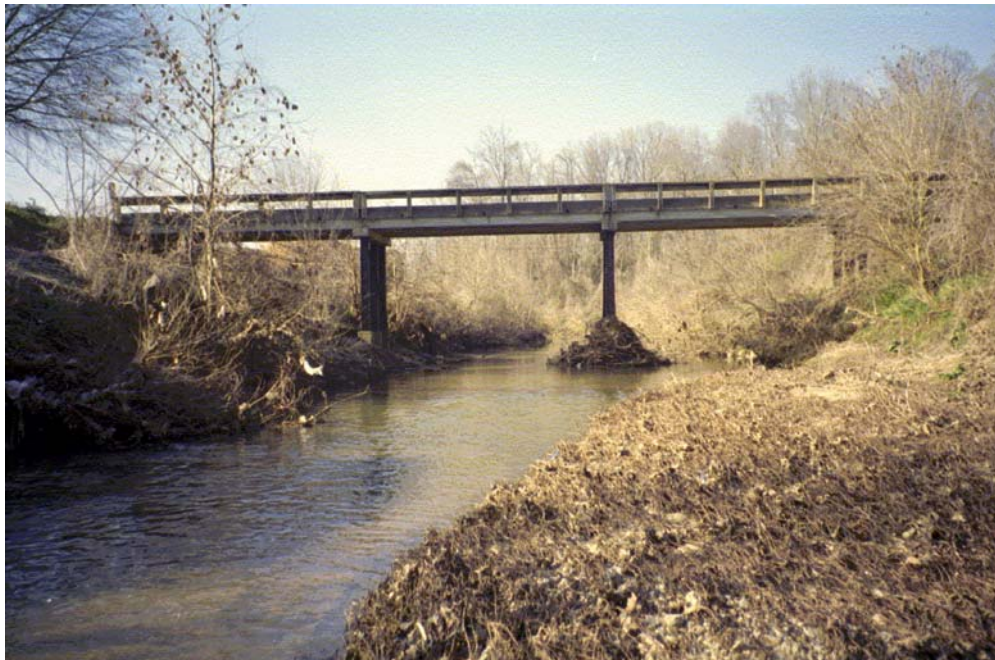
Lower Little Sugar Creek      View U/S      Roll #4      Photo #5  
UPSTREAM FACE OF BRIDGE CROSSING TO WWTP. SAND DEPOSITION AND DEBRIS  
ACCUMULATION. SCOUR PRESENT ON CENTER PIER.

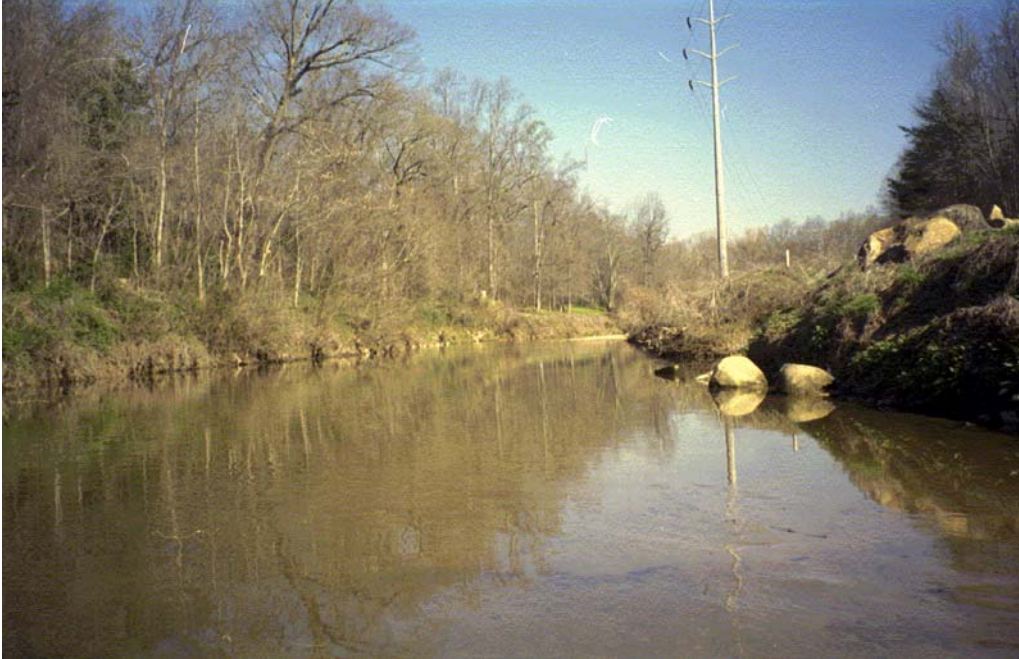
Lower Little Sugar Creek      View U/S      Roll #4      Photo #10  
SHALLOW, WIDE CHANNEL UPSTREAM OF ARCHDALE ROAD BRIDGE CROSSING.

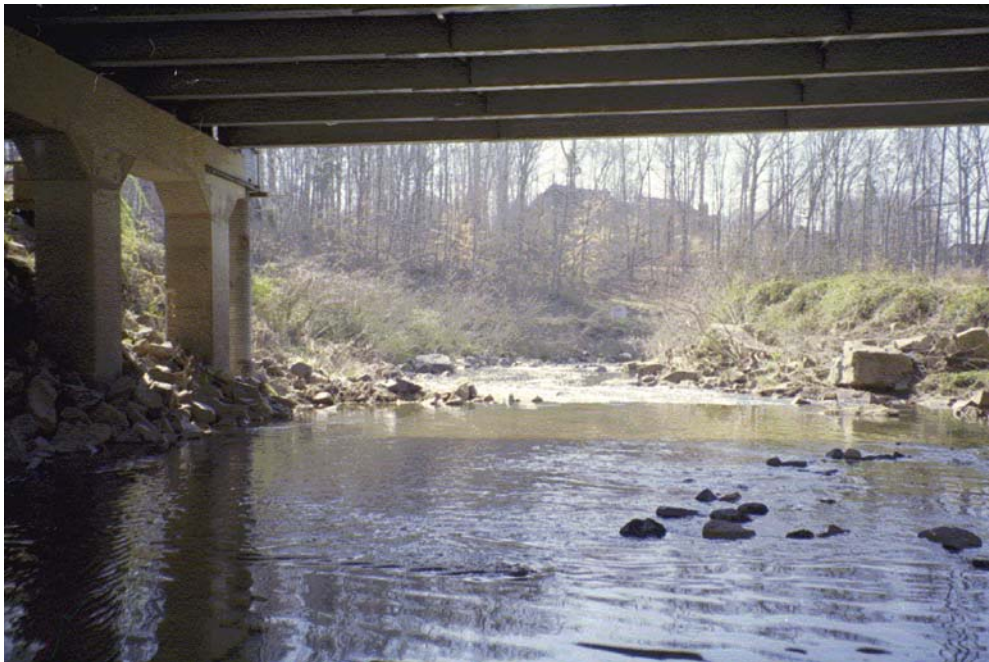
Lower Little Sugar Creek      View D/S      Roll #4      Photo #12  
ROCKY BOTTOM MATERIAL AT ARCHDALE ROAD BRIDGE CROSSING. VEGETATED  
BANKS.

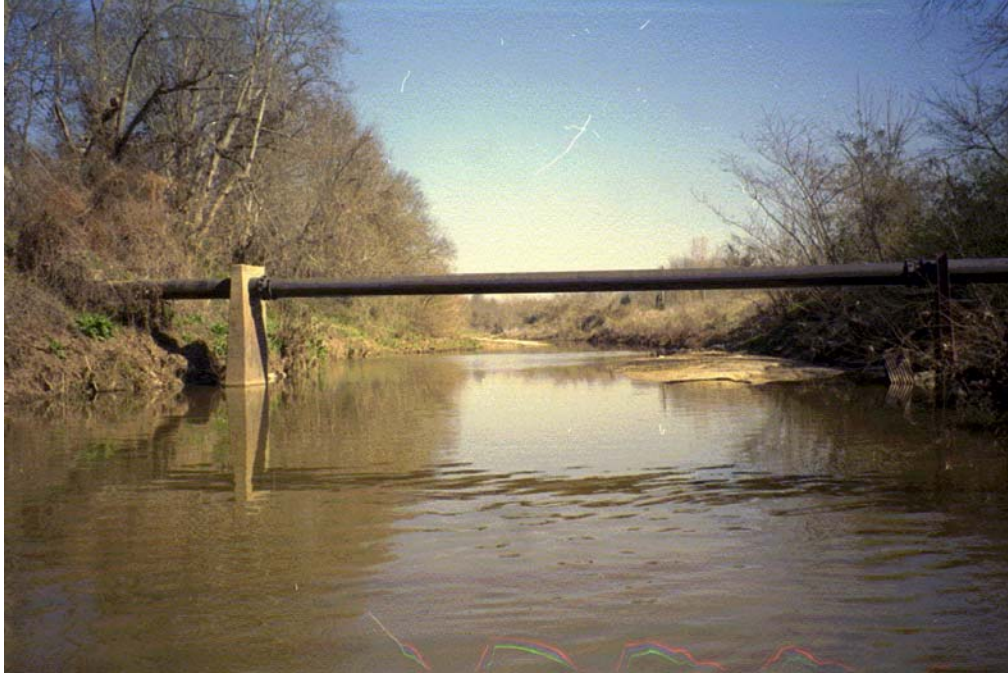
Lower Little Sugar Creek      View U/S      Roll #4      Photo #13  
SANITARY SEWER CROSSING UPSTREAM OF SHARON ROAD WEST. SHALLOW, WIDE,  
REALIGNED CHANNEL.

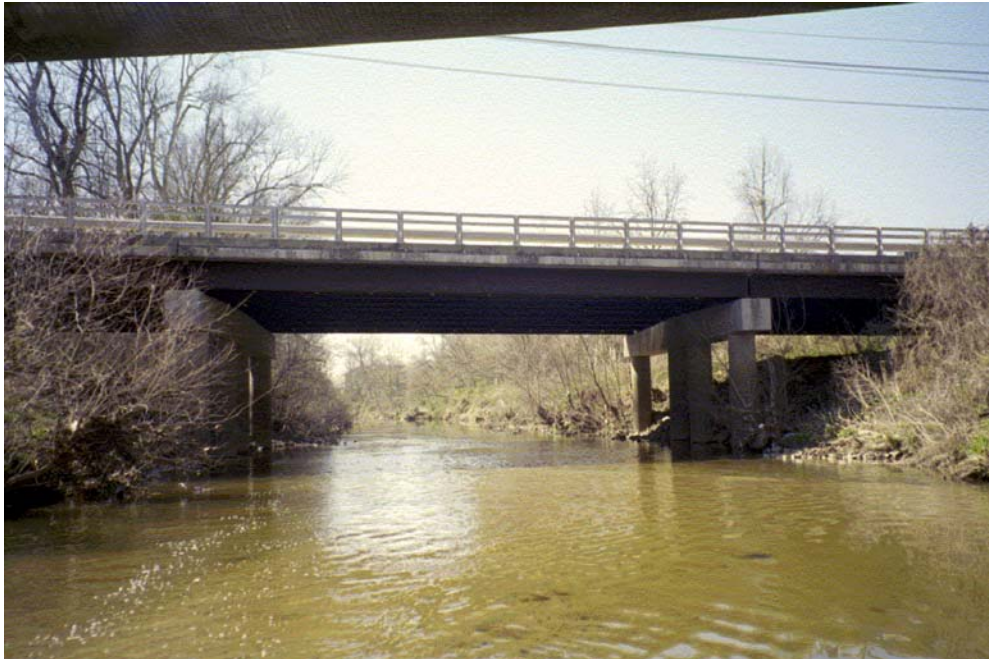
Lower Little Sugar Creek      View D/S      Roll #4      Photo #14  
SHALLOW FLOW DOWNSTREAM OF SHARON ROAD WEST BRIDGE CROSSING.

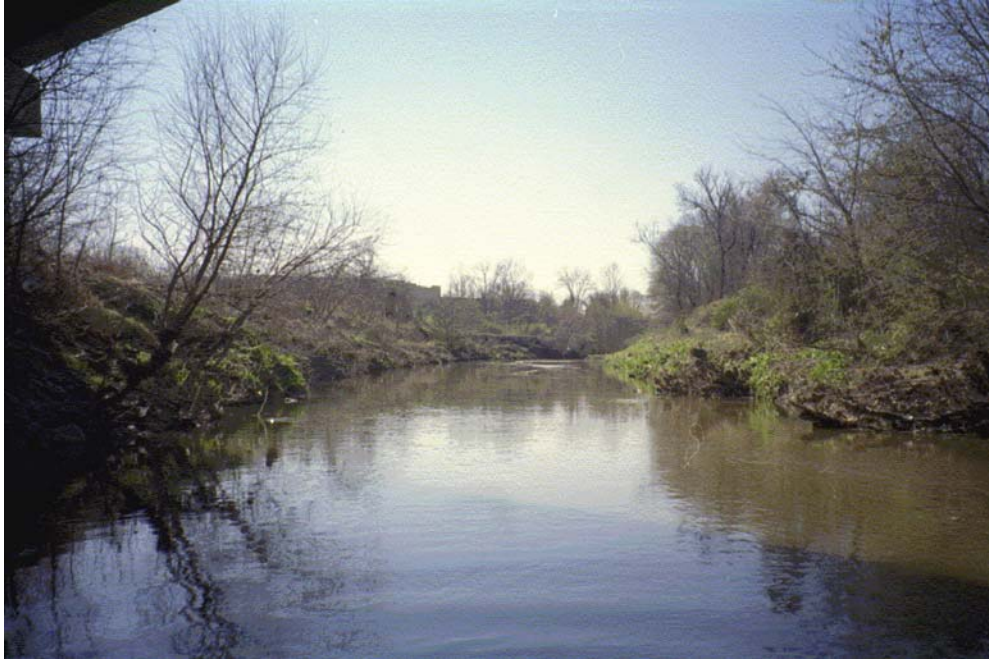
Lower Little Sugar Creek      View D/S      Roll #4      Photo #15  
WELL VEGETATED OVBANKS DOWNSTREAM OF I-485 BRIDGE CROSSING.

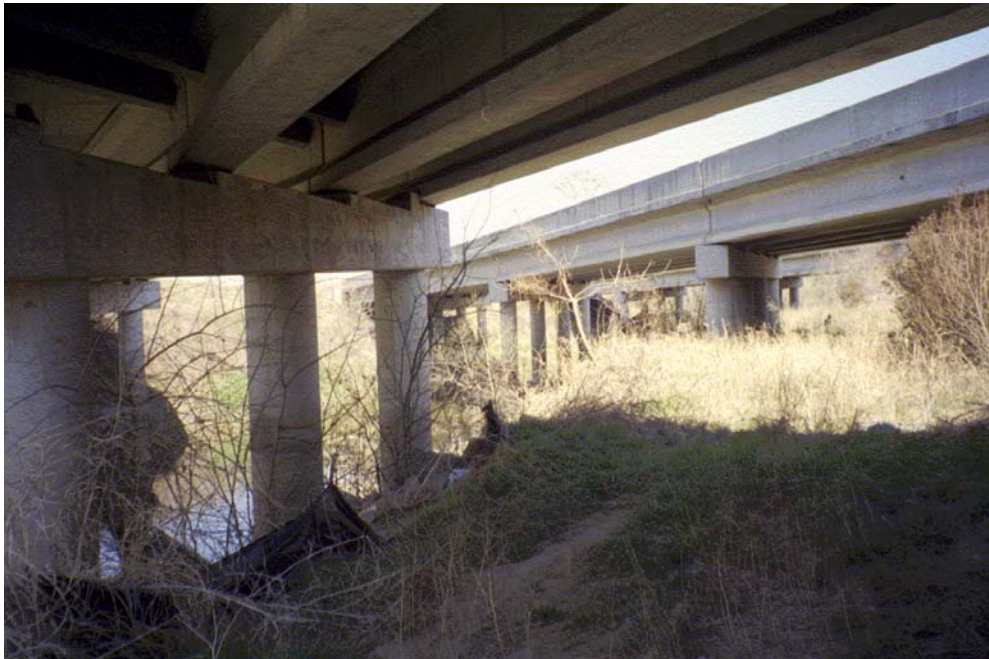
Lower Little Sugar Creek      View (under bridge)      Roll #4      Photo #16  
I-485 THREE BRIDGE CROSSING (WEST BOUND, EAST BOUND, AND EAST BOUND RAMP).

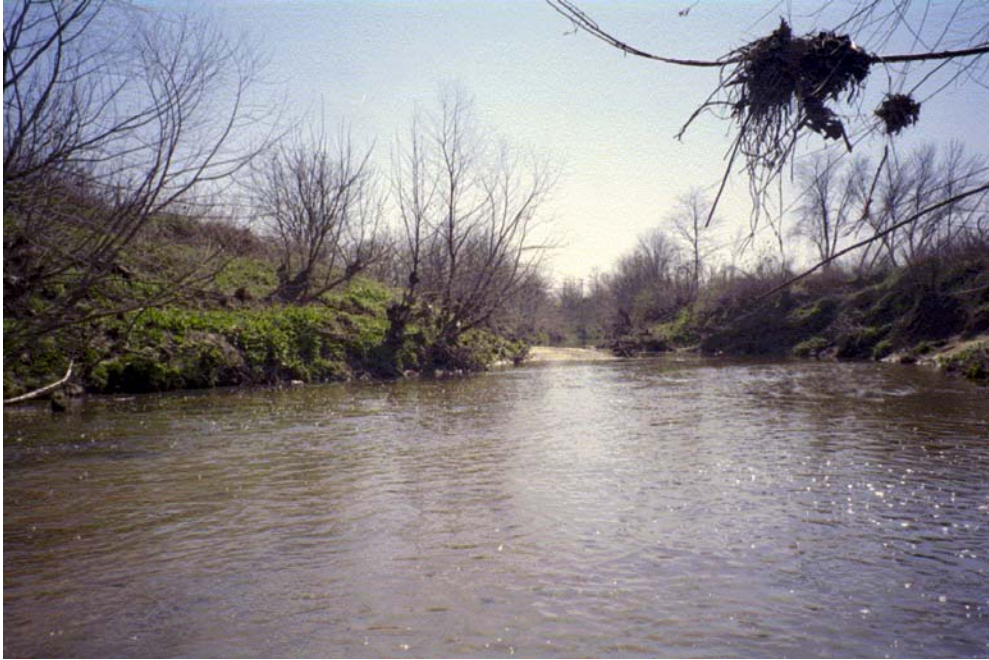
Lower Little Sugar Creek      View D/S      Roll #4      Photo #17  
GRASSY VEGETATED BANKS DOWNSTREAM OF HWY 51 (PINEVILLE-MATTHEWS ROAD)  
BRIDGE CROSSING.

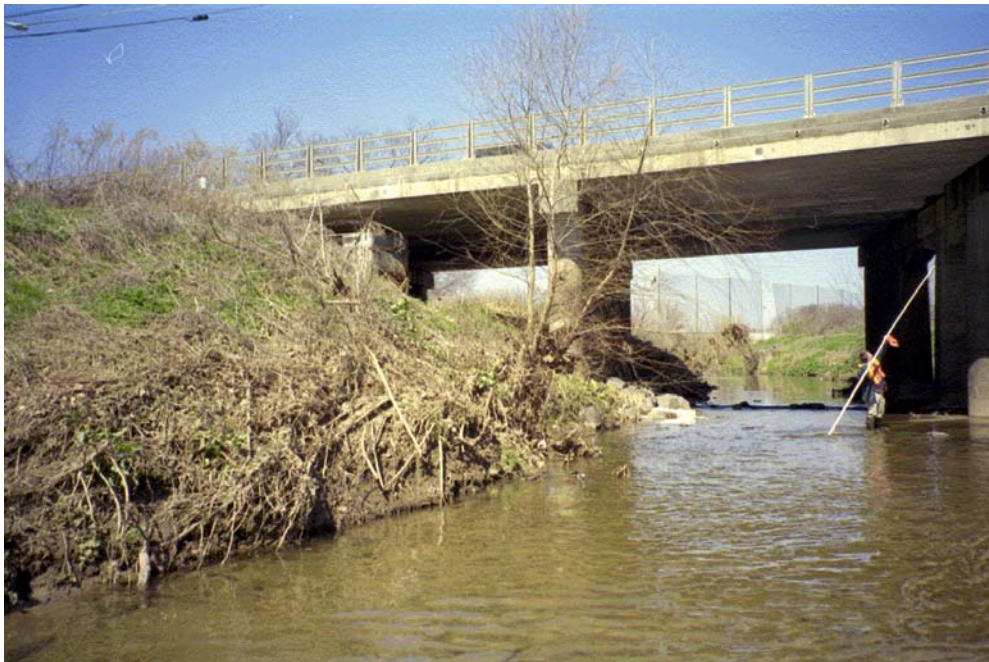
Lower Little Sugar Creek      View D/S      Roll #4      Photo #18  
DOWNSTREAM FACE OF BRIDGE CROSSING HIGHWAY 51 (PINEVILLE-MATTHEWS ROAD).

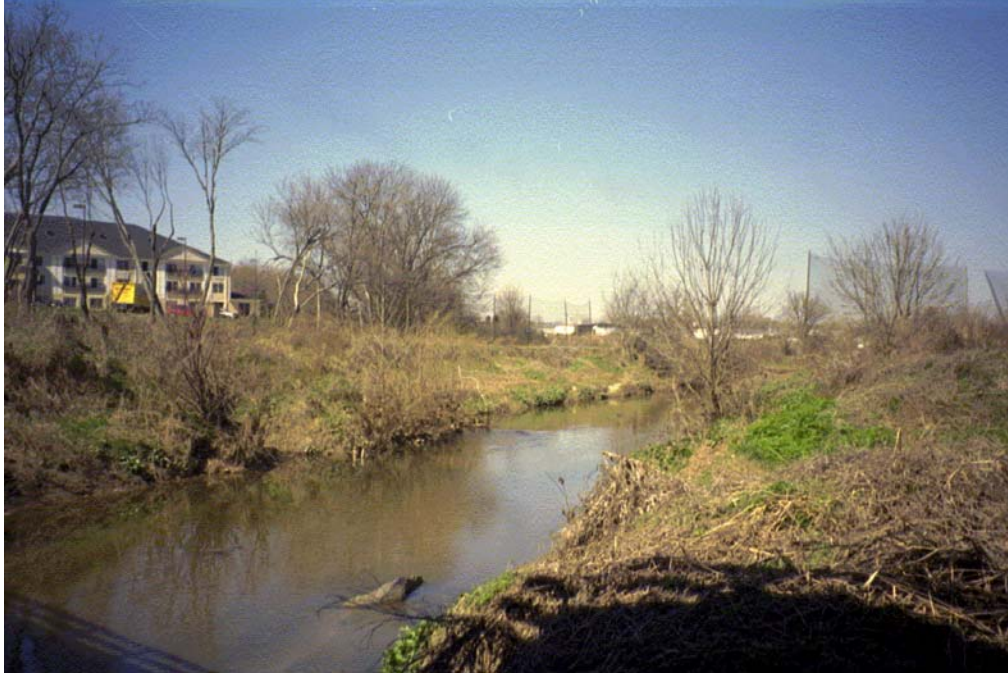
Lower Little Sugar Creek      View U/S      Roll #4      Photo #20  
VIEW OF DEVELOPMENT UPSTREAM OF HIGHWAY 51 (PINEVILLE-MATTHEWS ROAD).

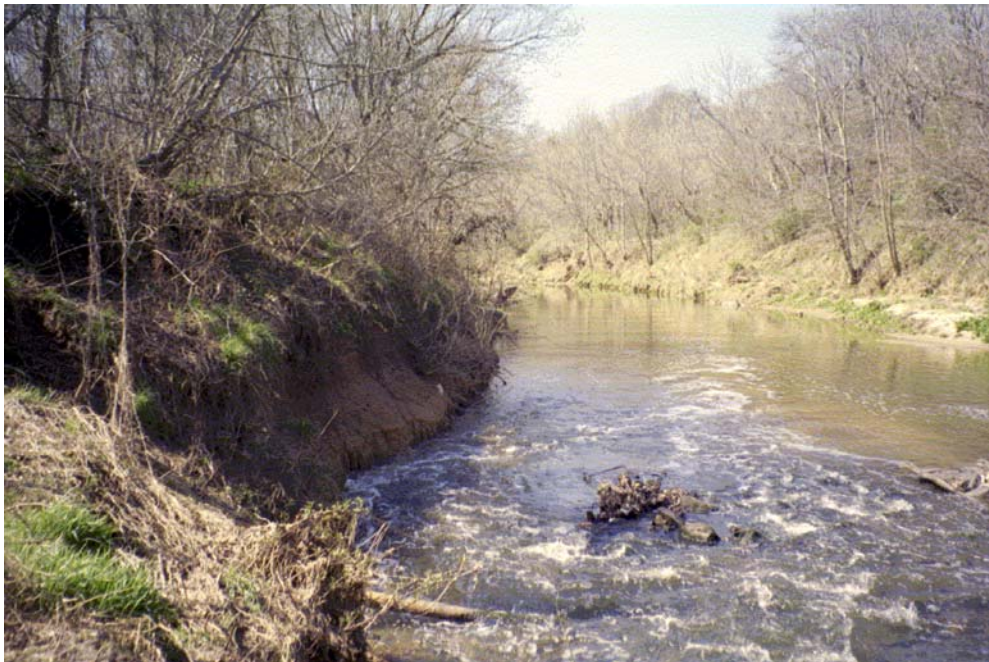
Lower Little Sugar Creek      View D/S      Roll #4      Photo #21  
RIFFLS DOWNSTREAM OF POLK ROAD BRIDGE CROSSING. LOWER LEFT BANK EROSION.  
TOE IS UNPROTECTED.

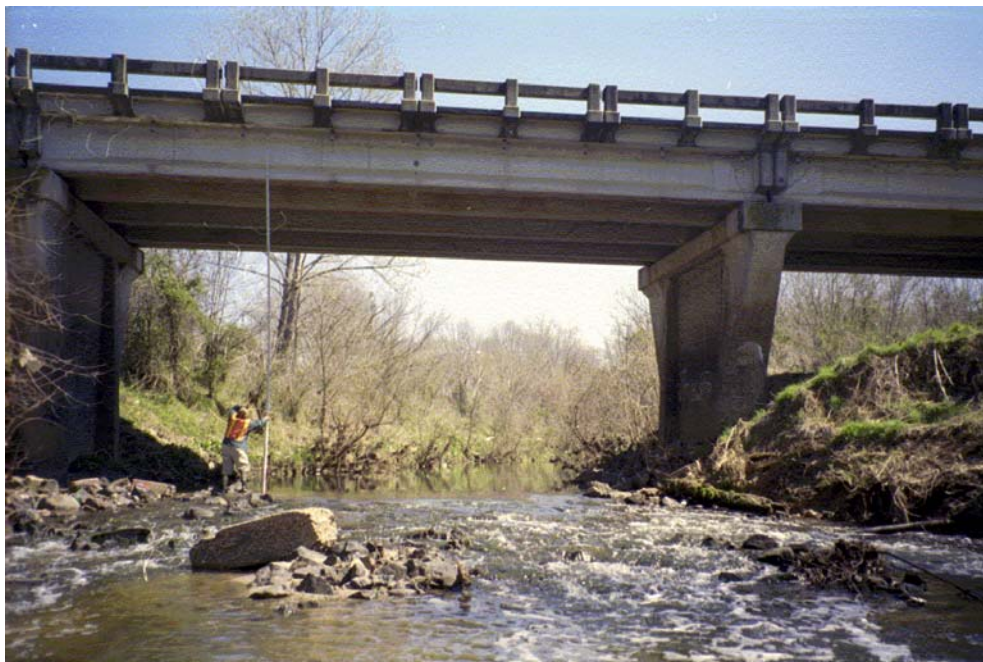
Lower Little Sugar Creek      View D/S      Roll #4      Photo #23  
DOWNSTREAM FACE OF POLK ROAD BRIDGE CROSSING.
