Watershed Study No. 6

McDowell Creek Watershed

Preliminary Engineering Report

MCSWS Project No. 28001

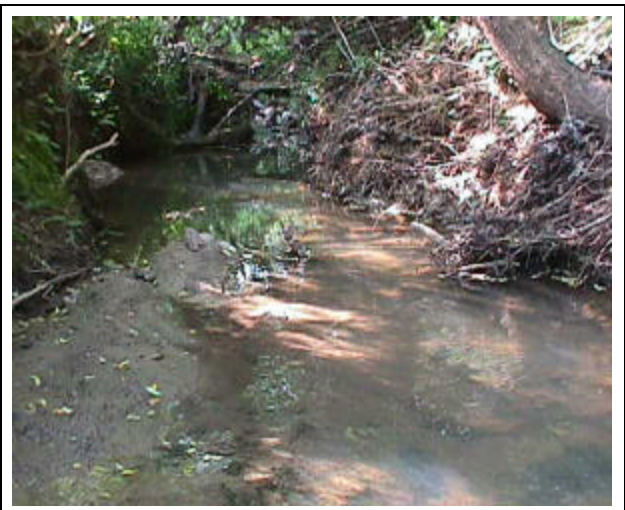
Fig.1 At Statesville Road

Rosgen classification of McDowell Creek is presented in Section 1.4 of this report. Qualitative descriptions of the creek and its tributaries are given in the following paragraphs. Similar to the other creeks in the City of Charlotte, there is a sewer trunk line along McDowell Creek and its tributaries. Installation of these trunk lines has resulted in stabilized banks and trained stream alignment throughout the length of the McDowell Creek system. The banks and floodplains are densely vegetated and in some parts heavily wooded, creating a stable stream. Figure 1 shows the stream at its upstream end at Statesville Road crossing. The flow is shallow and tranquil in a well-defined floodway with relatively steep banks. Figure 2 shows the creek downstream, past the confluence with McDowell Trib 1 at Beatties Ford Road. The flow in this area is shallow and tranquil with stabilized banks and a relatively straight main channel alignment. The sewer trunk line is on the right bank of the

creek. Vegetation is taking over the riprap and is dense along the more gently sloped banks in this section. Compared to other creeks, McDowell is in a less urbanized setting, although the rapid pace of development is evident along the stream and its tributaries. Frequent occurrence of point bars is indicative of increased sediment transport due to heavy development activity.

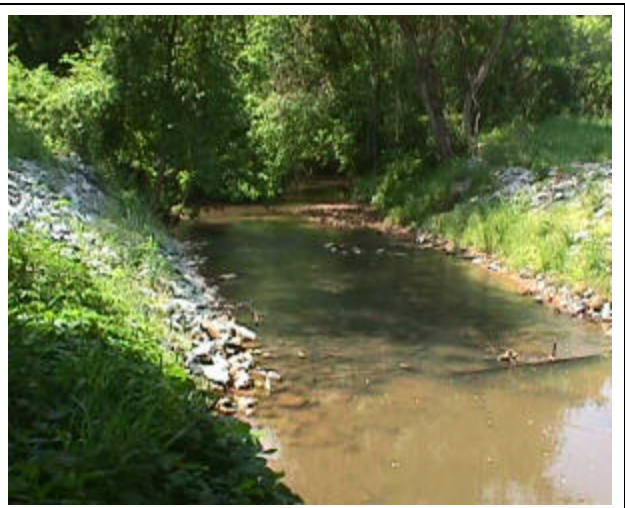
Fig. 2 Near Beatties Ford Road

The McDowell Creek system was observed under base flow conditions when the photos of this report were taken. Under the observed conditions, the flow is mostly tranquil and shallow. The floodway is lined with heavy brush and tree growth making access to the stream difficult in most places, although the banks must have been disturbed and cleared at one time for the installation of the sewer main line. By visual observation, the manholes of the sewer line seem to be below the 100-year flood level in many places visited. There is a greenway along the creek near the intersection of Bradford Hill Lane and Gilead Road, further stabilizing the banks and floodplain in that region of the creek.

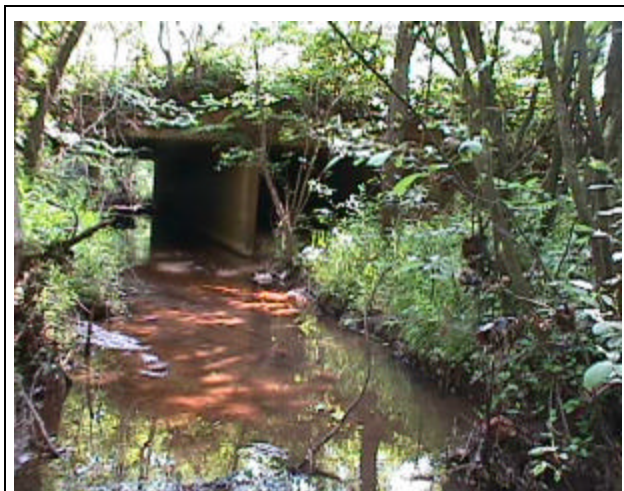
Fig. 5 Caldwell Station Creek at Statesville Road

Although MCSWS regularly maintains areas of known flooding problems, the tendency of vegetation to establish over depositions in the streambed can affect the hydraulic capacity of the stream. Figure 5 shows Caldwell Station Creek at Statesville Road crossing. Deposition has occurred immediately in front of one of the two box culverts. Vegetation has taken root

and now sizable trees and brush line the deposits. Flood flows may not be able to uproot the trees and the capacity of the culvert may be compromised. Figure 6 shows Torrence Creek at Bradford Hill Lane crossing. The flow of the entire creek is occurring in the right barrel of the triple circular culvert. Signs of vegetation taking root on the deposited sediments are visible. If floods of sufficient magnitude that flush the sediments downstream of the culvert do not occur, more vegetation may stabilize the deposits and eventually compromise the capacity of the culvert. In order to maintain full capacity for the stream and ensure the safe passage of a flash flood, it may be necessary for the County to undertake a stream maintenance program or install hydraulic structures for sediment exclusion from the structures at road crossings. The maintenance program would include keeping the road crossing free of unwanted vegetation, other obstructions, and sediment deposits, and assuring that bridges and culverts will operate at or near their design capacity during a flood. Further discussion of a creek maintenance program will be presented later in this report.

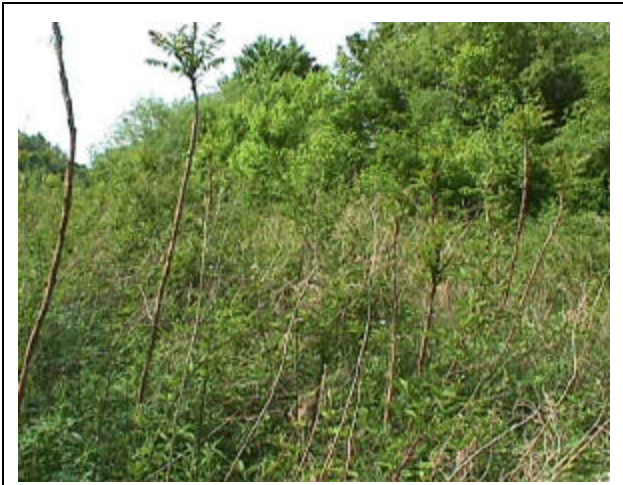
Fig. 7 Near Westmoreland Road

floodplain does not seem to be a serious problem. The floodplains in two sections of the creek are shown in Figure 7 (near Westmoreland Road) and Figure 8 (at Glenwyck Lane, off Bud Henderson Road).

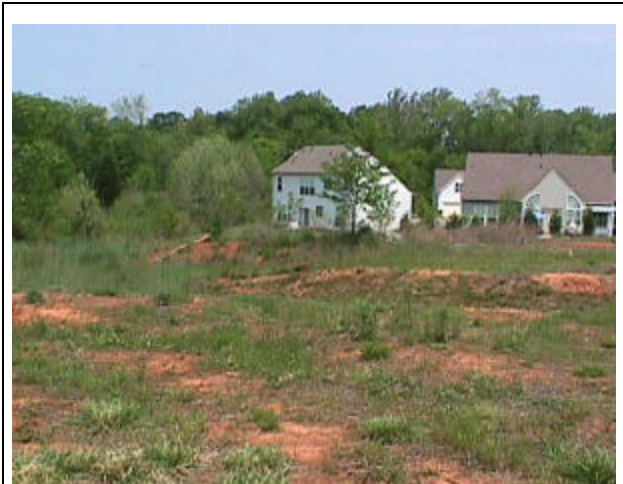
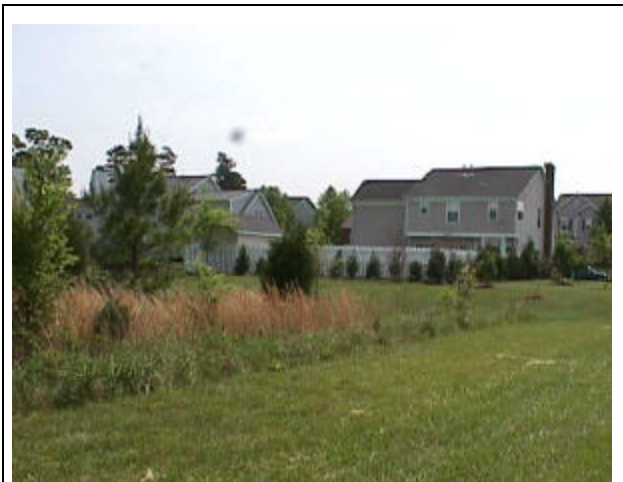
Development along McDowell Creek and its tributaries is less intense than other basins of the City of Charlotte at present. However, heavy commercial and residential development activity is underway. Visual judgment based on the site visit of May 2, 2001 suggested that a number of residential and commercial buildings are near or within the floodplain. Four cases of such structures in the flood fringe areas are presented in the next four figures, although sites with flooding potential are not limited to those shown in these figures. Figure 9 shows houses on Stawell Drive. These are three of 7 houses whose footprints plot within the ECF. Figure 10 shows houses on the intersection of

Torrence Crossing Drive and Bradford Hill Lane. Several houses in this neighborhood are in the flood fringe areas. Figure 11 shows an older house on Gilead Road. The elevation certificate for this house places the finished floor elevation above the BFE. However, the lower level garage could be flooded. There are other older houses in the same neighborhood with footprints in the ECF or the FCF. Figure 12 shows houses on Leisure Lane, off Bud Henderson Road. In plan view, the entire row of houses on the creek side of this street is located within the ECF. There was extensive development activity with earth moving at the time of the site visit in this neighborhood.

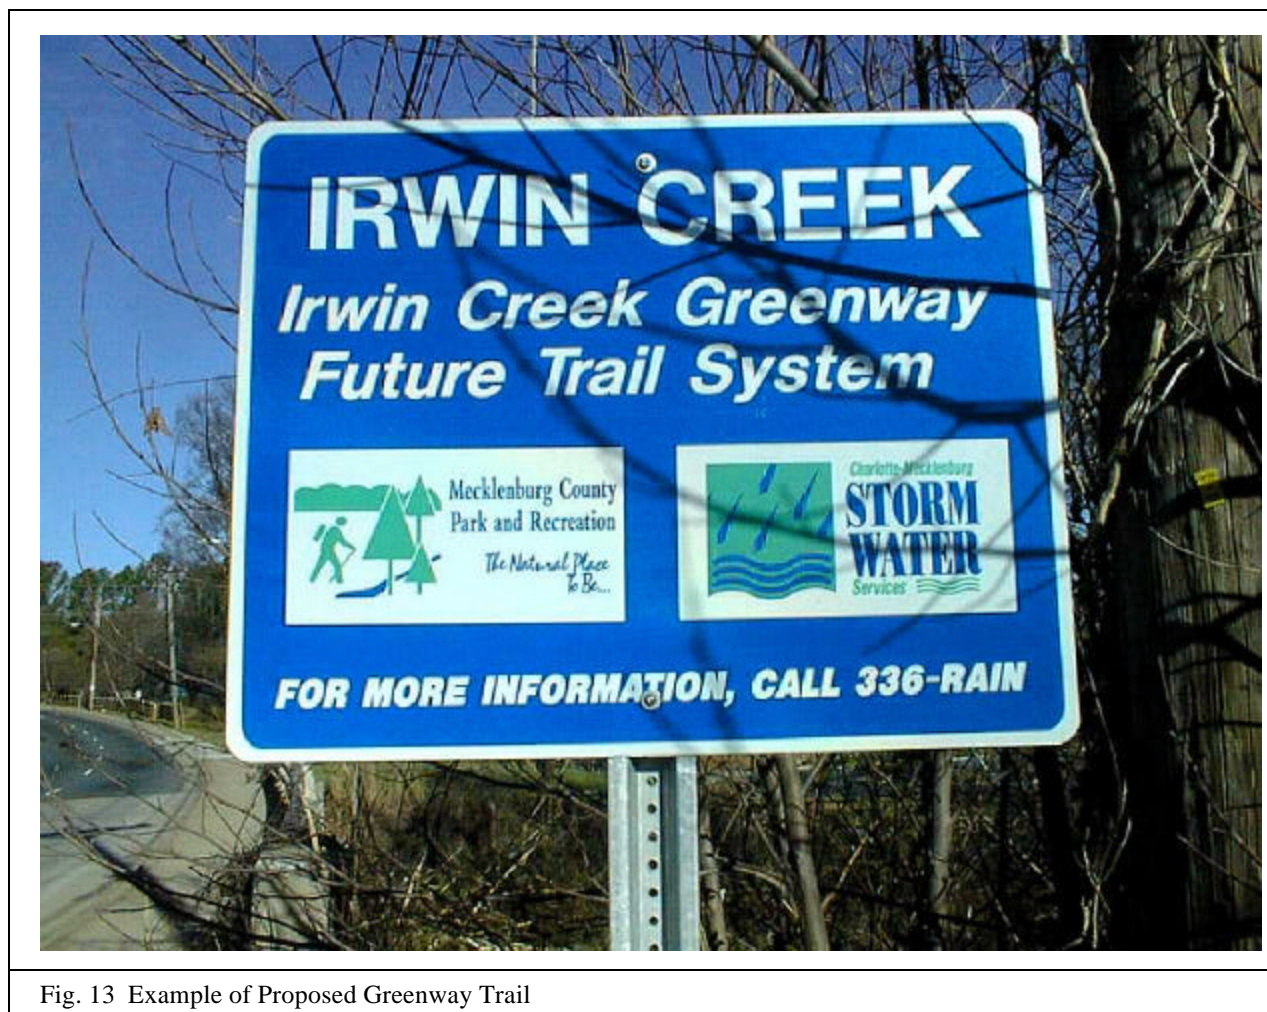
Fig. 13 Example of Proposed Greenway Trail

Existing sanitary sewer trunk lines, completed in the mid 1980's, are installed along the entire length of FEMA-regulated portions of McDowell Creek and its tributaries. Currently, no additional capital sewer improvements are planned along the creek based on the Charlotte-Mecklenburg Utility Department 2002 Capital Improvement Plan (CIP). A greenway trail is planned along the creek, which will be explained in more detail later. Development of such trails is announced for public information similar to the example shown in Figure 13.

Currently, the only planned CIP in the McDowell Creek basin includes the creation of three greenway trails (See Fig. 13) consisting of:

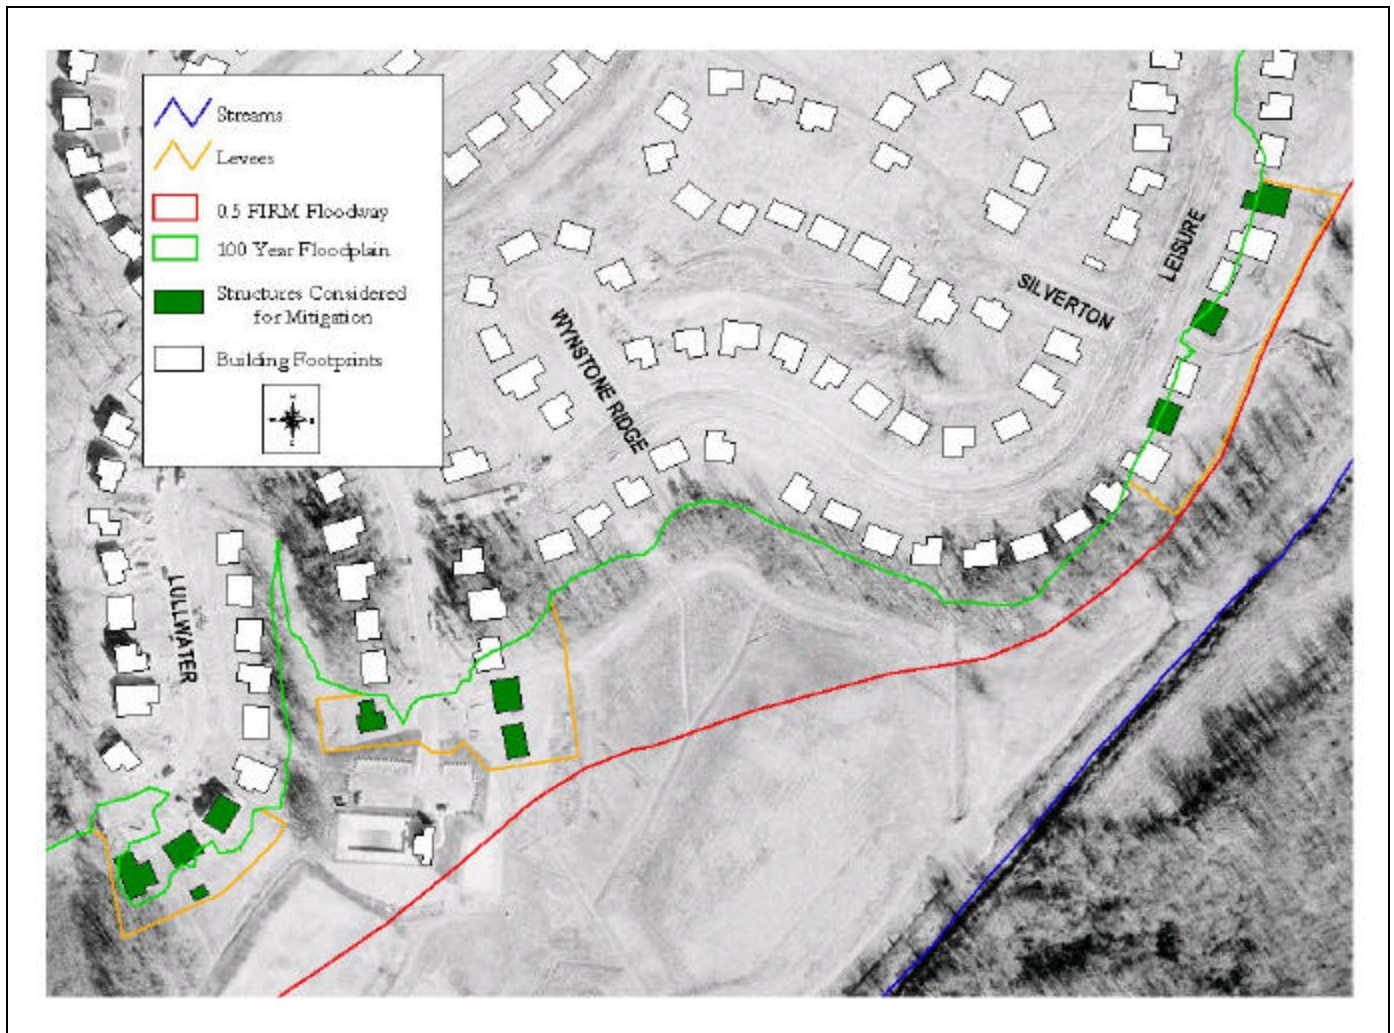
Fig. 17 Houses with Flooding Potential in Henderson Park/Leisure/Lullwater Neighborhood

The summary of the benefit:cost analysis for the Henderson Park Road, Leisure Lane and Lullwater Cove neighborhood is shown in Table 8. The general neighborhood is shown in Figure 17. A total of 9 structures in this neighborhood are in flood fringe areas. The highest benefit:cost ratio for any of the mitigation measures for the neighborhood is 0.161 for the levee (flood barrier) alternative, well below the acceptable level of 1.0 for adoption of the mitigation measure. The highest benefit:cost ratio for an individual structure in this neighborhood is 0.12 for the elevation option for 7641 Henderson Park. The levees in this neighborhood are used for a cluster of houses, and hence individual costs for this option cannot be used for comparison of structures.

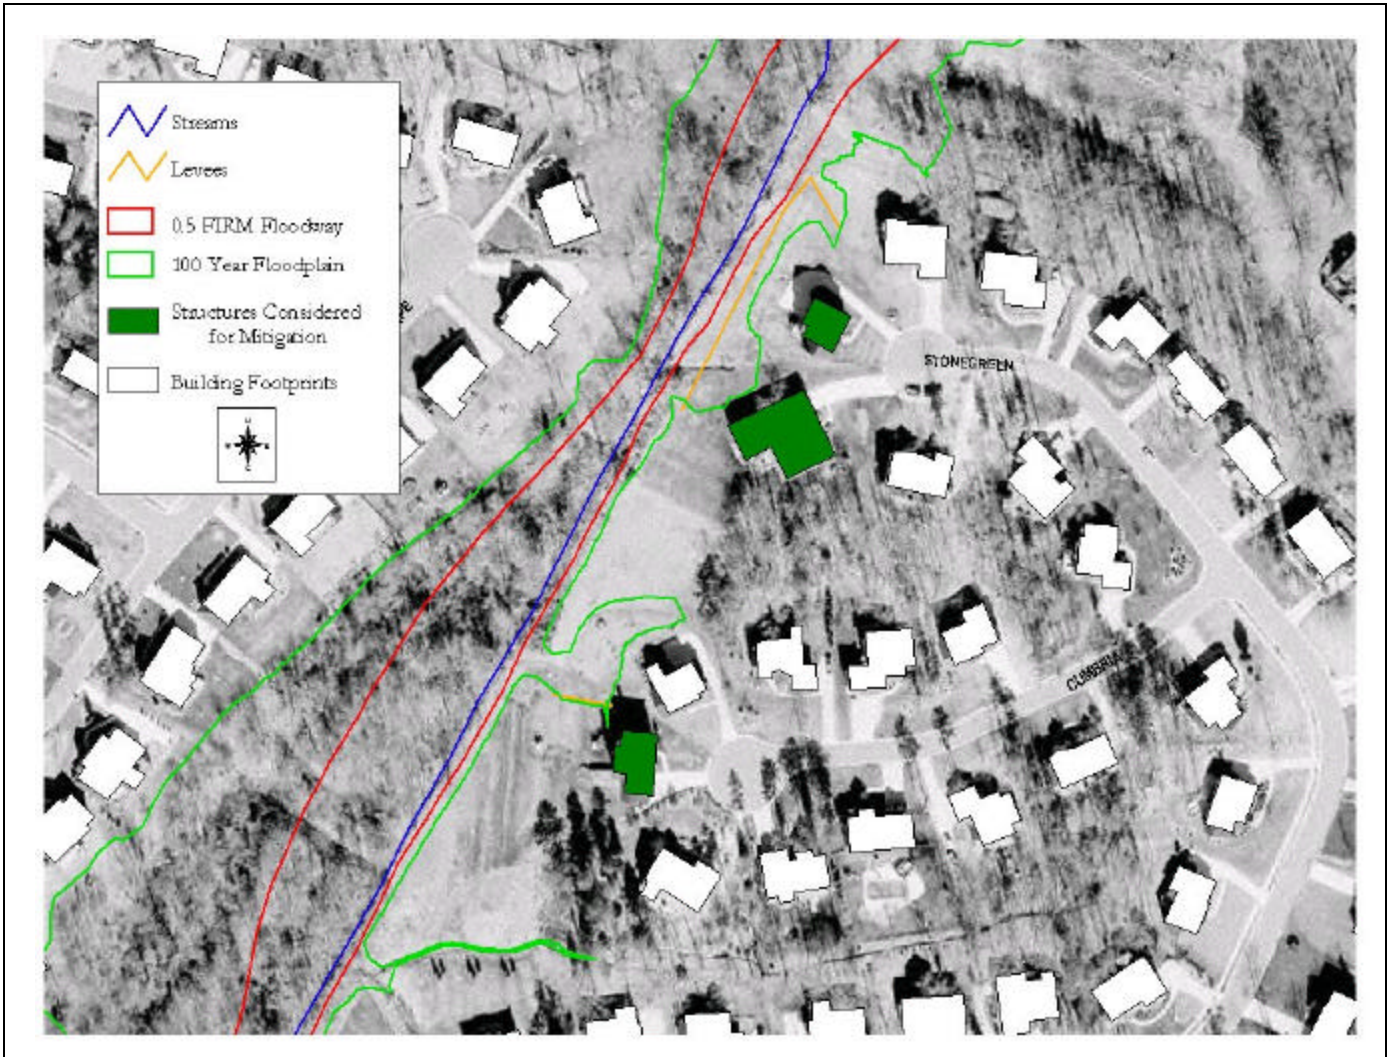
Fig. 19 Houses with Flooding Potential in Cumbria/Stonegreen Neighborhood

The summary of the benefit:cost analysis for the Cumbria Ct and Stonegreen Ln neighborhood is shown in Table 10. The general neighborhood is shown in Figure 19. Three structures in this neighborhood are in flood fringe areas. The highest benefit:cost ratio is 0.42 for the levee alternative, decidedly below the acceptable level of 1.0 for feasibility of the mitigation measure. The highest benefit:cost ratio for an individual structure in this neighborhood is 0.12, still well below the feasible level of 1.0.
