PRELIMINARY ENGINEERING REPORT

Watershed Study No. 3

Sugar Creek Watershed

**PRELIMINARY ENGINEERING REPORT
FOR
WATERSHED STUDY No. 3**

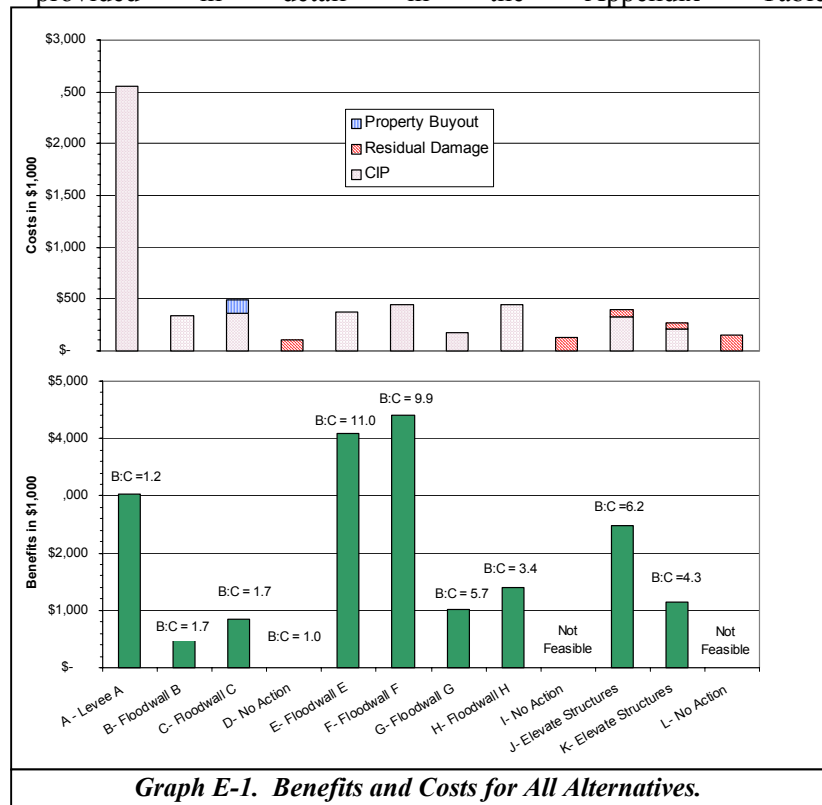
A-1. Of 164 flood potential structures, 51 were constructed before 1973 (Pre-FIRM). A majority of these structures are along Sugar Creek (133). While structures are within the limits of the FCF along all streams in this study, flooding structures are only along Sugar and Coffey Creeks. Therefore, flood hazard mitigation options are only presented along these two creeks. The total improvement construction costs, operation and maintenance costs, and buyout costs for the improvements along Sugar Creek and Coffey Creek are estimated at \$4,557,400 and \$816,300, respectively, for a total cost of \$5,373,700 (using the January 29, 2001, Federal Discount Rate of 5.5 percent) (Graph E-1, Table E-1).

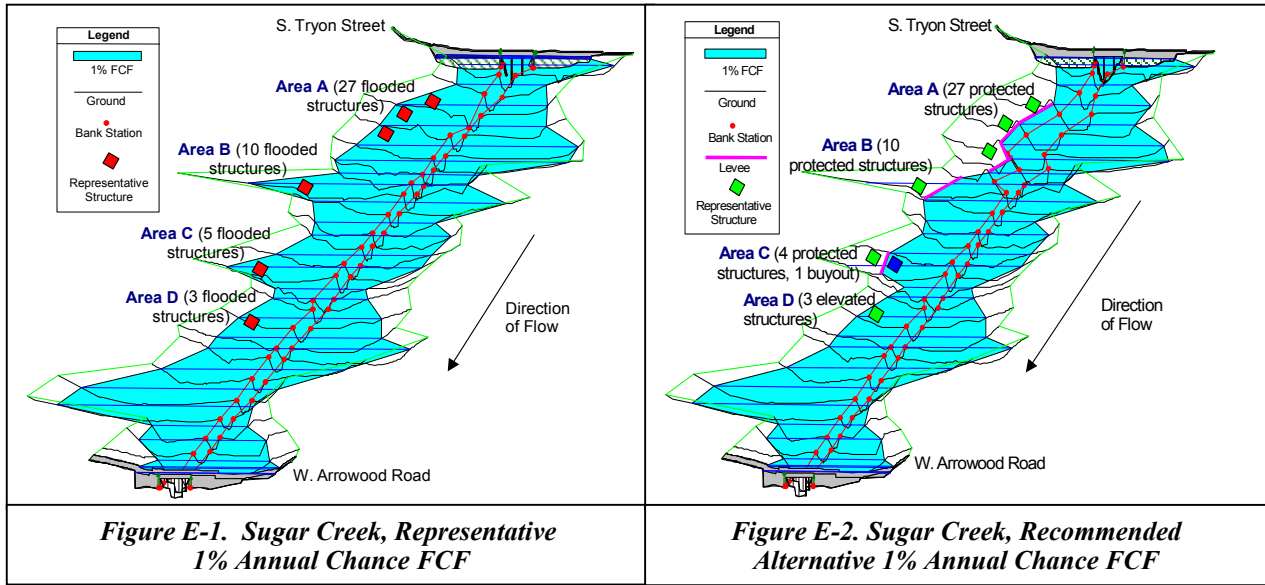
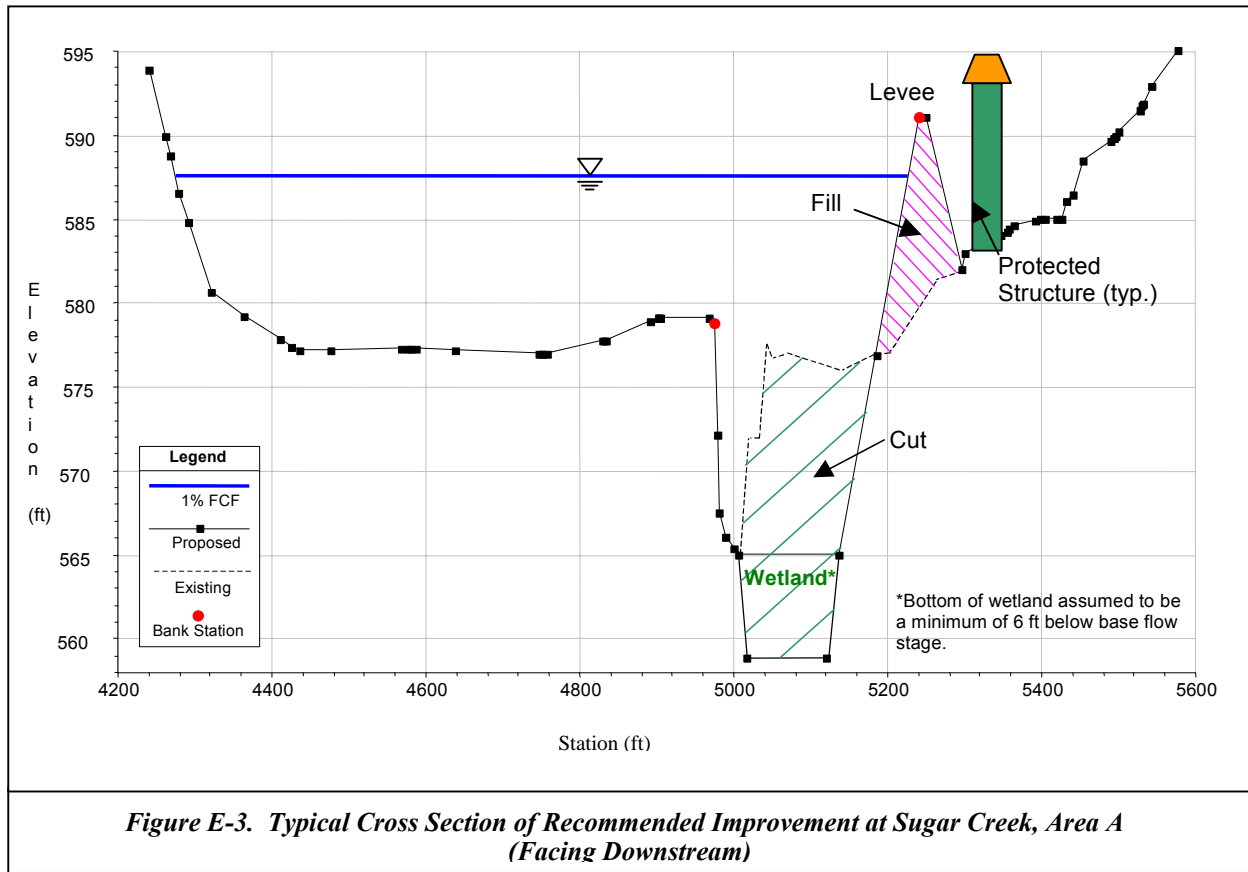
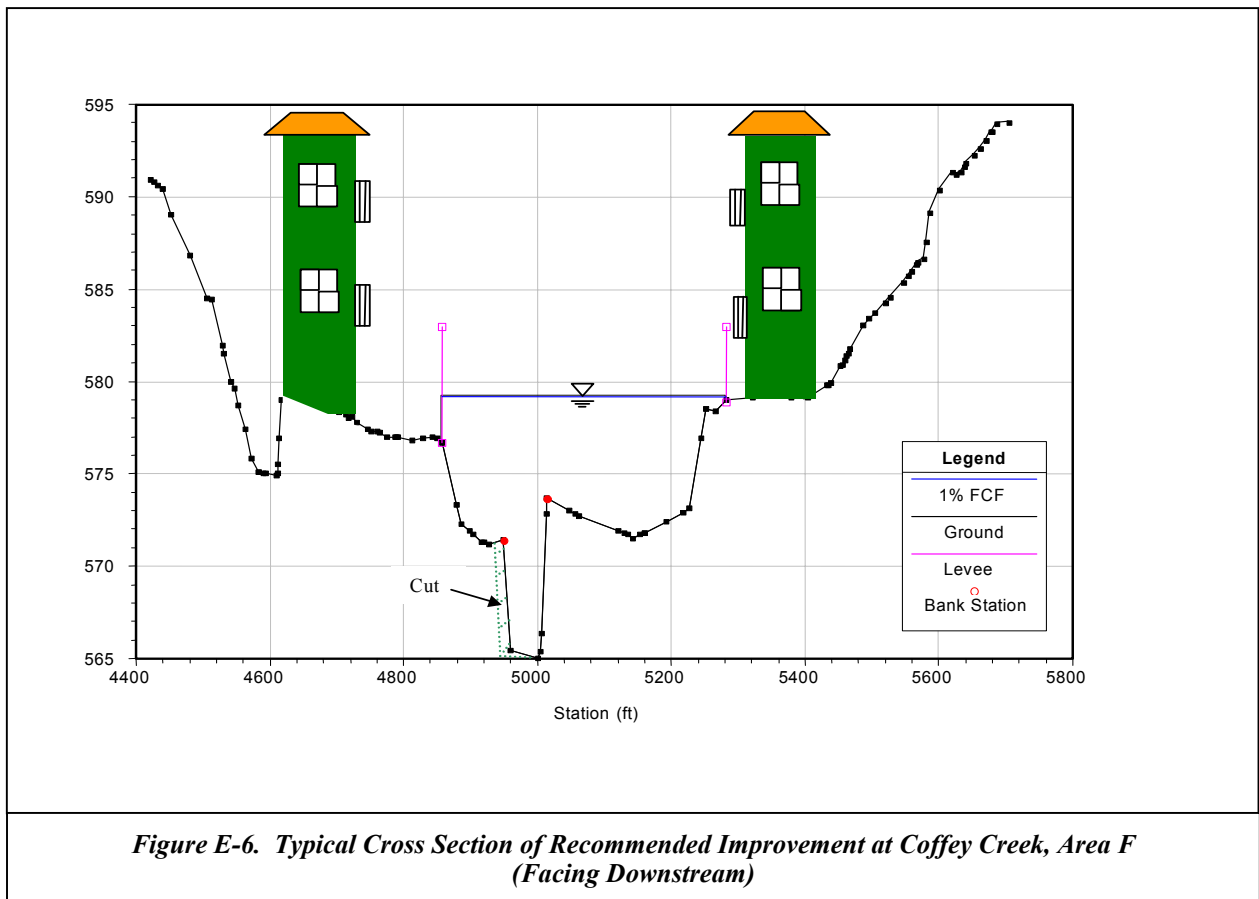
Figures E-1 and E-2 show the Sugar Creek locations where mitigation options were applied, and Figures E-4 and E-5 show the Coffey Creek locations where mitigation options were applied. Figures E-3 and E-6 exhibit representative cross sections in these locations for both existing conditions and mitigation options.
