# PRELIMINARY ENGINEERING REPORT

## Watershed Study No. 10 Upper Little Sugar Creek Watershed

Mecklenburg  
Storm Water Services

November 2003

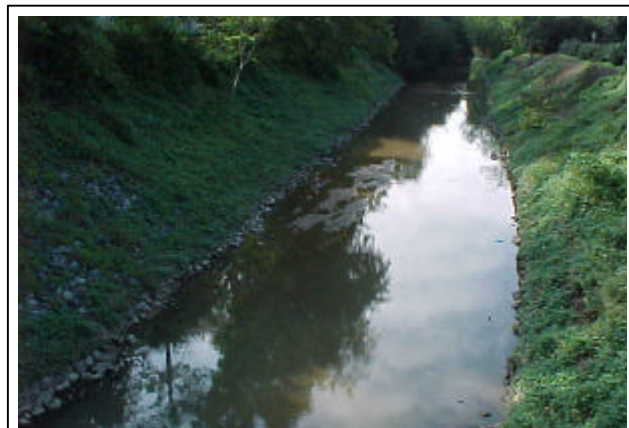
**Figure 1. Little Sugar Creek – Looking downstream from Princeton Avenue**

The Upper Little Sugar Creek main channel exhibits different characteristics along its length, but can be generally described as a straight, relatively wide, trapezoidal channel with steep banks, and a relatively shallow normal flow depth. The upper reaches tend to exhibit narrower banks and steeper channel slopes, whereas, the lower reaches have wider banks, milder slopes and finer bed materials. The width of the main channel typically ranges from 20 to 60 feet wide in the upper stream reaches, and transitions to widths of 60 to 90 feet around the Belmont Avenue crossing (River Station 80292).

With the exception of scattered heavily vegetated areas, the channel banks of Little Sugar Creek are lightly vegetated (e.g. grass-lined) and/or armored (e.g. riprap, gabions, etc.) for much of its length. The channel bed is generally comprised of sand, gravel, and cobble in the upper reaches, and transitions to almost entirely sand and silt in the downstream reaches. Significant bed rock outcrops are present at scattered locations (e.g. between Woodlawn Road and Brandywine Road).

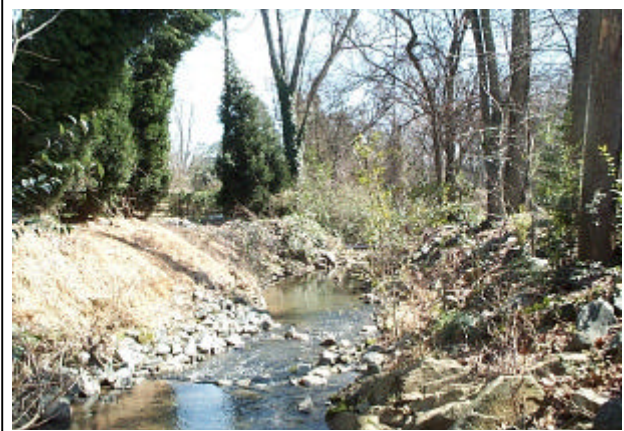
**Figure 2. Dairy Branch – Looking downstream near apartments off Salem Drive.**

The Dairy Branch channel is similar in shape to the upper portions of the Upper Little Sugar Creek channel, having an average top width of approximately 40 feet. The channel is grassed with a silt-rock bed and armored with riprap for much of its length.

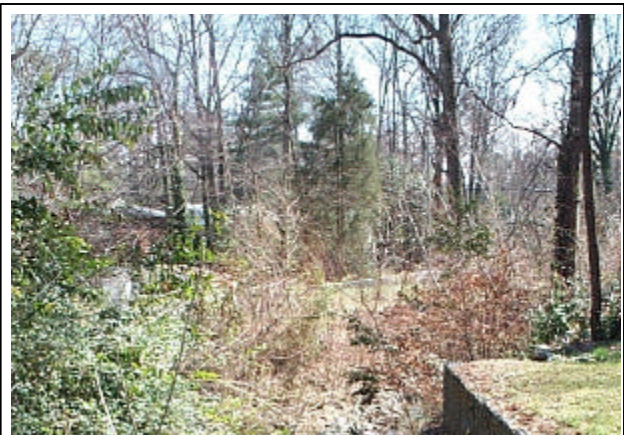
**Figure 3. Little Hope Creek – Looking downstream from pedestrian bridge near Heather Lane.**

The Little Hope Creek channel is similar in shape to the upper portions of the Upper Little Sugar Creek channel, with a top width ranging from 20 to 50 feet. Unlike the main stem of Little Sugar Creek, the channel banks are heavily vegetated in many places.

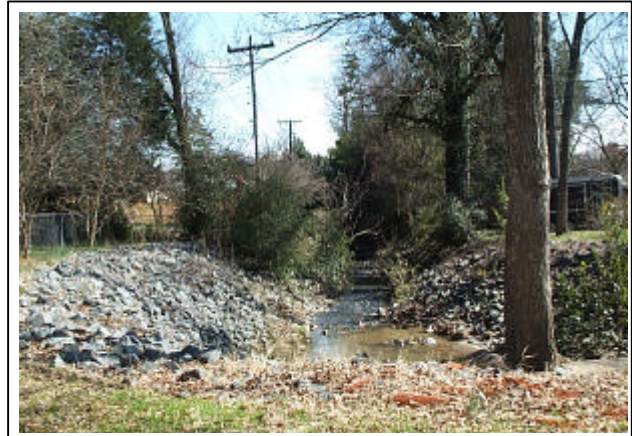
**Figure 4. Little Hope Creek Trib #1 – Looking downstream from Bradbury Drive.**

The Little Hope Creek channel is similar in shape to the Little Hope Creek main channel, having an average top width of approximately 30 feet.

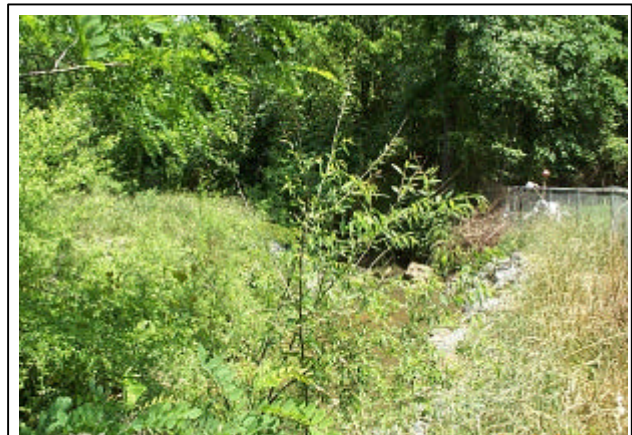
**Figure 5. Derita Branch – Looking upstream from Craighead Road**

The Derita Branch channel is similar in shape to the upper portions of the Upper Little Sugar Creek channel, having an average top width of approximately 40 feet. The channel banks are generally heavily vegetated as an established riparian zone lines much of the creek.

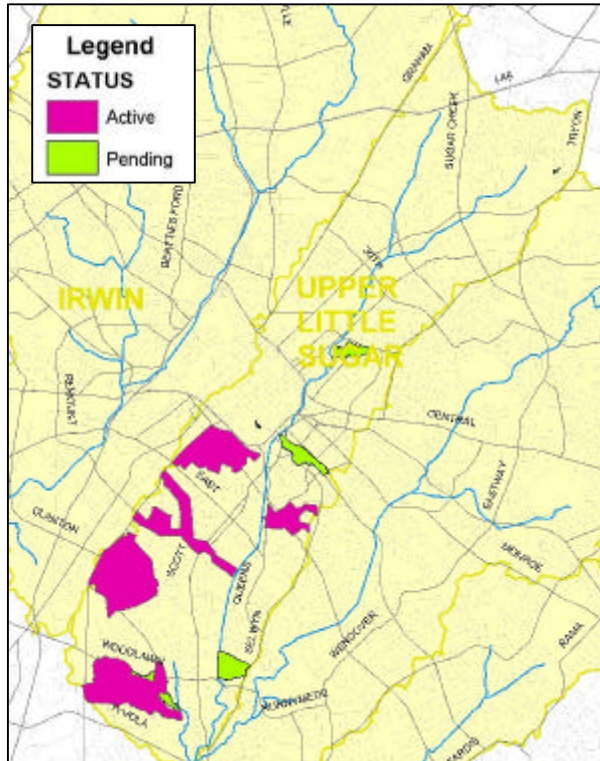
Figure 6. City of Charlotte Storm Water Services Capital Improvement Projects (CIPs)
