Rocky River Watershed Management Plan

**Completed by: Charlotte-Mecklenburg Storm Water Services
Draft
October 18, 2010**

Rocky River Watershed Management Plan Draft

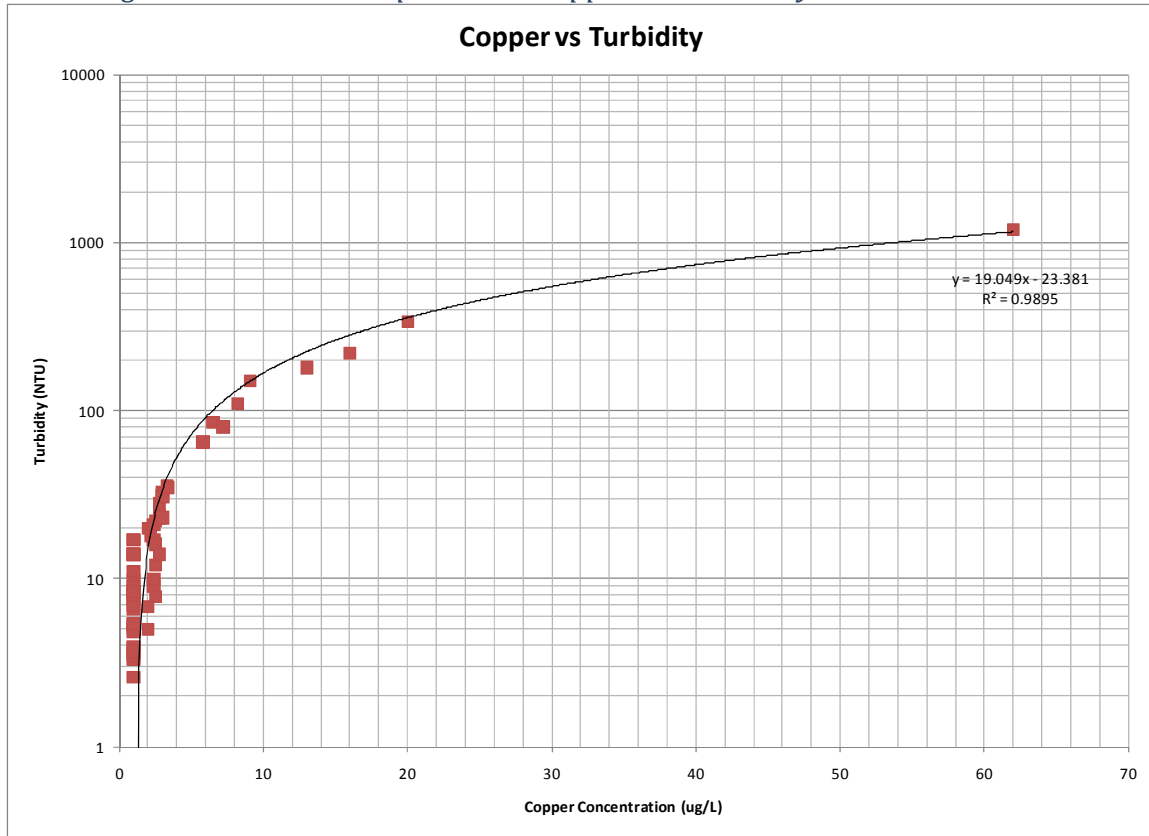
Figure 10: Relationship between copper and turbidity at MY1B

A very strong relationship between Copper and Turbidity was detected from the data collected at MY1B. Figure 10 shows the relationship for Copper and Turbidity from data collected from July, 2004 through September, 2010.

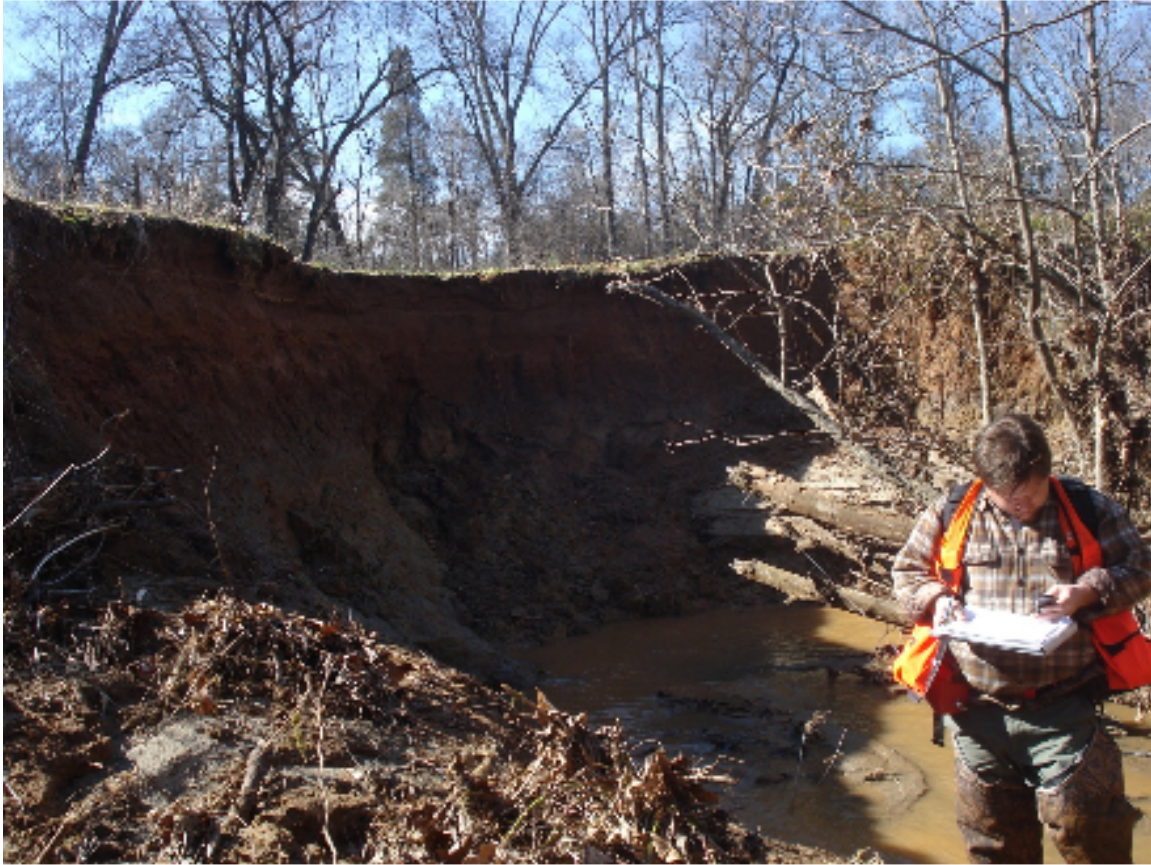
Figure 12: Severe Erosion along West Branch of the Rocky River.

Systematic physical monitoring of the Rocky River watershed has not been conducted. As a part of the implementation of this watershed plan, routine physical monitoring will be conducted. Figure 12 shows a fairly typical location in the watershed with severe erosion and vertical banks.
