# Watershed Study No. 4

## Four Mile Creek Watershed

Preliminary Engineering Report

MCSWS Project No. 61001

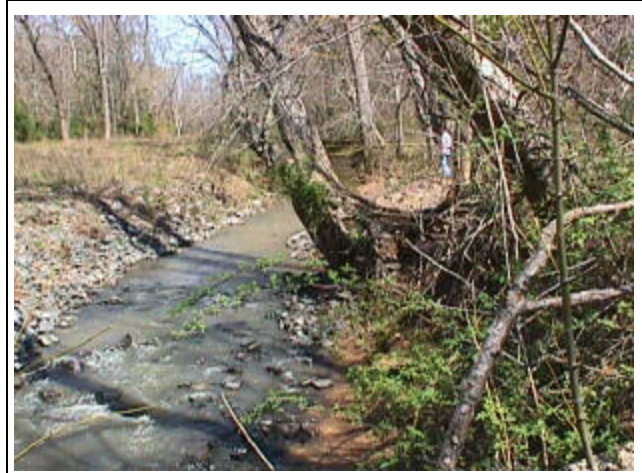
Fig. 7 Near High Ridge Road

The channel bed and floodplain have been stabilized along most of the stream due to the sewer main line. The channel is also stabilized at the road crossings. Most of the riprap used for this purpose seems to be stable, possibly due to better design or construction. Figure 7 shows a typical reach of the stream at the sewer line crossing.

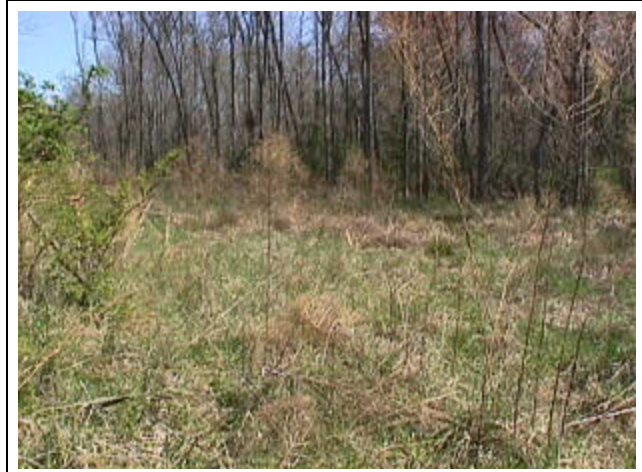
Fig. 8 Near Providence Road

The floodplain in this reach of the creek is also wide, heavily vegetated, and stable. In undisturbed sections, the floodplain is wooded with heavy undergrowth. In disturbed sections, due to the sewer line or other human activity, the cover is grass, weeds, and trees. Figure 8 shows a typical section near Providence Road crossing. Due to the similarity of the floodplains in the two reaches of Four Mile Creek, the behavior of the stream under the existing 100-year flood conditions is expected to be fairly similar. Because of the wooded nature and dense vegetation, water velocity will probably be low, with damages caused by the inundation of low-lying areas or lower levels of the homes. Velocities are expected to be too low to cause any major erosion or undercutting of the homes or foundations.
