PRELIMINARY ENGINEERING REPORT

Watershed Study No. 2

Mallard Creek Watershed

MCSWS Project No. 25001

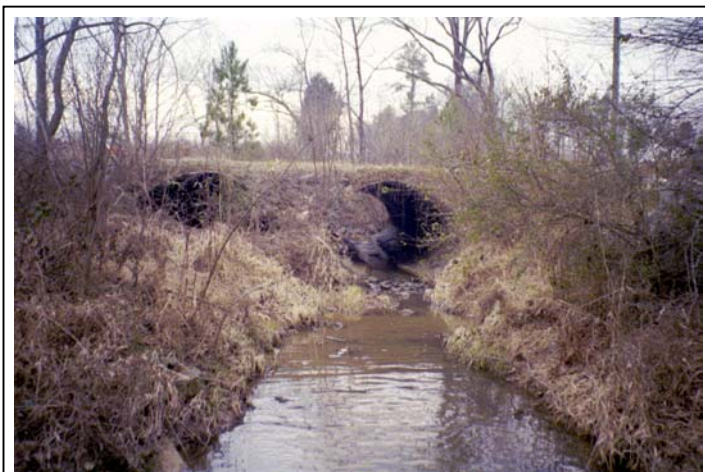
Figure 2. Typical Channel, Clarks Creek at Dearmon Road, Downstream Face (Roll #1, Photo #2)

Road. Thick vegetated riparian zones line most of the channel, providing shade and stabilization of the banks (Figure 2). From the vantage point of road crossings, riprap, often overgrown with vegetation, was observed as a bank stabilization mechanism. Riprap on the channel bottom also helps to control erosion and sediment movement, and provide instream habitat.

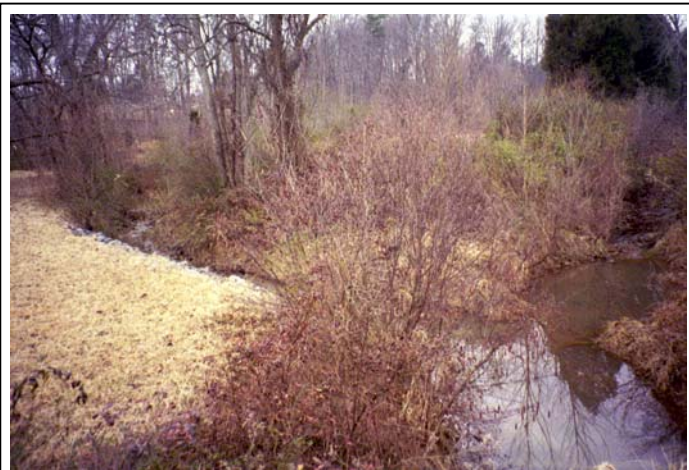
Clarks Creek Tributary No. 1, with its tributary, Clarks Creek Tributary No. 1A, begins to the west of Clarks Creek and joins the main channel between stations 13322 and 13767. Clarks Creek Tributary No. 1A, with its headwaters east of Old Statesville Road, joins Clarks Creek Tributary No. 1 at Browne Road (Figure 3). Davis Lake was created on Clarks Creek Tributary No. 1A, and the channel downstream of the outfall was lined with riprap. Here, flows are typically low. These narrow channels often are lined with thick brushy vegetation as they flow through residential subdivisions. Riprap on the channel bottom also helps to control erosion and sediment movement, and provide instream habitat.

Figure 3. Typical Channels, Confluence of Clarks Creek Tributaries No. 1 and No. 1A (Roll #1, Photo #9)

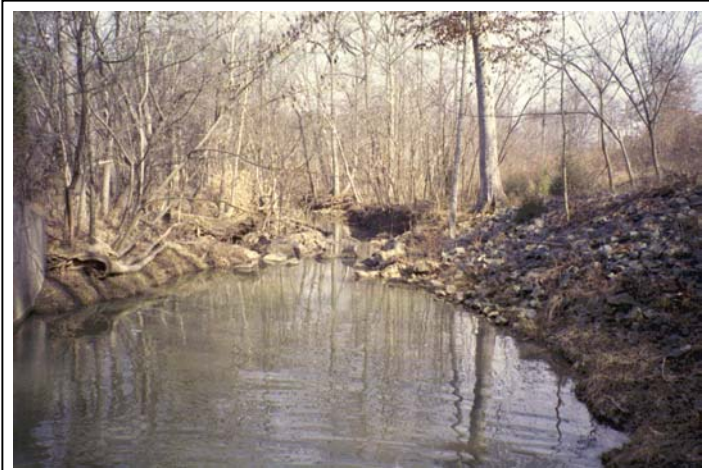
Stoney Creek flows southeast from its headwaters in the most northern reaches of the Mallard Creek watershed to its confluence with Mallard Creek near US Highway 29. Vegetation, as well as riprap near road crossings, stabilizes banks throughout the creek (Figure 6). At the major crossings of I-85, I-485, and US Highway 29, banks are heavily stabilized by large riprap. At I-85, banks are steep but stabilized, and the double-barrel box culvert houses a 3-foot diameter sanitary sewer line in its right cell. At I-485, the channel is realigned to run parallel to the highway. There the banks are steep with riprap and shrub and grass vegetation for stabilization. Throughout the creek, bottom material is sandy with cobble and rocks creating riffles. One location of concern is the culvert crossing at Mallard Creek Road. The corrugated metal arch culvert is supported internally with pillars. Debris is collecting behind these support efforts.

Figure 6. Typical Channel, Stoney Creek near I-85, Looking Downstream (Roll #2, Photo #12)

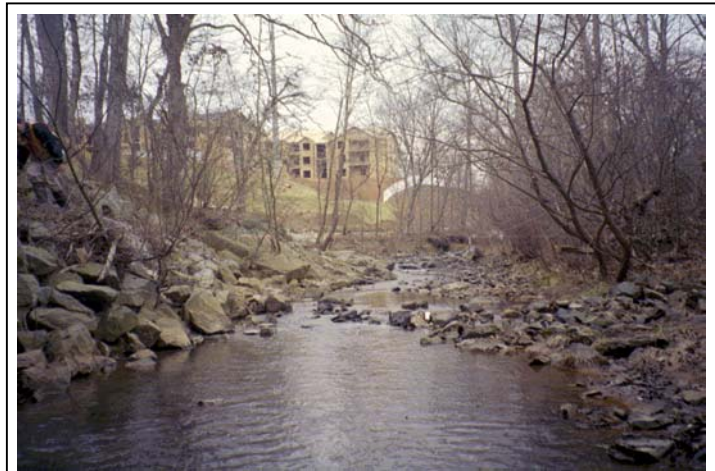
Figure 9. Development, Mallard Creek at Mallard Creek Road, Looking Upstream (Roll #1, Photo #19)

The Mallard Creek watershed is a rapidly developing suburban and commercial watershed (Figure 9). I-85 traverses the watershed, I-485 is under construction, and Highway 49 crosses the watershed diagonally as it passes by UNCC. The UNCC property includes part of Toby Creek, while the IBM Corporate Park is bisected by Doby Creek and one of its tributaries. In turn, these land use changes have spurred residential development in the watershed. Therefore, the Mallard Creek watershed is known to be among the fastest-growing watersheds within Mecklenburg County.

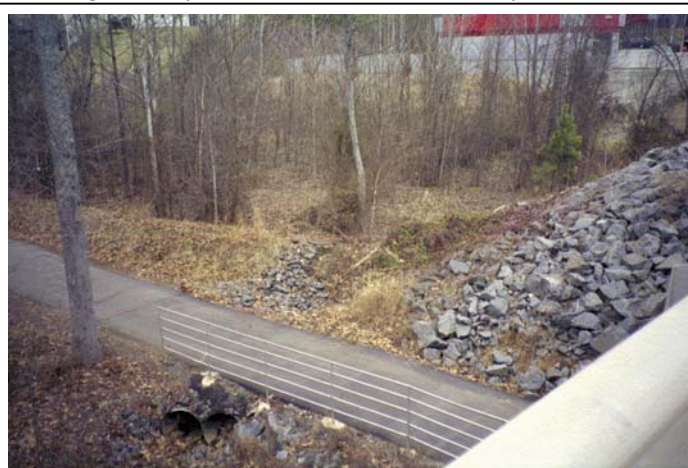
Figure 11. Mallard Creek Greenway at Mallard Creek Road (Roll #1, Photo #20)

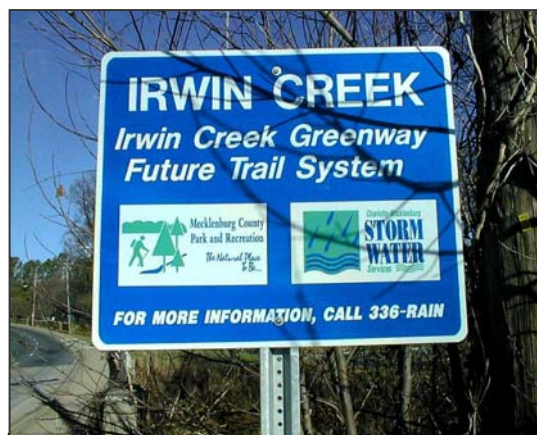
A typical greenway with a creek identification sign within the County is shown in Figure 11-1.

Figure 11-1. MCSWS Creek Identification Sign

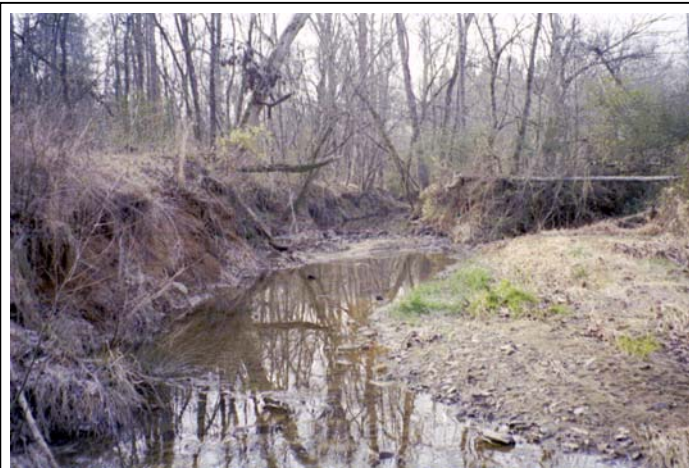
Figure 12. Toby Creek, Looking Upstream from Rocky River Road (Roll #3, Photo #10)

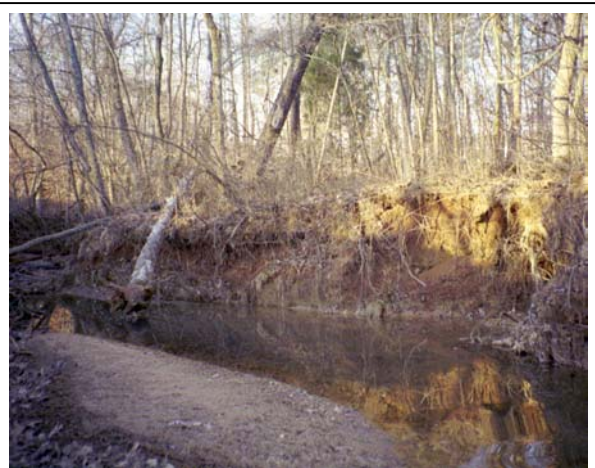
Figure 16. Bank Erosion, Doby Creek Upstream of Governors Road (Roll #2, Photo #22)

High levels of shear stress eroding steep banks in entrenched channels can characterize the majority of bank instability in the Mallard Creek watershed. Upstream of Goveners Road, Doby Creek's steep left bank is collapsing due to high shear stress (Figure 16). Roots are exposed and trees are collapsing into the channel. The left bank of Mallard Creek upstream of I-85 is also suffering from full bank erosion as a result of high shear stresses on the steep bank (Figure 17). In addition, the right bank of Toby Creek is collapsing as a result of these same factors (Figure 18).

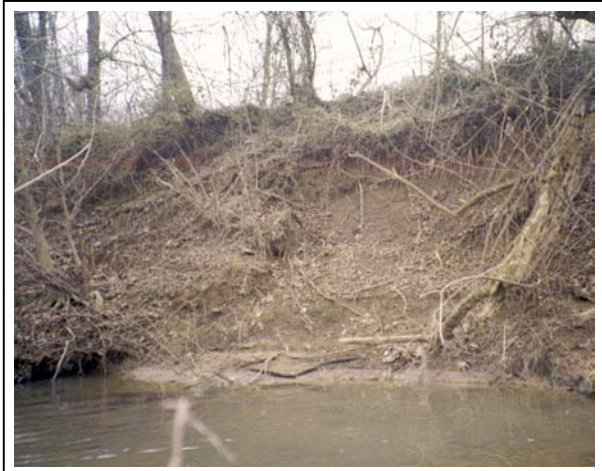
Figure 17. Bank Erosion, Mallard Creek Looking Downstream of I-85 (Roll #2, Photo #1)

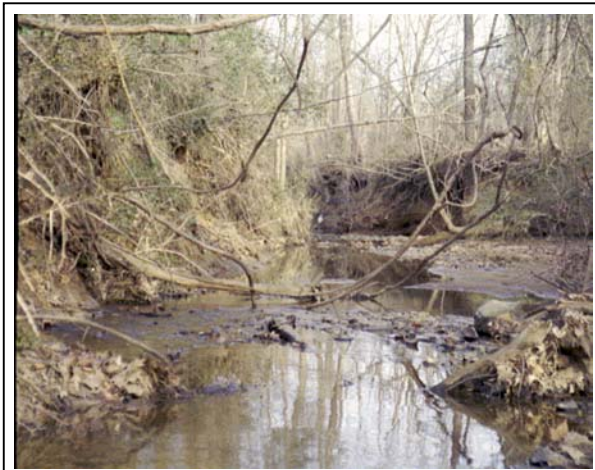
Figure 18. Bank Erosion, Toby Creek at Rocky River Rd, View Downstream. (Roll #3 Photo#13)

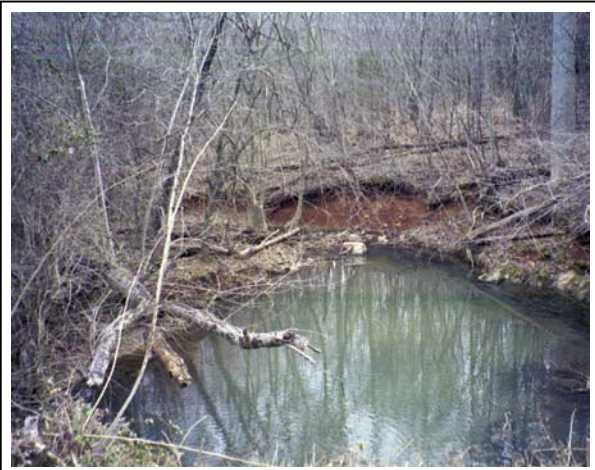
Flows from the culvert outfall at Homewood Drive have eroded a deep pool in Stoney Creek. Here, water velocities are also eroding the banks surrounding this pool (Figure 19). While pools do provide valuable aquatic habitat, this situation is unstable and would benefit from stabilization.

Figure 19. Bank Erosion, Stoney Creek Downstream of Homewood Drive. (Roll #2 Photo #15)

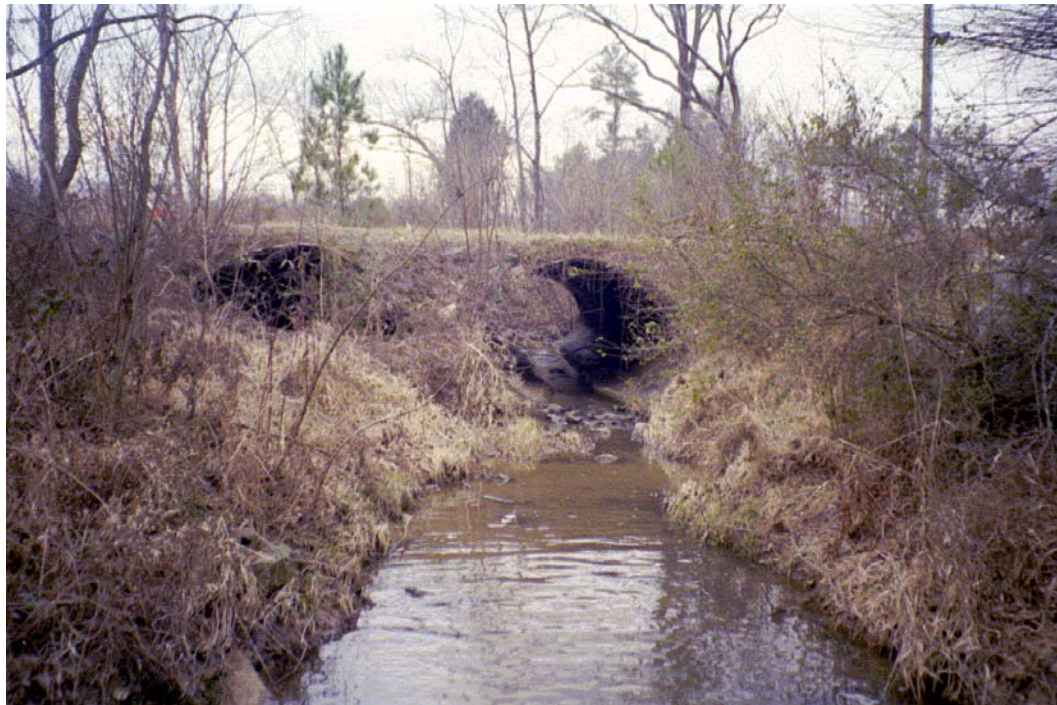
Clarks Creek View, D/S Roll #1 Photo #2
DOWNSTREAM FACE OF 3 BARRELCMPA 102"x72" CROSSING AT DEARMON RD.

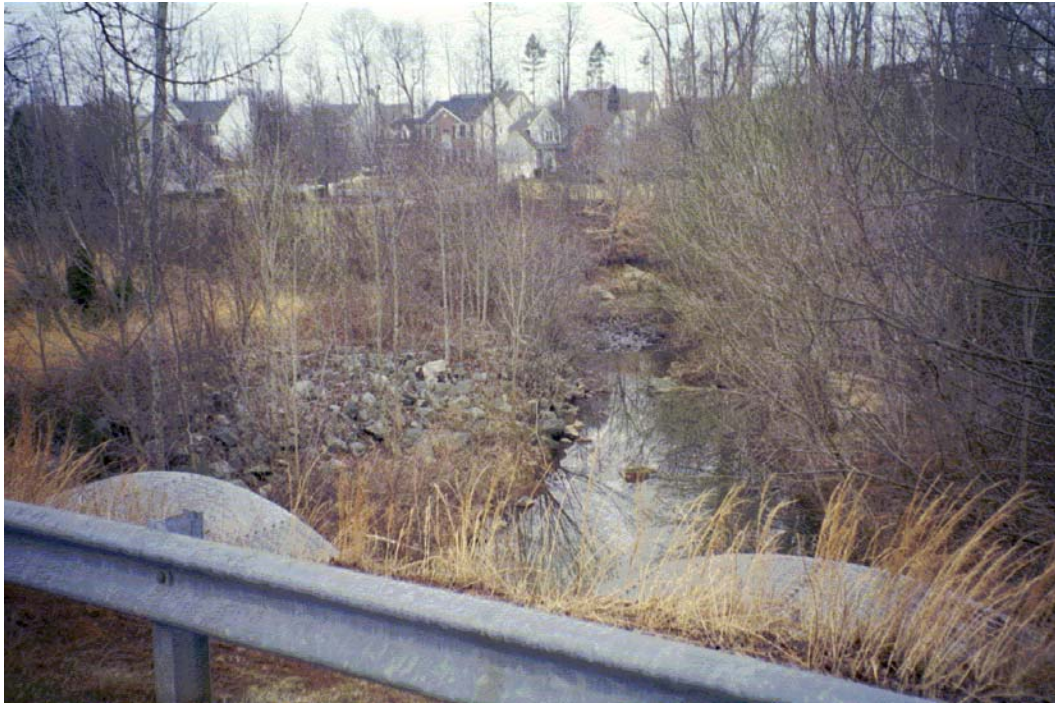
Photo #4

Clarks Creek View, U/S Roll #
DEVELOPMENT UPSTREAM OF SAXONBURY WAY CROSSING.

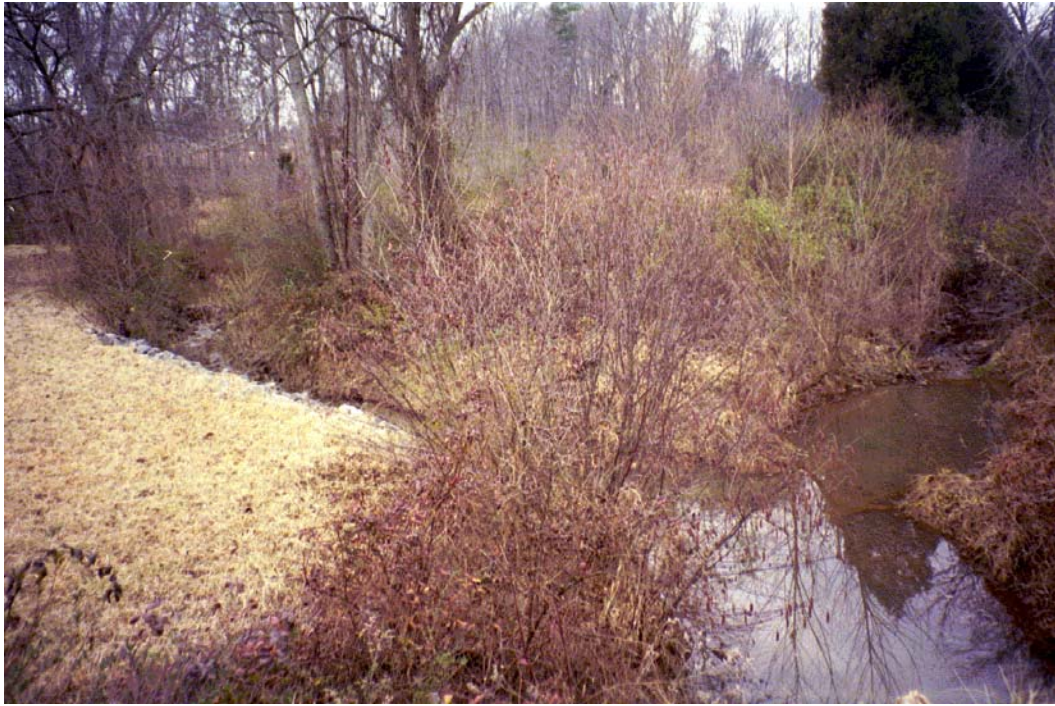
Clarks Creek Tributary #1 View, U/S Roll #1 Photo #9
CONFLUENCE OF CLARKS CREEK TRIBUTARY #1 AND CLARKS CREEK TRIBUTARY
#1A UPSTREAM OF BROWNE ROAD CROSSING.

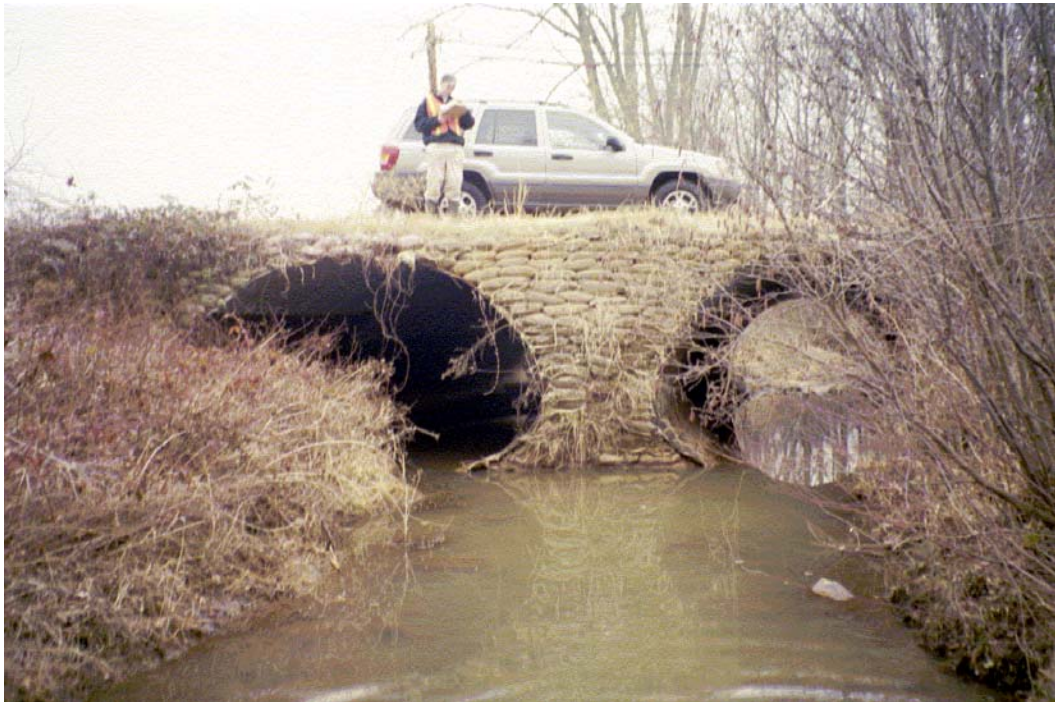
Clarks Creek Tributary #1 View, U/S Roll #1 Photo #10
UPSTREAM FACE OF DOUBLE BARREL CMPA CROSSING AT BROWNE ROAD.

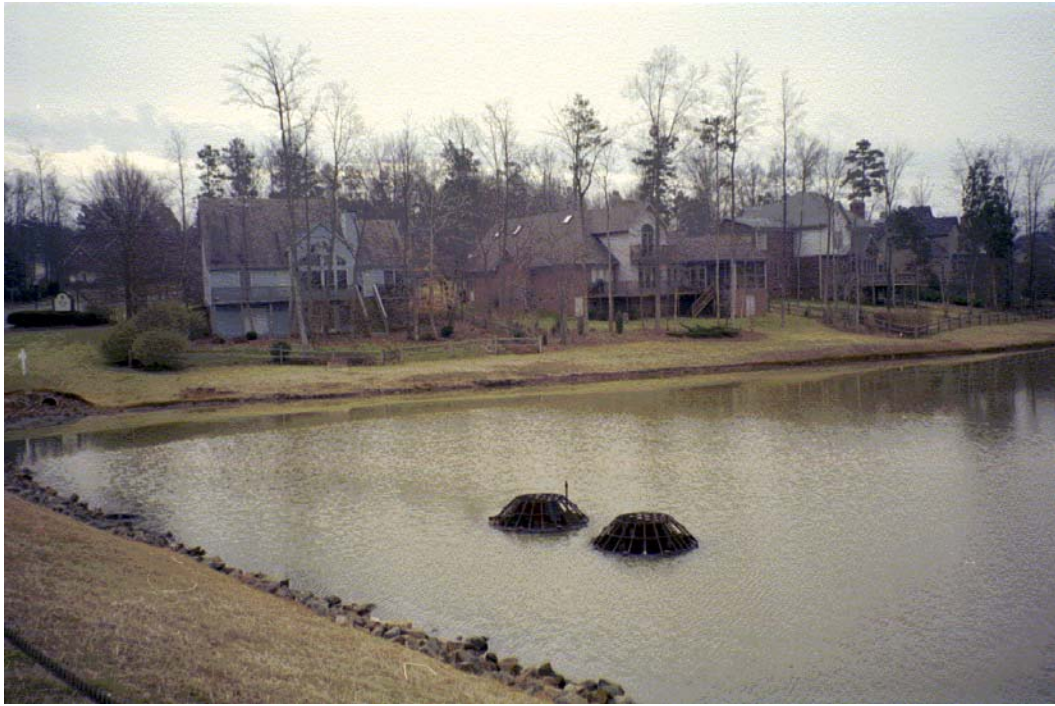
Photo #11

Clarks Creek Tributary #1A
INTAKE STRUCTURES AT DAVIS LAKE.

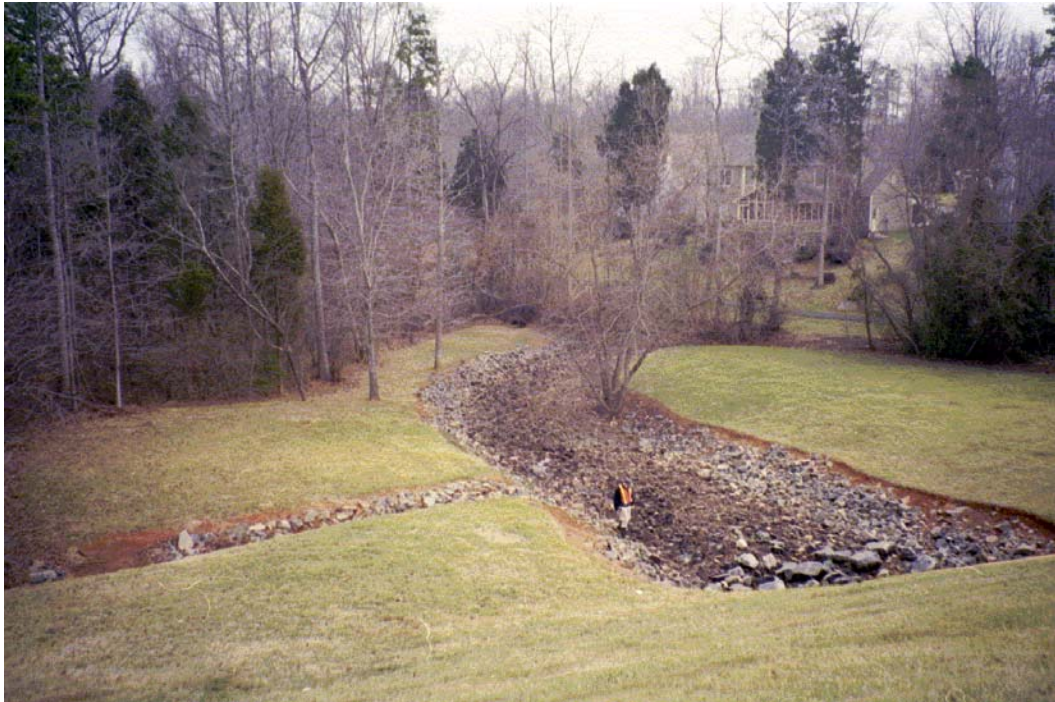
Photo #12

Clarks Creek Tributary #1A View, D/S
RIPRAP CHANNEL DOWNSTREAM OF DAVIS LAKE OUTLET STRUCTURE. MOWING
TO EDGE OF STREAM CHANNEL.

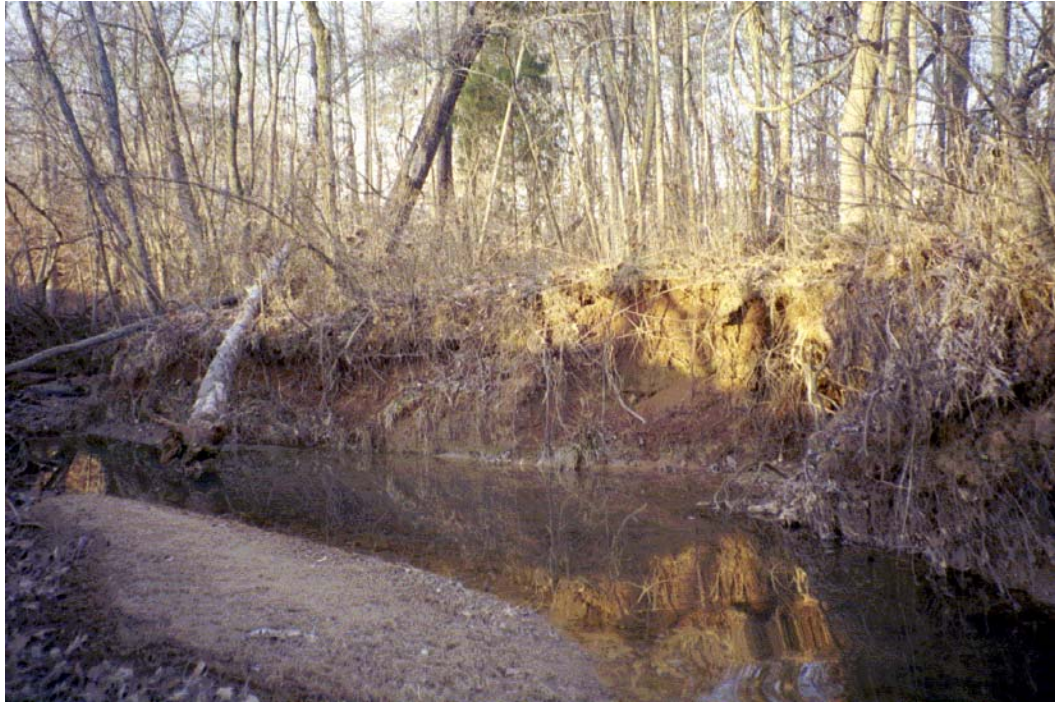
Doby Creek View U/S Roll #2 Photo # 22
BANK EROSION UPSTREAM OF GOVERNOR HUNT MIDDLE SCHOOL ROAD CONCRETE
BRIDGE CROSSING.

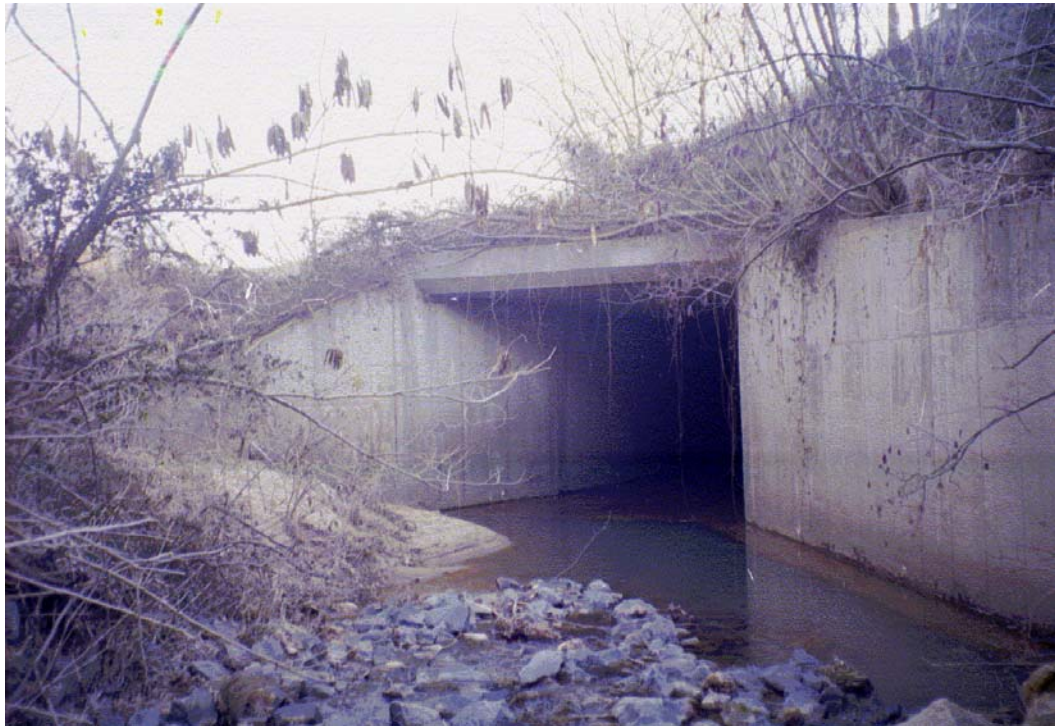
Doby Creek View U/S Roll #2 Photo #24
UPSTREAM FACE OF 12'x11' CONCRETE BOX CULVERT CROSSING W.T. HARRIS
BOULEVARD. BOX CULVERT BENDS UNDER ROAD.

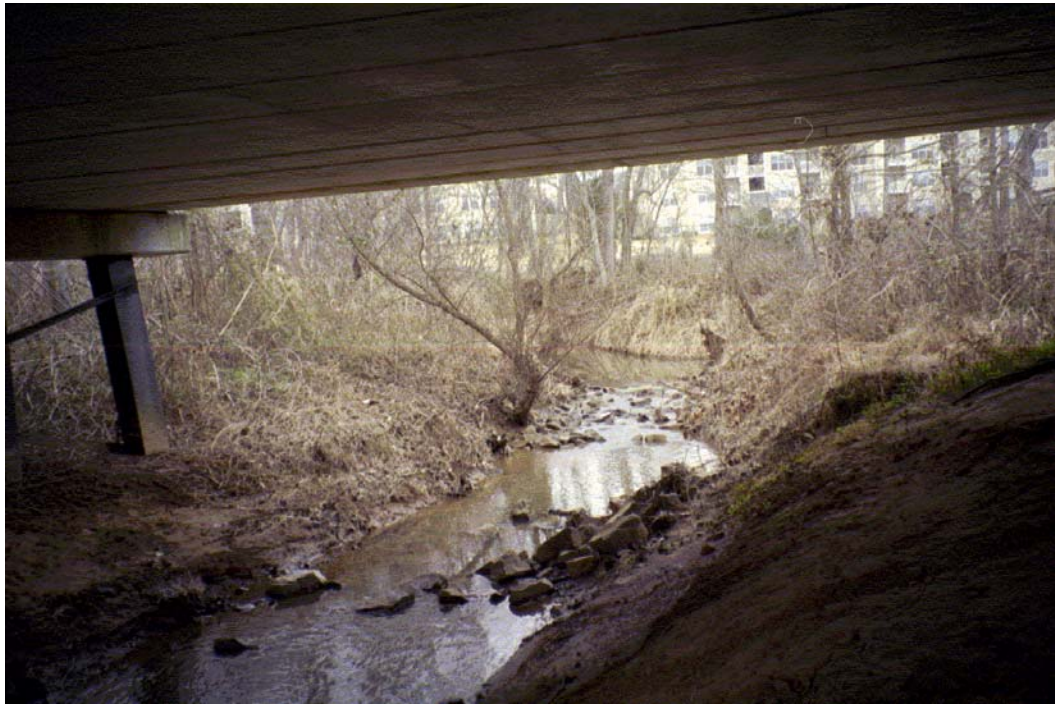
Photo #14

Mallard Creek View, U/S Roll #1
UPSTREAM VIEW OF BRIDGE CROSSING AT SUGAR CREEK ROAD.

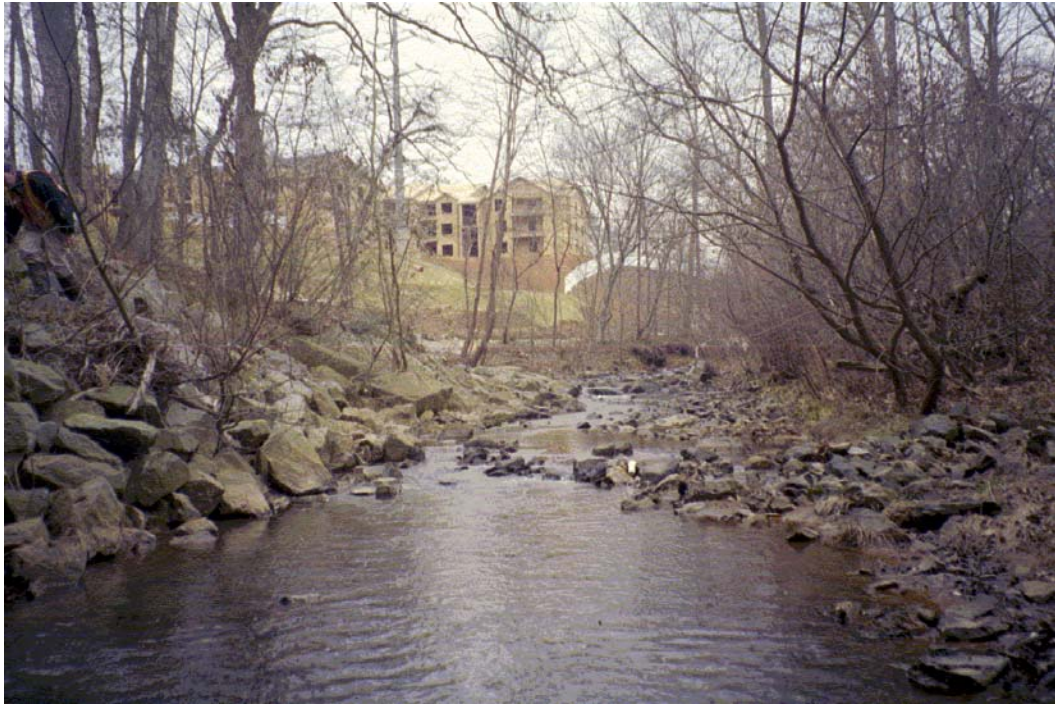
Mallard Creek View, U/S Roll #1 Photo #19
DEVELOPMENT UPSTREAM OF MALLARD CREEK ROAD CROSSING. RIFFLE AREA
WITH WOODY VEGETATION LINING CHANNEL.

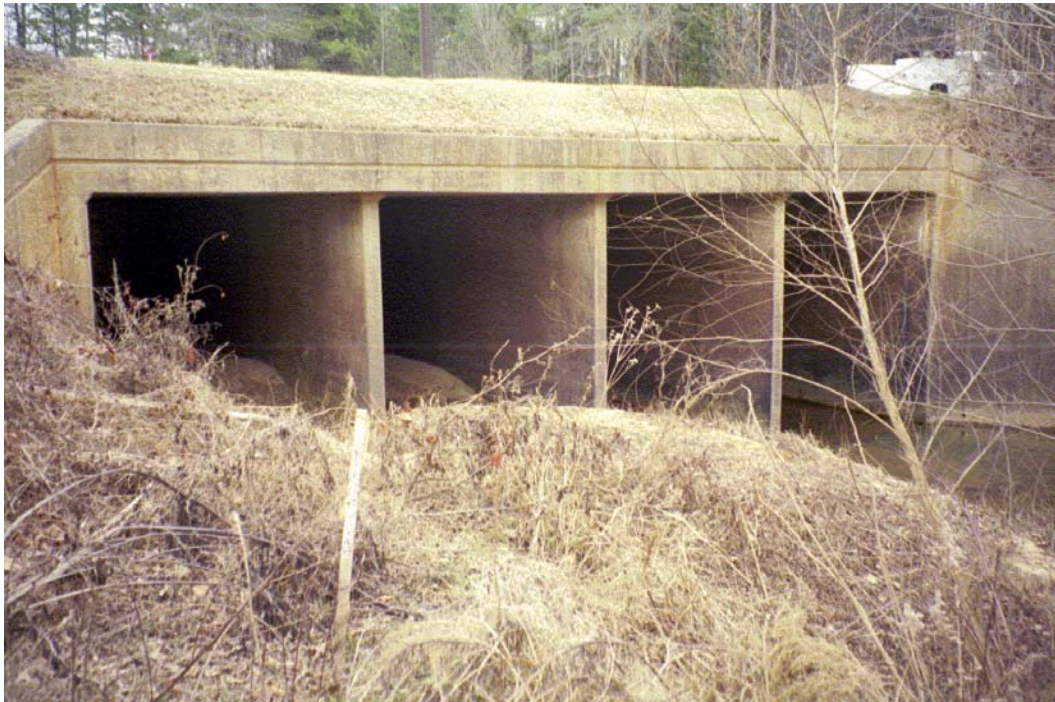
Mallard Creek View, U/S Roll #1 Photo #22
SCOUR ON UPSTREAM FACE OF 4 BARREL 12' x 15' CONCRETE BOX CULVERT
CROSSING AT DAVID TAYLOR DRIVE. SEDIMENT DEPOSITED IN 3 BARRELS OF
CROSSING.

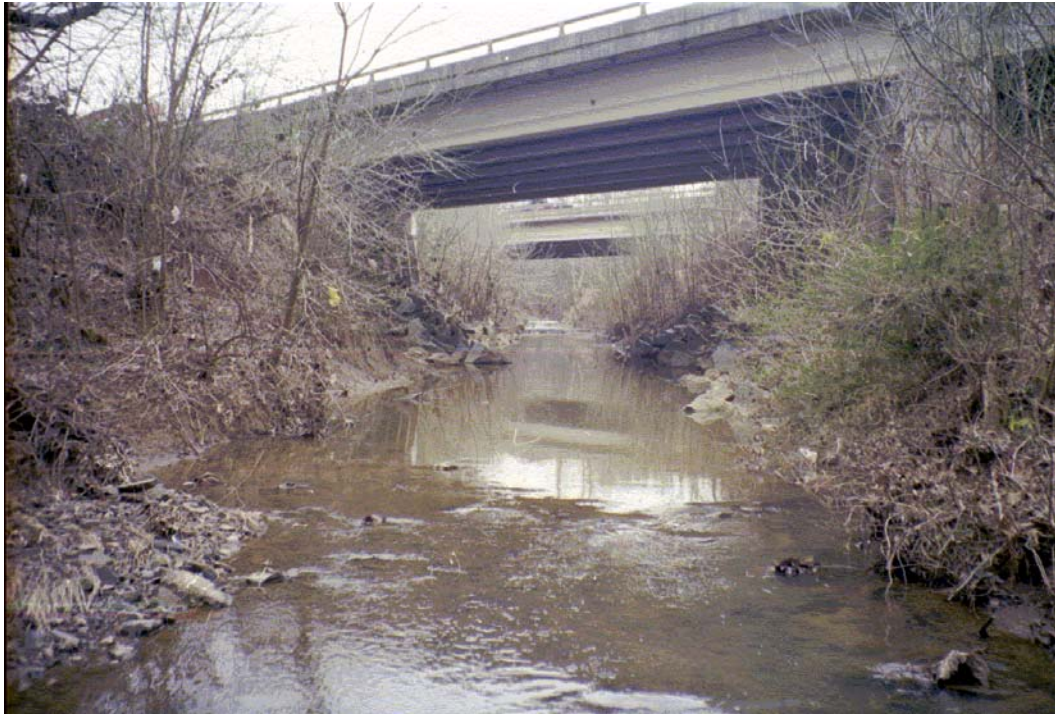
Mallard Creek View, D/S Roll #1 Photo #24
DOWNSTREAM FACE OF 2 BRIDGE CROSSINGS AT I-85. ENTRENCHED, STRAIGHT
CHANNEL.

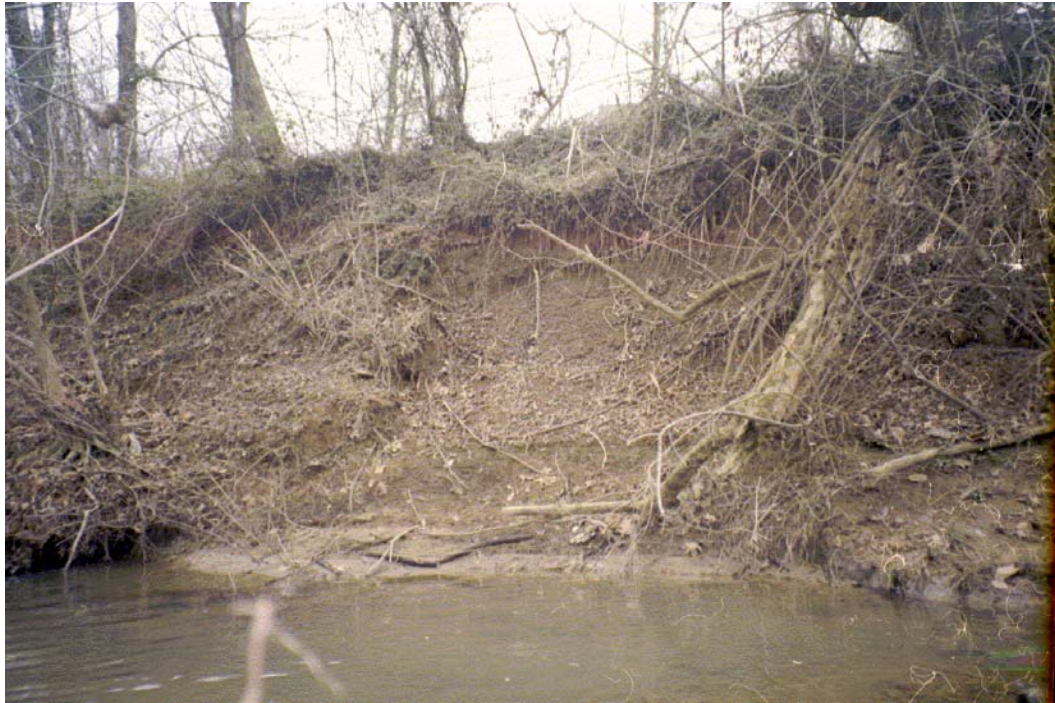
Mallard Creek View, D/S Roll #2 Photo #1
EXTENSIVE RIGHT BANK EROSION NEAR I-85 CROSSING. EXPOSED ROOTS AND TREE
COLLAPSED.

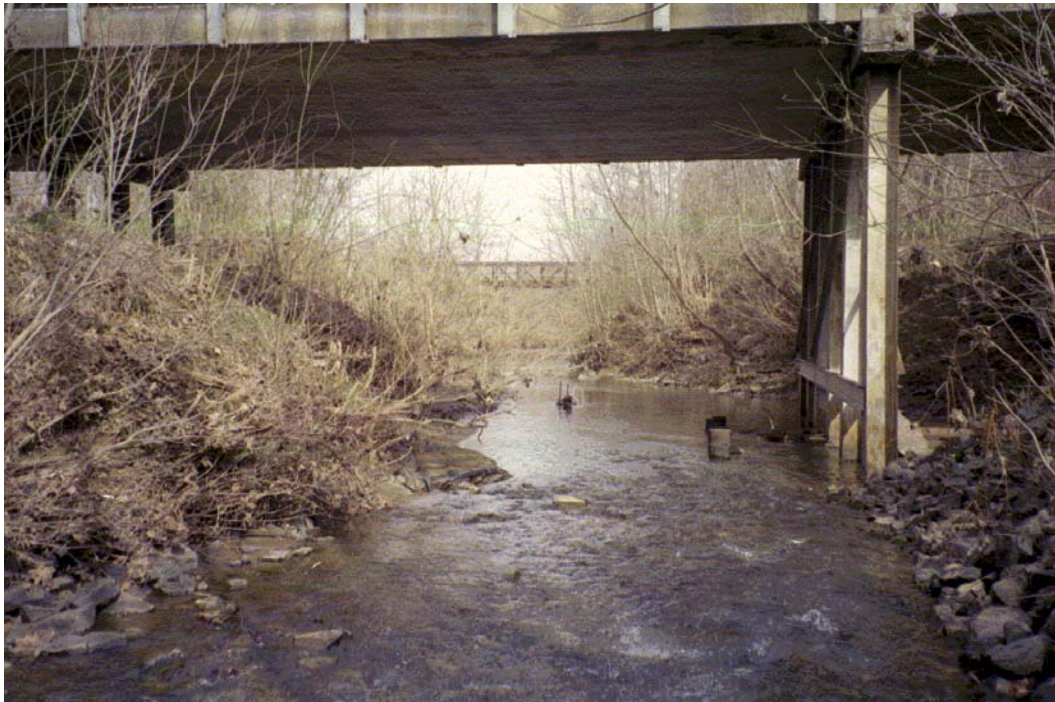
Mallard Creek View, D/S Roll #2 Photo #6
BRIDGE CROSSING AT MALLARD CREEK CHURCH ROAD. PEDESTRIAN BRIDGE AND
NCDOT MITIGATION WETLAND PRESENT IN BACKGROUND.

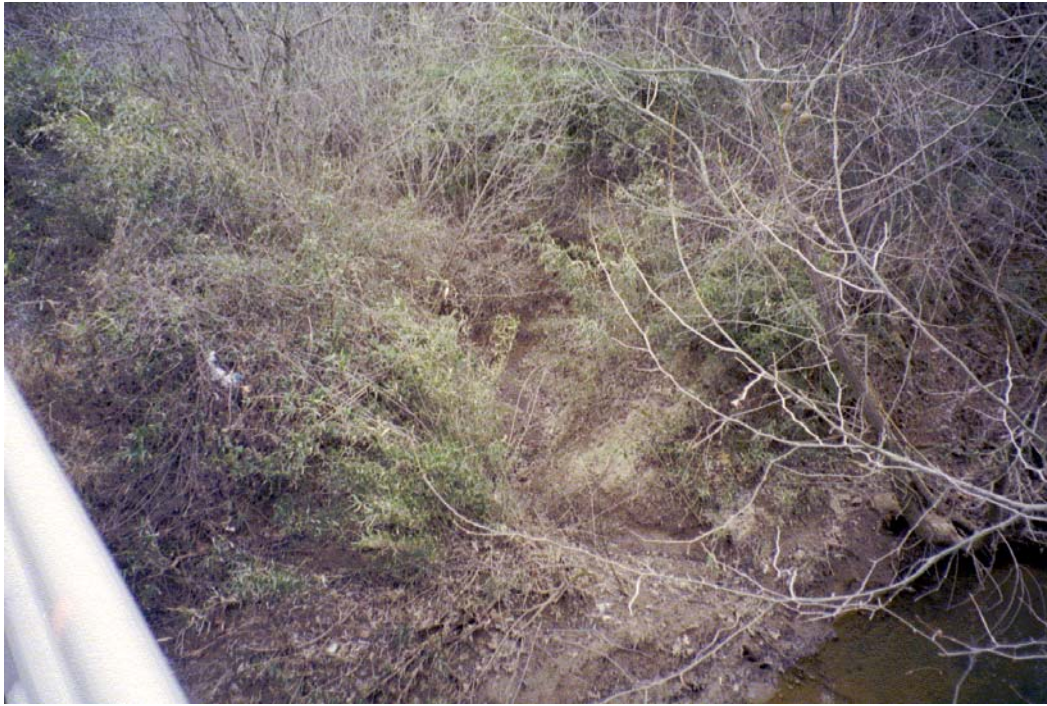
Mallard Creek View, U/S Roll #2 Photo #8
TRIBUTARY EROSION AND DOWNCUTTING IN RIGHT BANK NEAR PAVILION ROAD
BRIDGE CROSSING.

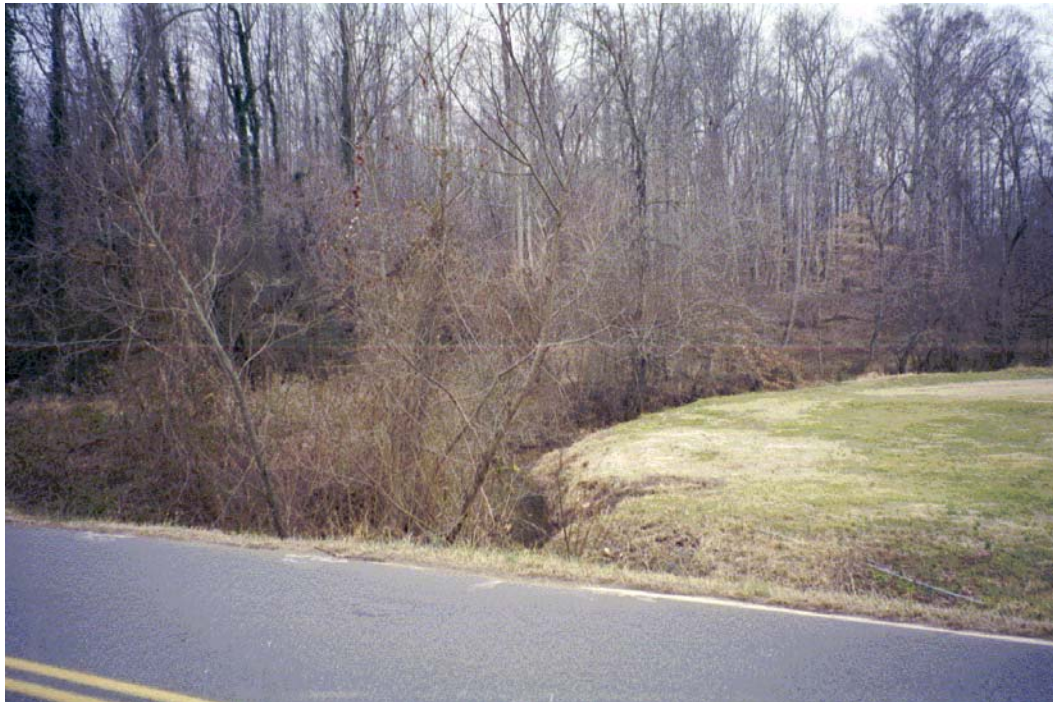
Mallard Creek Tributary View U/S Roll #1 Photo #16
UPSTREAM SIDE OF HUBBARD ROAD. CULVERT CROSSING. LEFT BANK IS MOWED
TO EDGE, BRUSH AND HEAVY VEGETATION PRESENT ON RIGHT BANK.

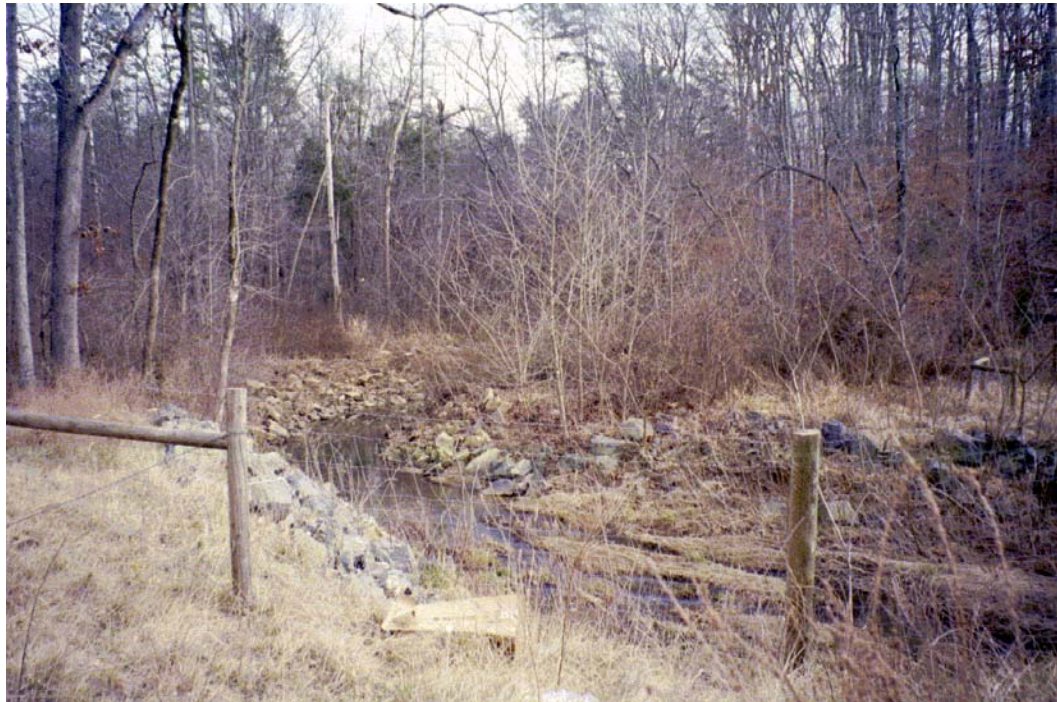
Stoney Creek View D/S Roll #2 Photo #11
DOWNSTREAM OF I-485 BOX CULVERT CROSSING. BANKS STABILIZED WITH RIPRAP.

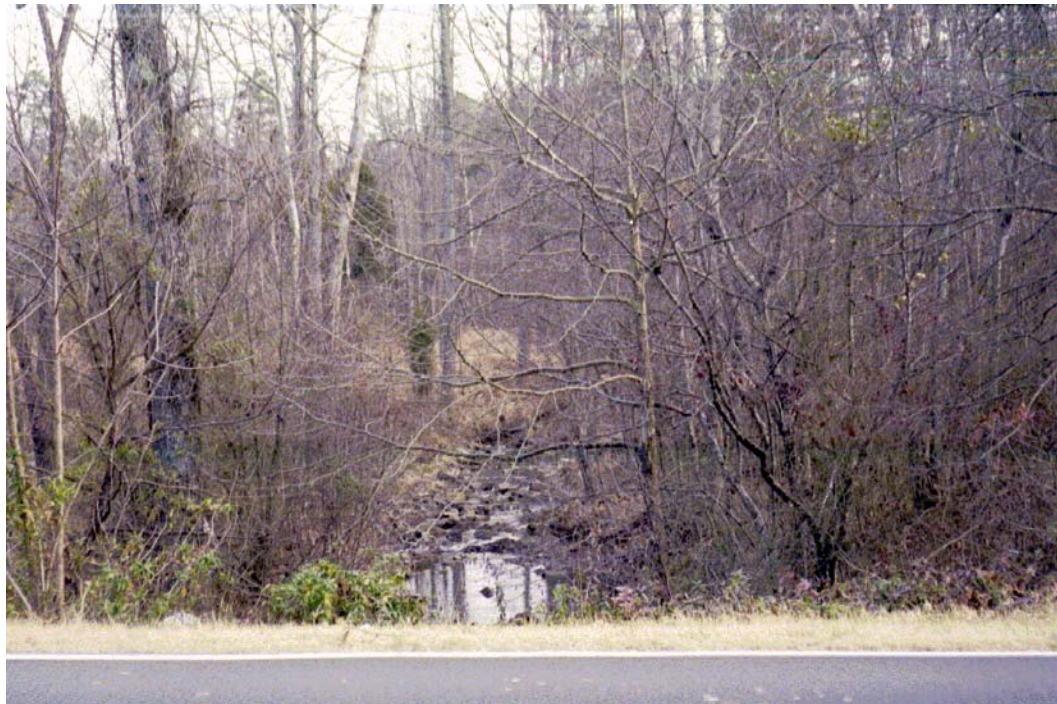
Stoney Creek View D/S Roll #2 Photo #17
THICK VEGETATION DOWNSTREAM OF MALLARD CREEK ROAD. ROCKS IN CREEK
CREATE RIFFLE.

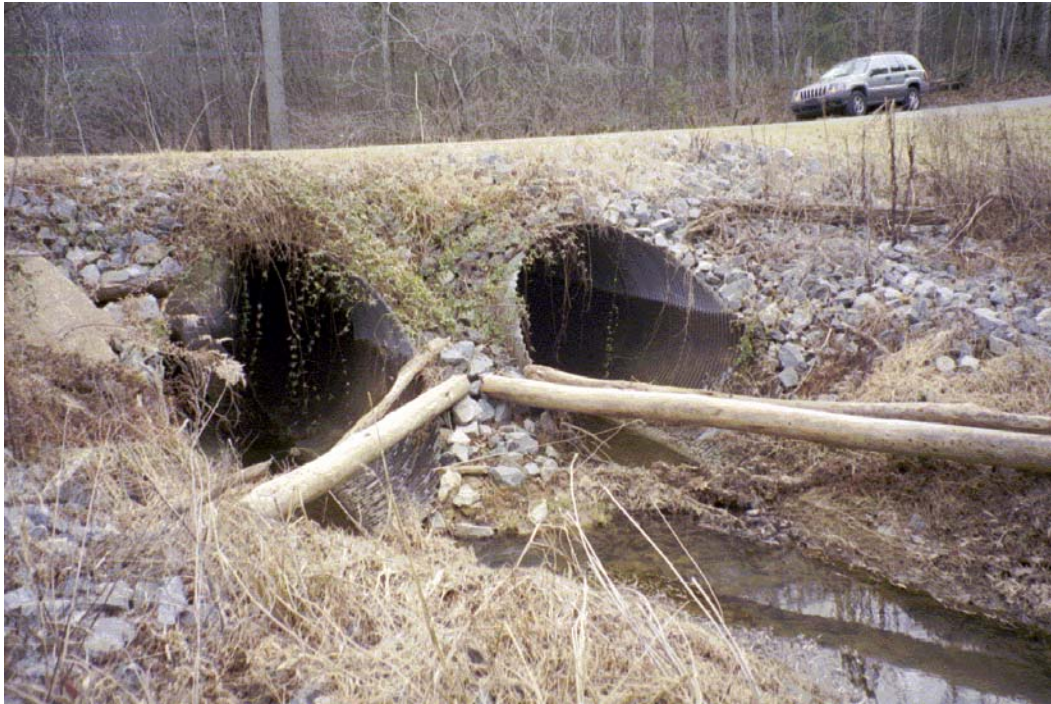
Stoney Creek Tributary View U/S Roll #2 Photo #14
DEBRIS BLOCKING UPSTREAM FACE OF 2 BARREL 6'8" CMP CROSSING AT HOMEWOOD DRIVE.

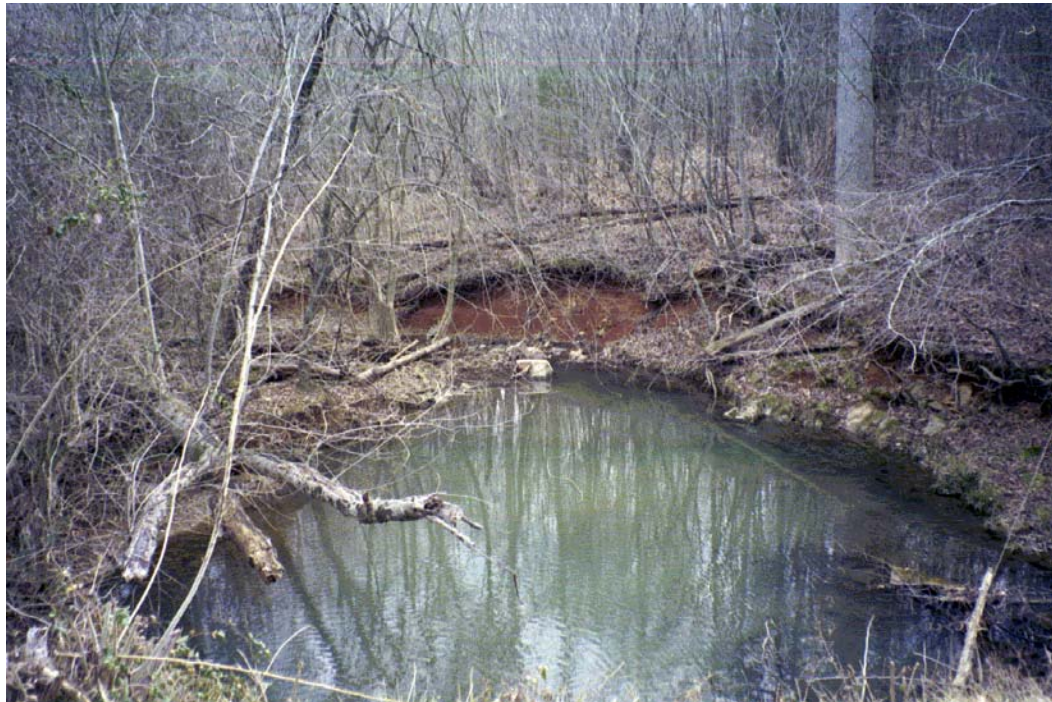
Stoney Creek Tributary View D/S Roll #2 Photo #15
LARGE POOL AND ERODED RIGHT BANK (LOOKING DOWNSTREAM) OF HOMEWOOD DRIVE CULVERT CROSSING.

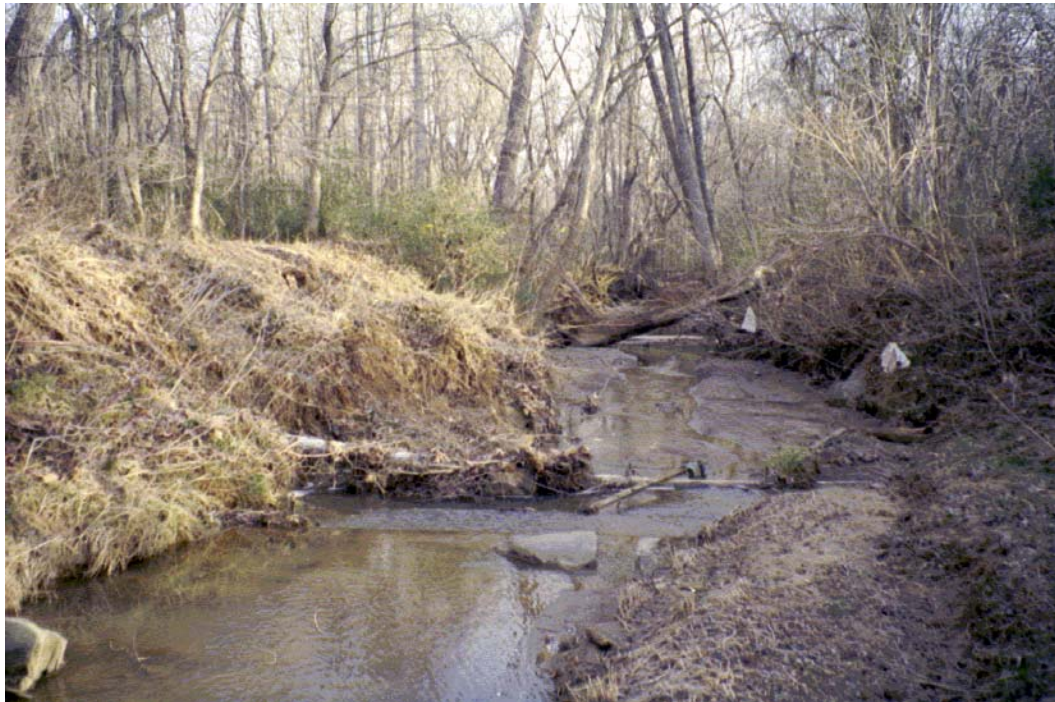
Toby Creek View D/S Roll #3 Photo #4
GRADE CONTROL IN FORM OF 2 WOOD PLANKS PRESENT DOWNSTREAM OF CONCRETE
BOX CULVERT CROSSING AT RAMP TO WEST HARRIS BLVD FROM UNIVERSITY CITY
BLVD SOUTH.

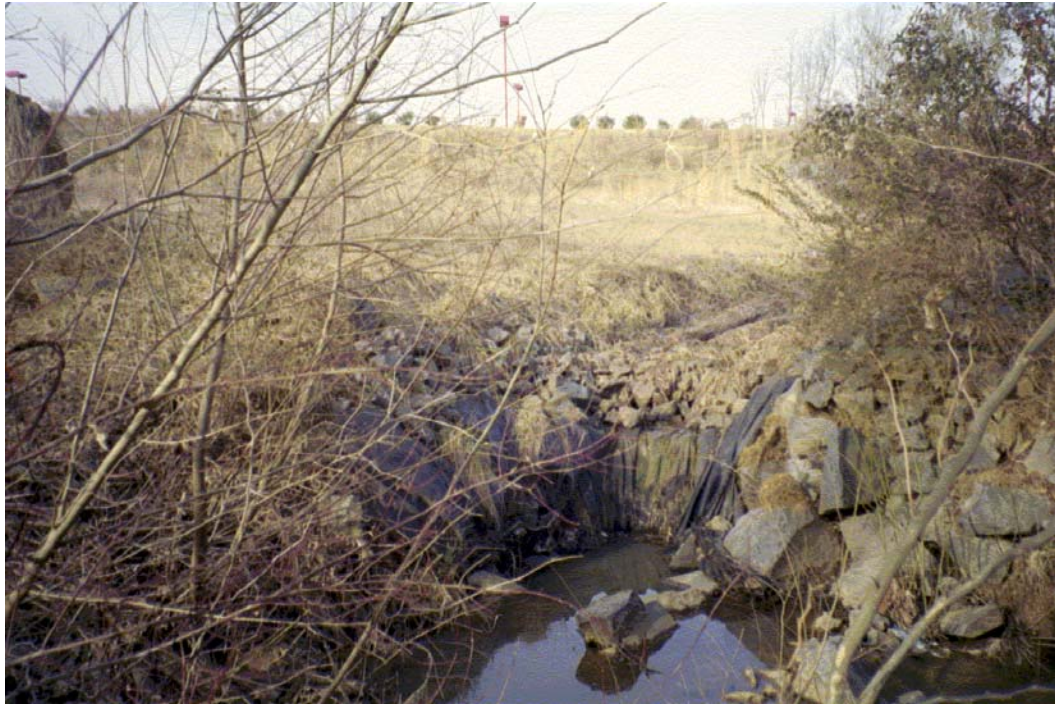
Toby Creek View D/S Roll #3 Photo #9
DRAINAGE ON LEFT BANK NEAR CHANCELLORS PARK CULVERT CROSSING. HEAD CUTTING PREVENTION MEASURES PRESENT.

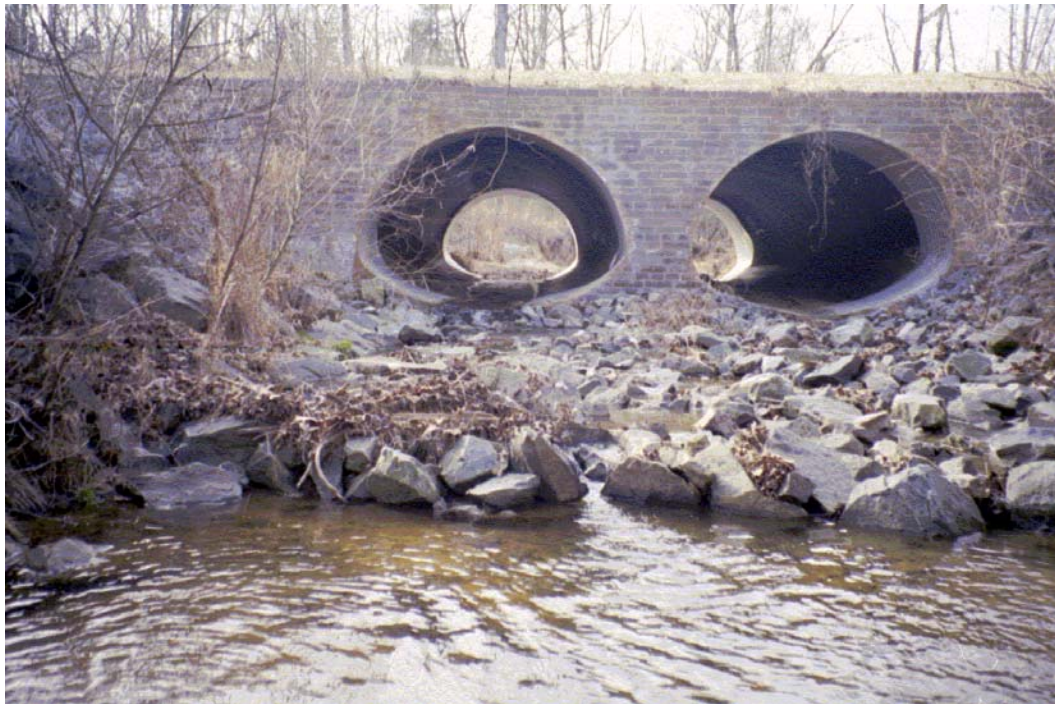
Toby Creek View D/S Roll #3 Photo #12
DROPOFF AT DOWNSTREAM FACE OF 2 BARREL 12' x 18' CMPA ROCKY RIVER ROAD CROSSING.
