PRELIMINARY ENGINEERING REPORT

Watershed Study No. 2

Mallard Creek Watershed

MCSWS Project No. 25001

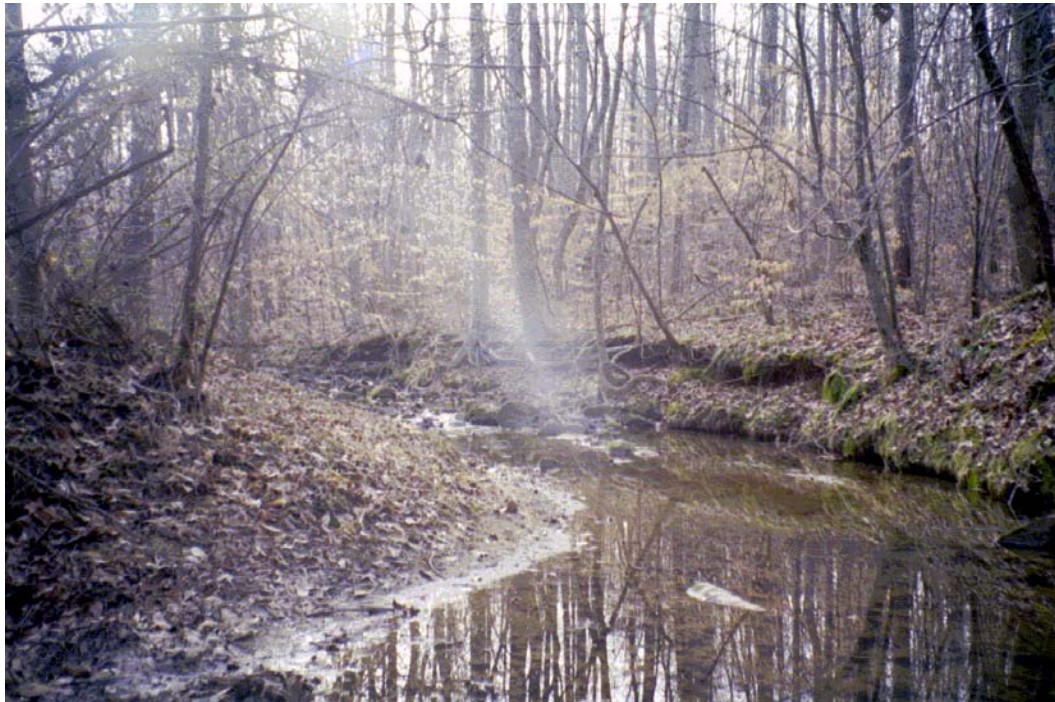
Photo #14

Toby Creek View U/S Roll #3
MILD BANK EROSION UPSTREAM OF AUTUMNWOOD CT. CULVERT CROSSING.
