# 1. GENERAL WATERSHED CONDITIONS

## 1.1 Watershed Characteristics

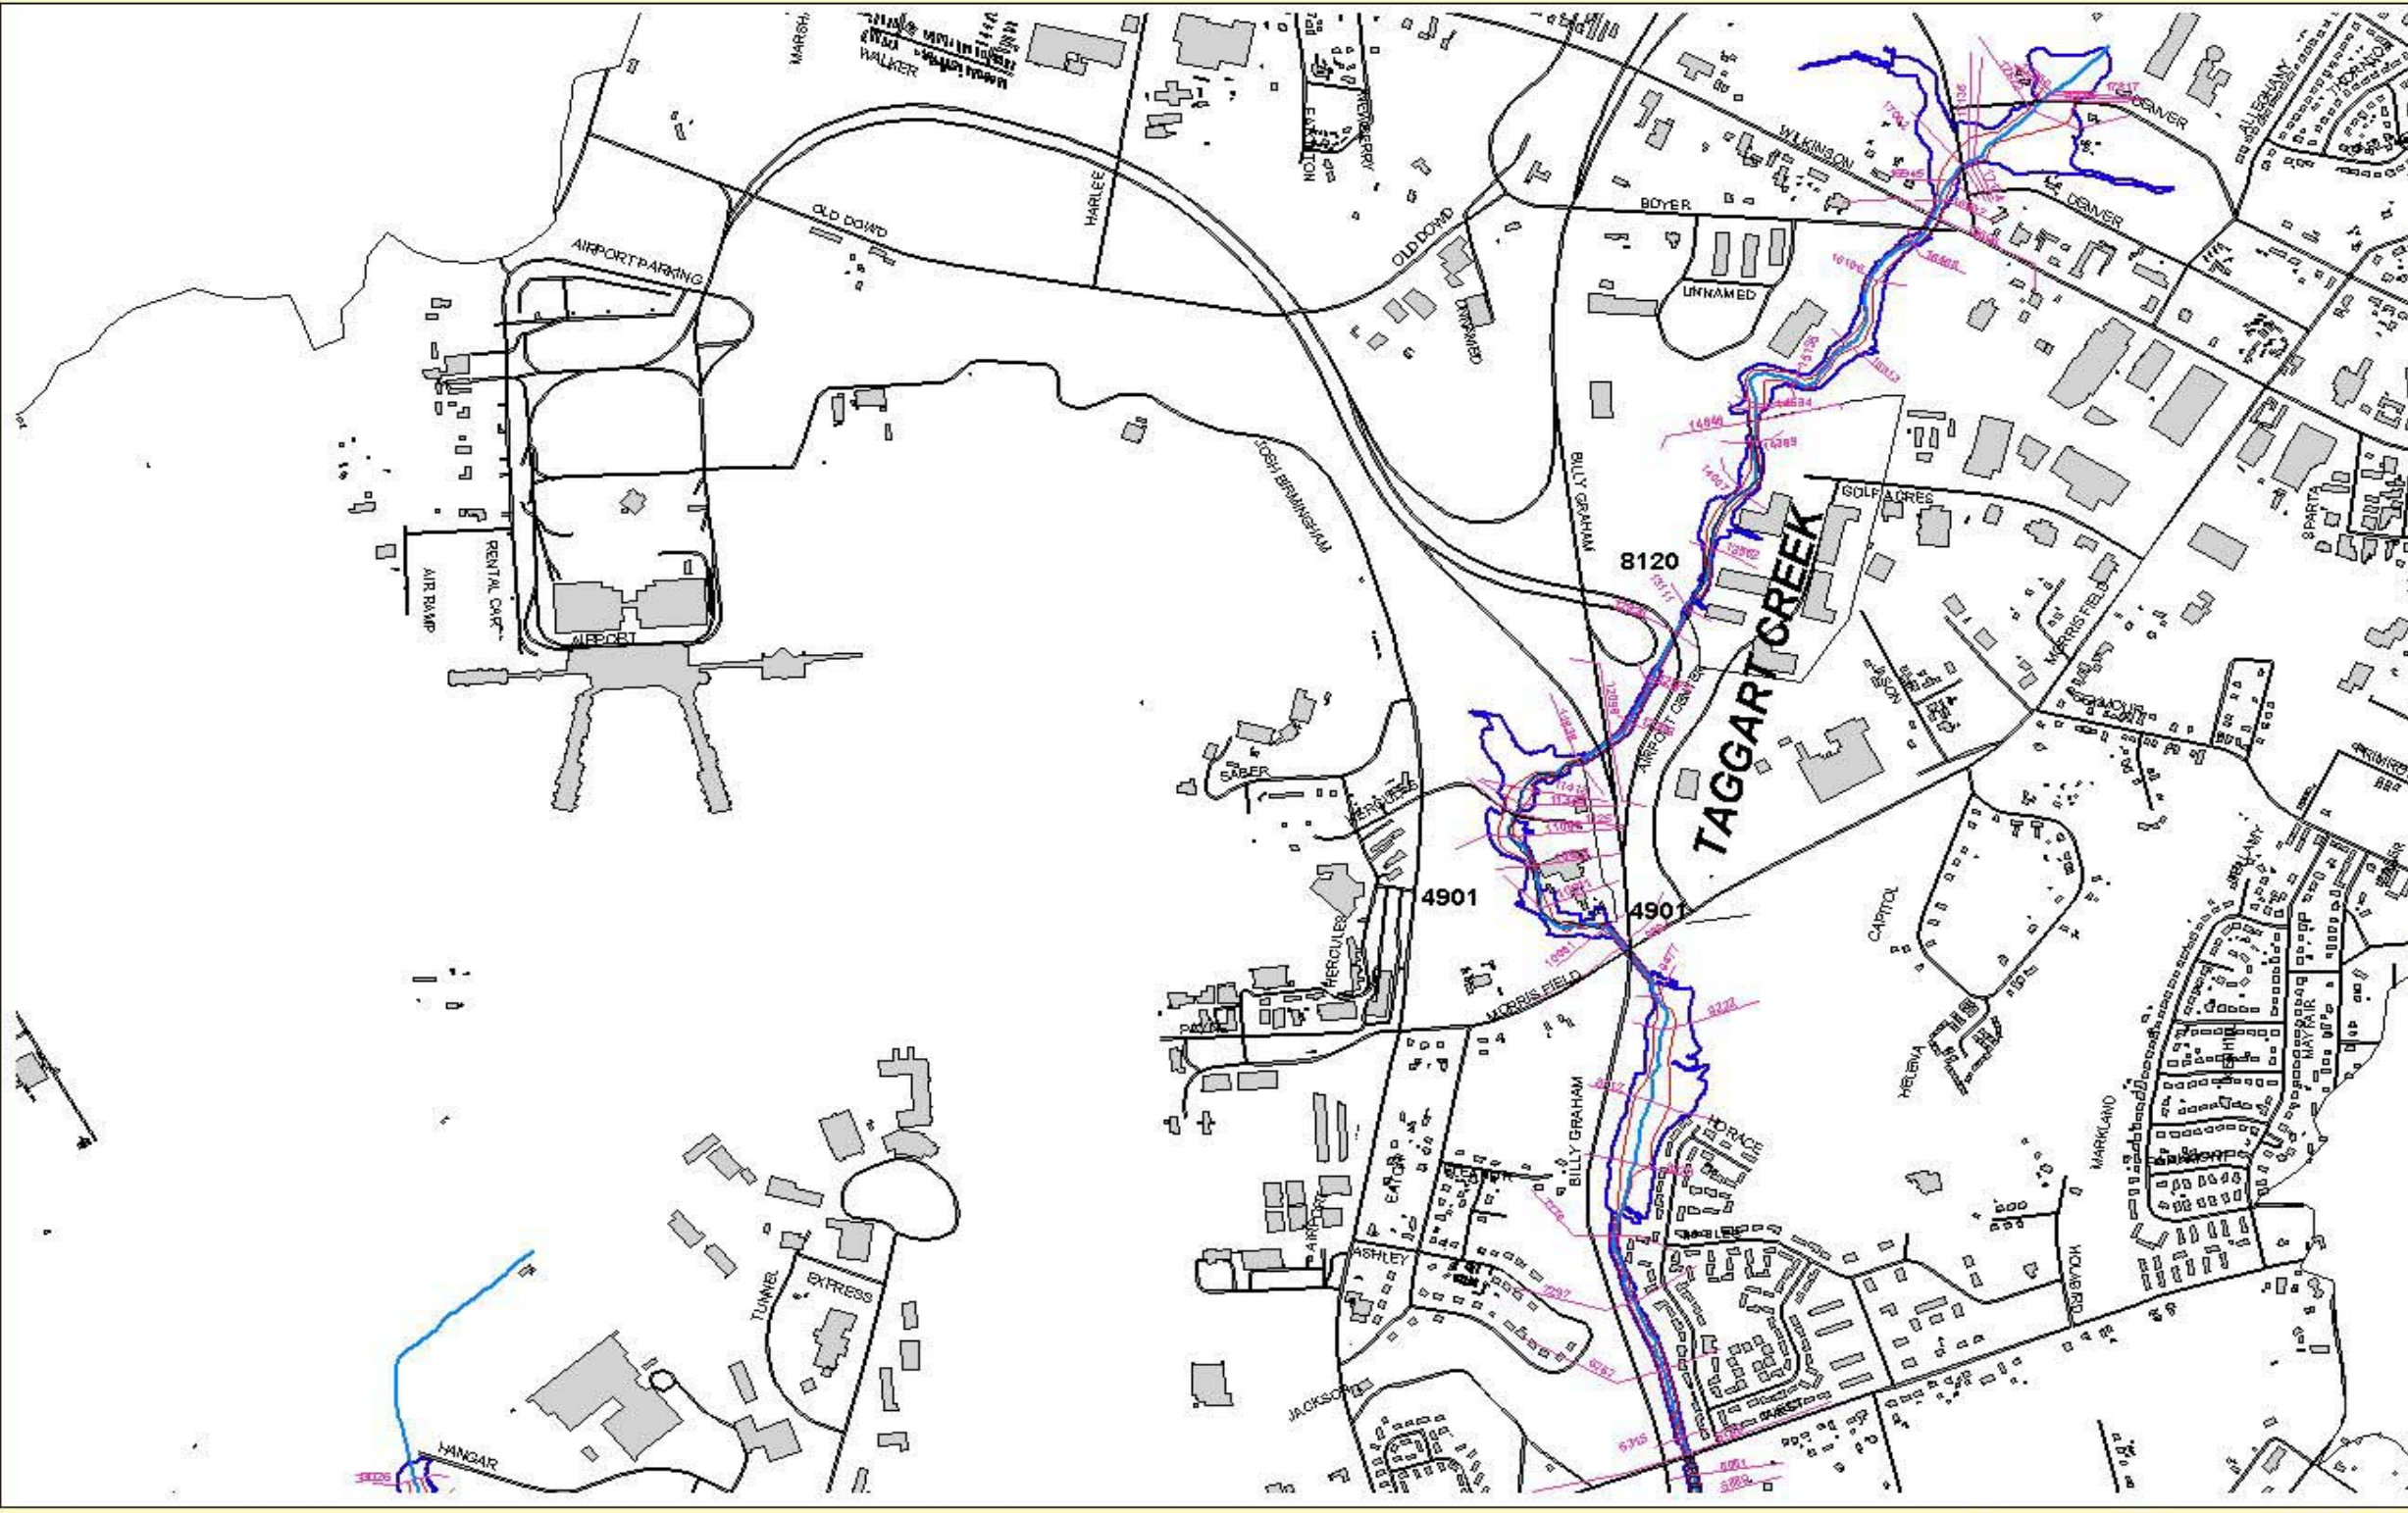
# Figure 18 Study No. 3, Sugar Creek Watershed Proposed Improvements, Sheet 1

The improvement alternative analyses use the FCF, which is based on the future ultimate built-out condition. Figure 18 illustrates these recommended improvement alternatives.

Several alternatives were considered to resolve flooding damage and bank stability problems in the Sugar Creek watershed. Based on the flood damage assessment and B:C analysis, the recommended improvements for Sugar Creek and Coffey Creek include a combination of floodwall and levee construction, leaving some flooded structures unprotected, elevating some structures, purchasing structures, and constructing a wetland (Figure 18). The damages removed from structures within 1 percent chance FCF are estimated to be \$18,959,500 (2001 dollars). The total estimated cost for the recommended improvements is \$5,373,700. Some structures are left unprotected because, relative to the damage assessment, it is not cost-effective to purchase/protect properties.
