Alteration Due to Mining Activities

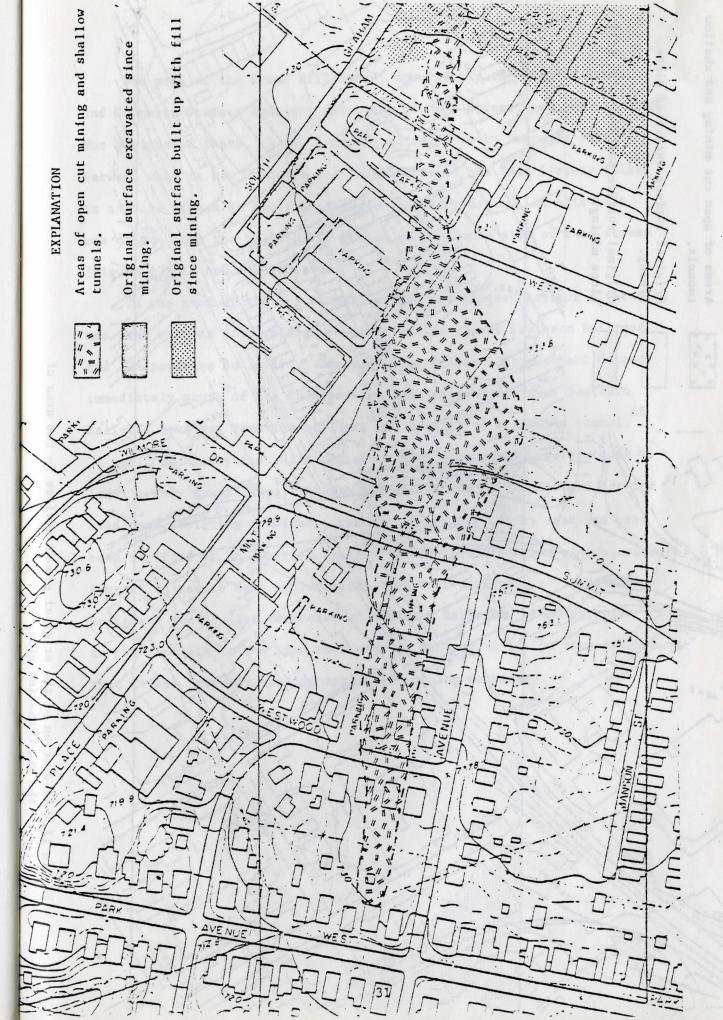
Figures 16 and 17 show areas of probable surface alteration due to mining. Surface alteration here includes exploratory trenches, open cuts for mining along the vein, and shafts, all presently filled with rubble. Future surface alteration along the Rudisill lode should be made with caution since cave-in or settling of shallow workings are possible.

Alterations to the ground surface along the Rudisill lode zone, since mining stopped, has primarily been a leveling process of grading down high area and filling in low areas as the City of Charlotte has grown outward (figures 16 and 17). Most changes have resulted from industrial and business development or road building. Small excavations for houses and small businesses will not be considered here.

The major change in the area of the Rudisill mine has been the excavation between Summit Avenue and Bland Streets removing much of the north and northwest sides of the original hill. The ground surface now approximately level with Mint Street is nearly 25 feet below the original summit.

At least one section of shallow mine tunnel was literally removed during that excavation.
